Subj: Comments On Draft NRC Bulletin On Loss Of Fill-Oil In
Rosemount Transmitters

PRESENTATION TO CPGR ON
PROPOSED GENERIC LETTER ON
DEFICIENCY IN BWR THERMAL LIMITS
CALCULATIONS CAUSED BY CHANNEL BOX BOW

SUBJECT: CORRECTION OF DEFICIENCY IN BWR CRITICAL POWER RATIO CALCULATION
DUE TO CHANNEL BOX BOW

NRC INFORMATION NOTICE NO. 89-69: LOSS OF THERMAL MARGIN CAUSED BY
CHANNEL BOX BOW

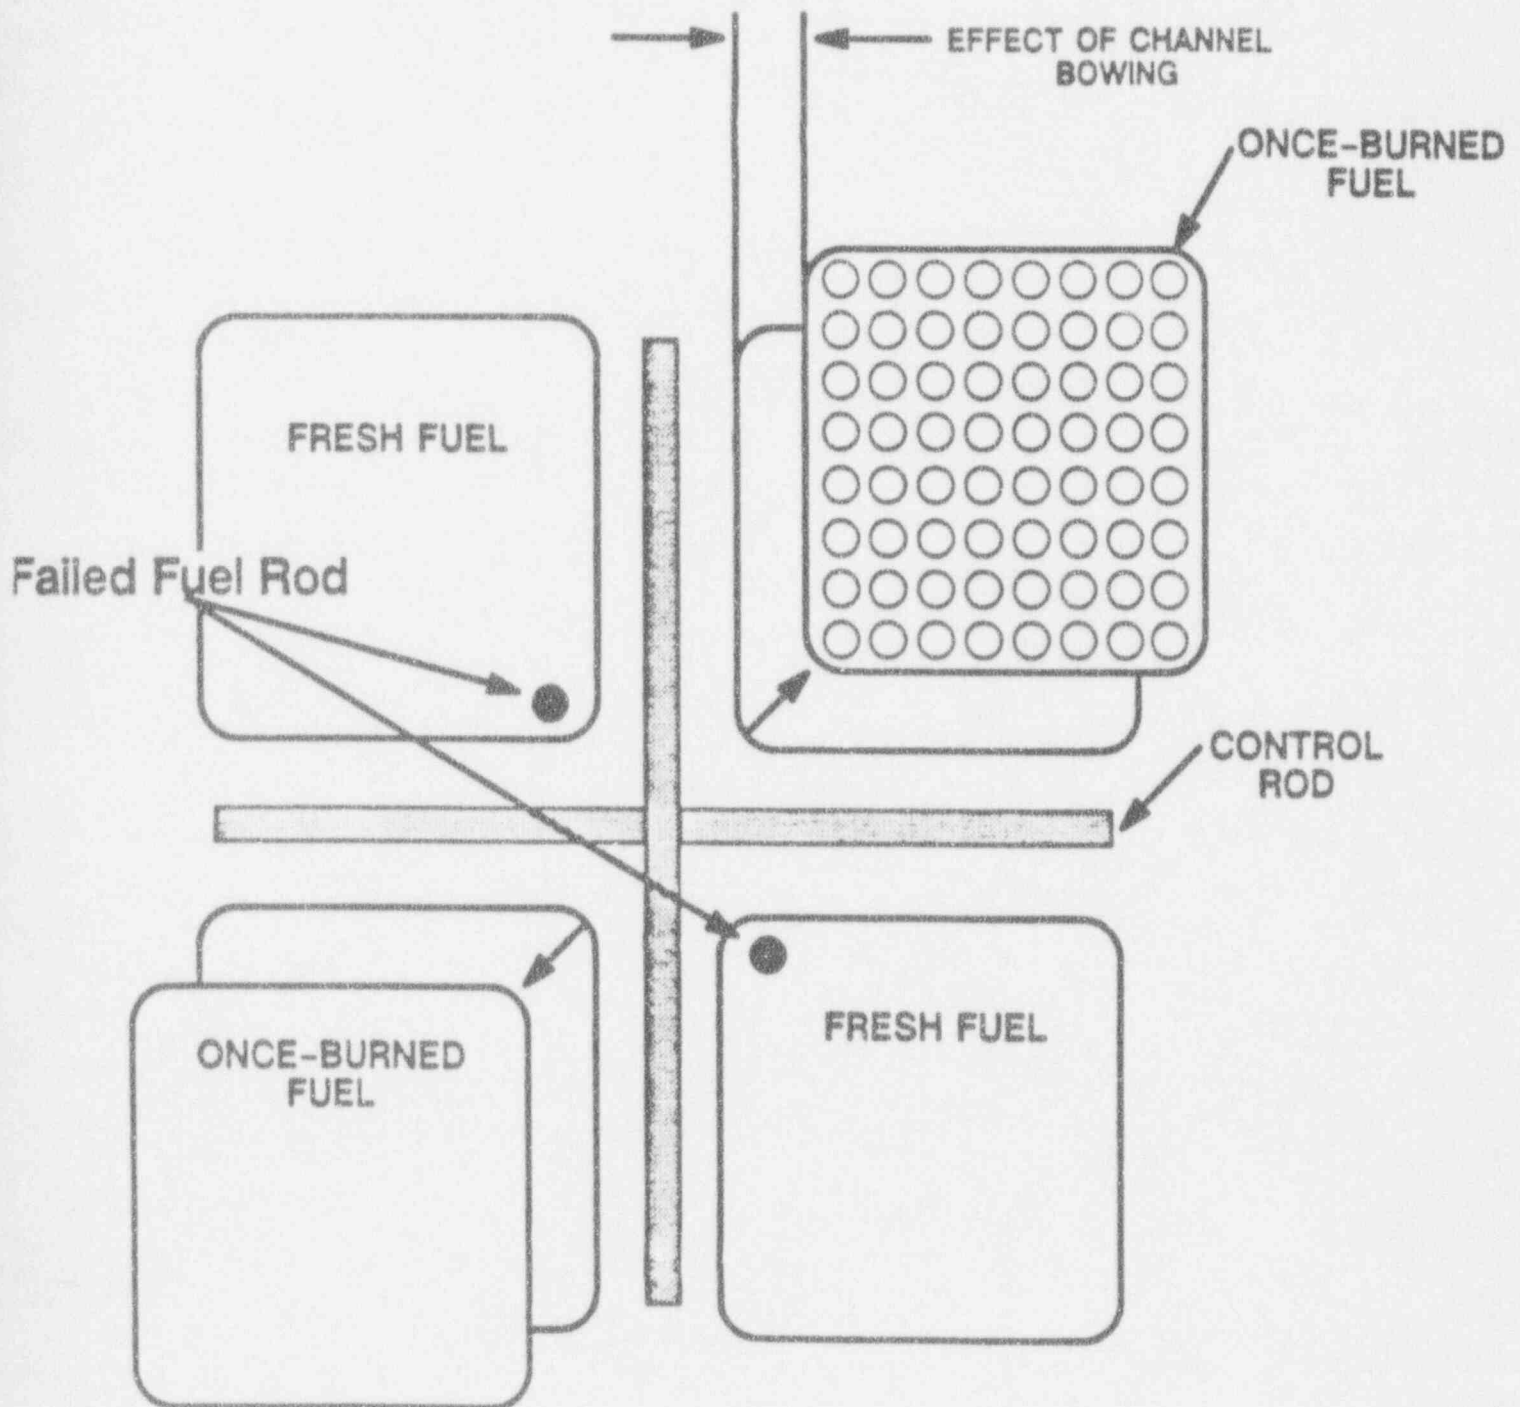
Figure 1
Channel Bow

axial Representation of Channel Bow

This side sees a higher differential growth

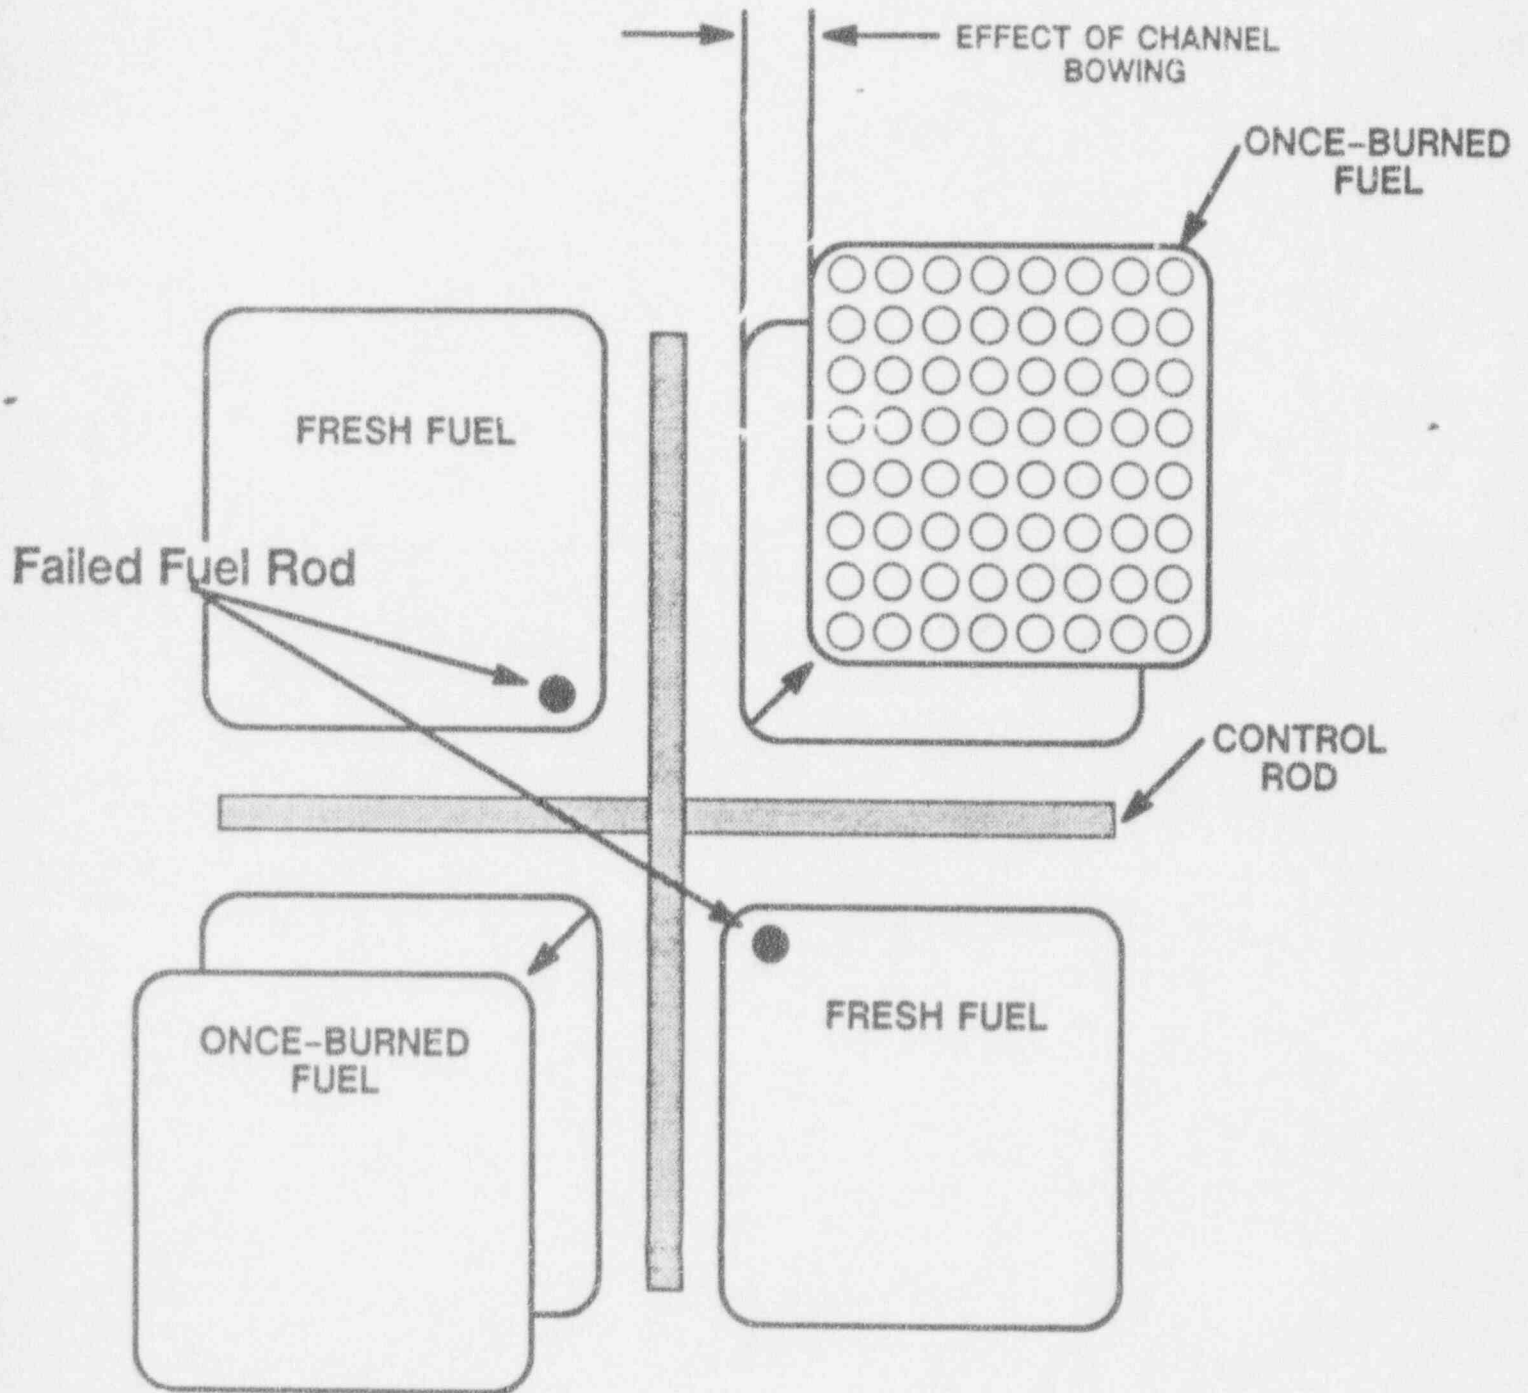
Figure 1
Channel Bow

The failed fuel rods were located symmetrically in the core. The fuel assemblies containing the rods that had failed were located adjacent to once-burned fuel assemblies with highly exposed fuel channels (see Figure 1). These fuel channels were in their second bundle lifetime and had excessive channel bowing. In each assembly with failed fuel, the corner rod facing the adjacent control rod was heavily oxidized and the cladding was penetrated just below the top spacer grid. In addition, each of the four failed rods had typical secondary internal hydriding damage near the bottom of the fuel rods, resulting in loss of fuel material.

modeling errors were caused by neglecting the effects of channel bowing and the geometric variation between the reloaded and once-burned fuel assemblies. These effects substantially increased the widths of the control rod water gaps for the assemblies that contained these four fuel rods beyond that assumed in the plant process computer calculations. The increased neutron moderation associated with the increased water gap widths led to very high localized power peaking at these four fuel rods. However, these effects were not properly accounted for in the MCPR calculations. For some time, the plant operators were misled by these erroneous MCPR calculations and were operating the plant in steady-state beyond the MCPR safety limit.

The modeling error of generic concern to all BWRs, regardless of the fuel supplier, relates only to the greater-than-expected bowing of fuel channel boxes, which contributed about 15 percent error in the calculated MCPR value for this foreign facility. Channel bowing is a manifestation of differences in the channel growth of opposite sides of the channel box and is proportional to channel growth. The information obtained by the NRC indicates that the channel growth shows an accelerated trend at higher burnup exposure, especially when the fuel channels are being reused in their second bundle lifetime. The effect on core operating MCPR is magnified when fresh fuel is located adjacent to the bowed fuel channels. Core operating limits imposed by technical specifications may be exceeded if the reduction in margin caused by fuel channel bowing is not properly accounted for in the plant process computer for thermal limits monitoring. Based on a preliminary evaluation by BWR fuel vendors of U.S. reactors, the impact of the new data on actual versus calculated MCPR values is expected to range from 0.0 to 0.03 CPR units. However, the impact could be much greater (about 15 percent) for any reactors operating with fuel channels being reused in their second bundle lifetime.
