IE Information Notice No. 81-27
September 3, 1981
Page 1 of 2

FLAMMABLE GAS MIXTURES IN THE WASTE GAS
DECAY TANKS IN PWR PLANTS

IE Information Notice No. 81-28
September 3, 1981
Page 1 of 2

FAILURE OF ROCKWELL-EDWARD MAIN STEAM
ISOLATION VALVES

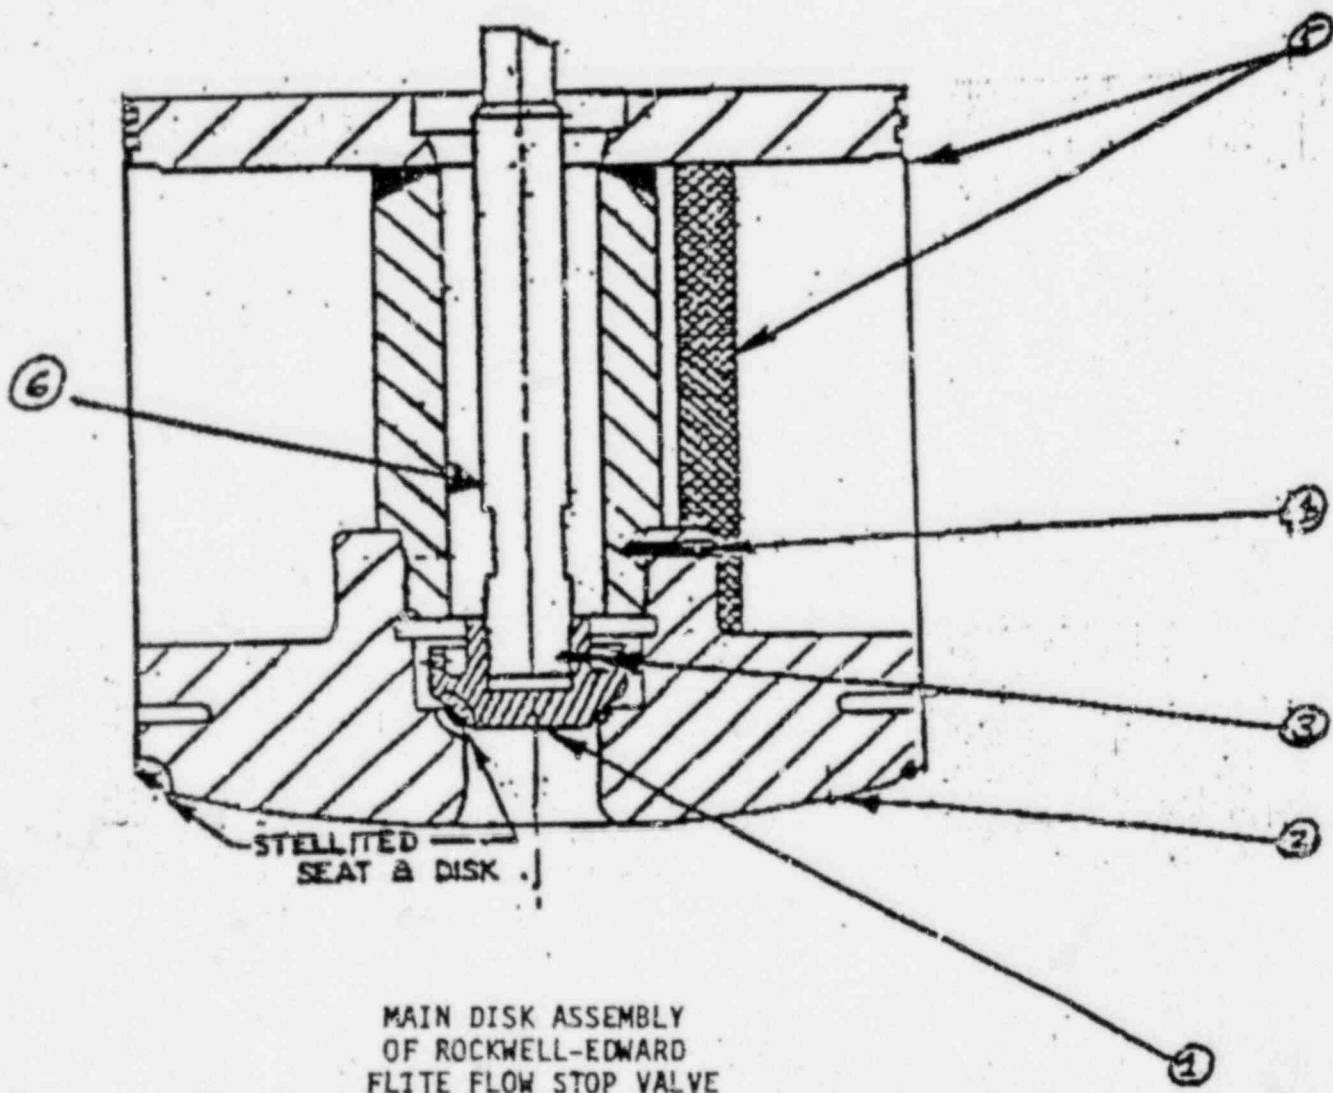
FIGURE 1

The valve components that have failed are shown in Figure 1. The piston assembly is attached to the main disk (2) by thread engagement and then restrained from unwinding by pin (4). The stem disk (1) is also attached to the stem (6) by thread engagement tightened to 1050 ft-lb torque specifications with an anti-rotation restraint provided by pin (3). The valve is closed primarily by spring forces. The valve is installed so that reactor steam pressure works to seat the main disk. The stem disk provides pressure equalization action to reduce over-seat load for opening the main disk against system pressure.

The failures that have occurred involved a mechanical separation of valve internals. This separation was either at the stem-to-stem-disk threaded connection or at the main-disk-to-piston threaded connection. Either failure permits the main disk to be free of the stem. The failure in either mode results from failure of the threaded connection, which in some cases is caused by vibration-induced rotation of the disk so that it becomes disconnected from its threaded mate. Such rotation is believed to be caused by or aided by the propensity of steam flow to produce vibration and to create turning forces on valve internal components when antirotation restraint is inadequate due to a failed or missing pin. Other contributing causes are believed to result from reassembly of the valve after disassembly at the site; such reassembly may have included inadequately torqued connections and failure to properly install the pins. Also, an examination of spare parts at the Brunswick site showed that the thread dimensions on the stems and stem disks did not meet drawing tolerances.

1. In January 1976, the Brunswick, Unit 2, "D" steam line inboard valve main disk separated from the piston. There was no evidence that pin (4) was installed.

2. On January 30, 1979, the Brunswick, Unit 2, "A" steam line inboard valve stem disk separated from the stem. A square pin was used in the round hole at point (3). The corners of the pin experienced high stress, thereby causing cracking of the pin.

3. On January 15, 1981, the Brunswick, Unit 2, "C" steam line outboard valve main disk separated from the piston. There was no evidence that pin (4) was ever inserted. This was deduced from finding the hole not deformed and no sign of a plug weld.

4. On March 5, 1981, the Hatch, Unit 2, "A" steam line inboard valve stem disk separated from the stem. Pin (3) was not fully inserted.
5. On March 30, 1981, the Brunswick, Unit 1, "C" steam line outboard valve stem disk separated from the stem. Pin (3) failed and was not recovered.

6. On July 2, 1981, the Brunswick, Unit 2, "C" steam line inboard valve stem disk separated from the stem. Pin (3) was not properly installed.
7. On July 18, 1981, the Brunswick, Unit 2, "D" steam line inboard valve main disk separated from the piston. Pin (4) was not fully inserted.

Detailed investigation of the July failures at Brunswick, Unit 2, led to the preliminary findings of possible excessive vibrations on valve internals from steam flow turbulences created by the piping direction changes. In addition, there was evidence of loose thread connections. Further investigations and evaluations are currently in progress. Preliminary corrective actions by the licensee include increasing the stem pin size from 5/16-inch to 3/8-inch, using three pins instead of one or two pins, and increasing the hole depth 1/8-inch into the stem. In addition, corrective actions for the main-disk-to-piston connection include adding an extra pin (of the same 1/2-inch size) and increasing the hole depth by 1/8-inch.
