SUBJECT: Broken Thermal Shield Bolts at Oconee Unit 1

Re: Oconee Nuclear Station
Docket No. 50-269
RO-269/81-11, Supplement 2

Thermal Shield Bolt Failure Supplementary Information

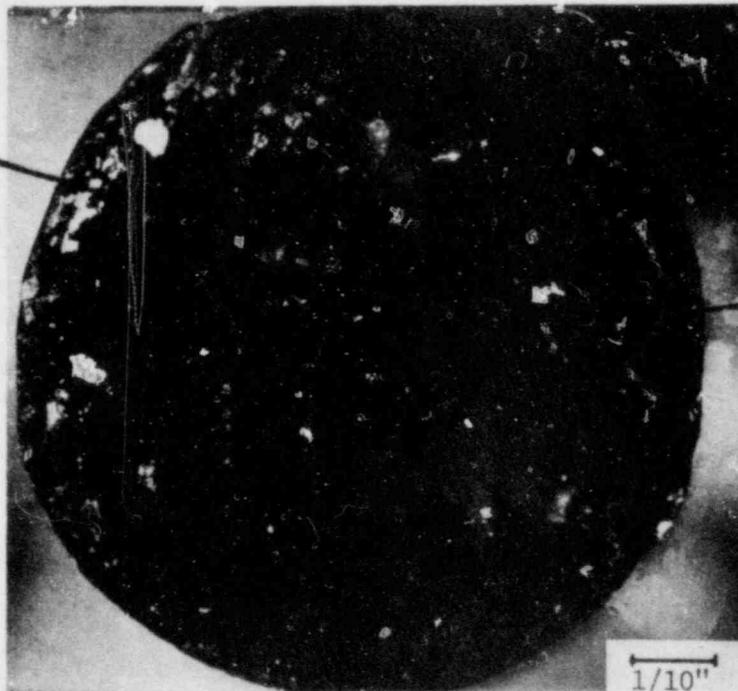
Figure 1. Macrograph of Fracture Surface on Bolt Shank 1

All of the broken bolts examined had fractured in or near the fillet between the head and shank. An island of transgranular fracture (as shown in Figure 1) with evidence of fatigue striations and/or crack arrest marks was surrounded by intergranular fracture, with evidence of grain boundary corrosion attack. No shear lips or other macroscopic indications of ductility were present on the fracture surfaces. The initiation and propagation of intergranular cracks with branch cracking in this material is consistent with a form of an environmentally assisted cracking process - stress corrosion and/or corrosion fatigue.

The factors which seem most likely at this time to have contributed to the lower thermal shield bolt failure are the rather pronounced microstructure transition at the head-to-shank fillet in the lower thermal shield bolts and the potential for this "metallurgical discontinuity" to increase the sensitivity to stress corrosion cracking and corrosion fatigue.
