UNITED STATES  
NUCLEAR REGULATORY COMMISSION  
WASHINGTON, D. C. 20555

Docket No. 50-306

FACILITY: Prairie Island Unit 2 (PI-2)

SUBJECT: SUMMARY OF MEETING ON OCTOBER 29, 1981 - REACTOR COOLANT PUMP SHAFT  
CRACK

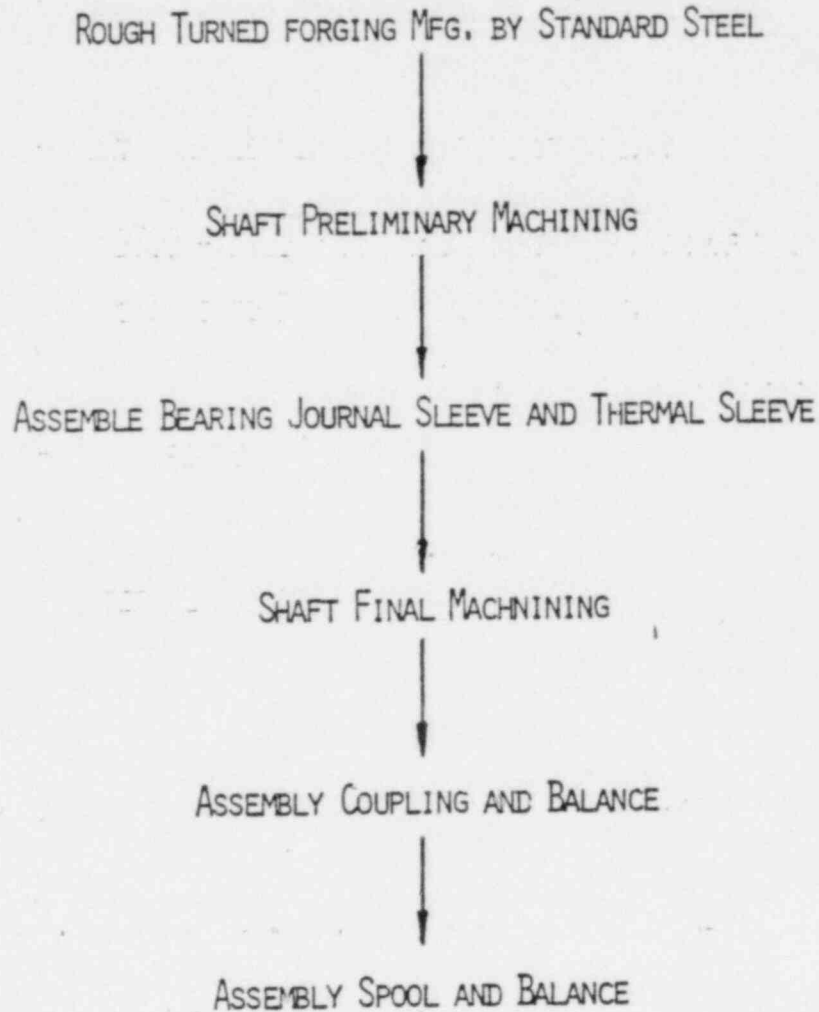
SHAFT REWORK ~ MRR 9052

Westinghouse's detailed examination revealed the crack was initiated from a pin hole in the pump shaft. The metallographic examination of the fractured surface indicates that the crack propagated due to high cycle fatigue. A review of the manufacturing history of the failed pump showed the pin that was inserted into the pin hole of the shaft was twice welded to the sleeve that could possibly impose a high residual stress in the vicinity of the pin hole of the shaft. This twice welding operation and the closeness of the welding operation to the shaft pin hole is unique to the failed PI pump. Although this condition could reasonably explain the high residual stress that could result in the crack initiation localized in the vicinity of the pin hole, the propagation of the crack (i.e., 270°-300° around the shaft) cannot be explained by any identified dynamic loads used in the fatigue stress analysis. Using the most conservative load values, the fatigue stress analysis shows the Factor of Safety to be 1.61 (61% margin) indicating that the observed failure should not have occurred. The licensee has engaged a third party consultant to review Westinghouse's effort regarding the cause of crack propagation.

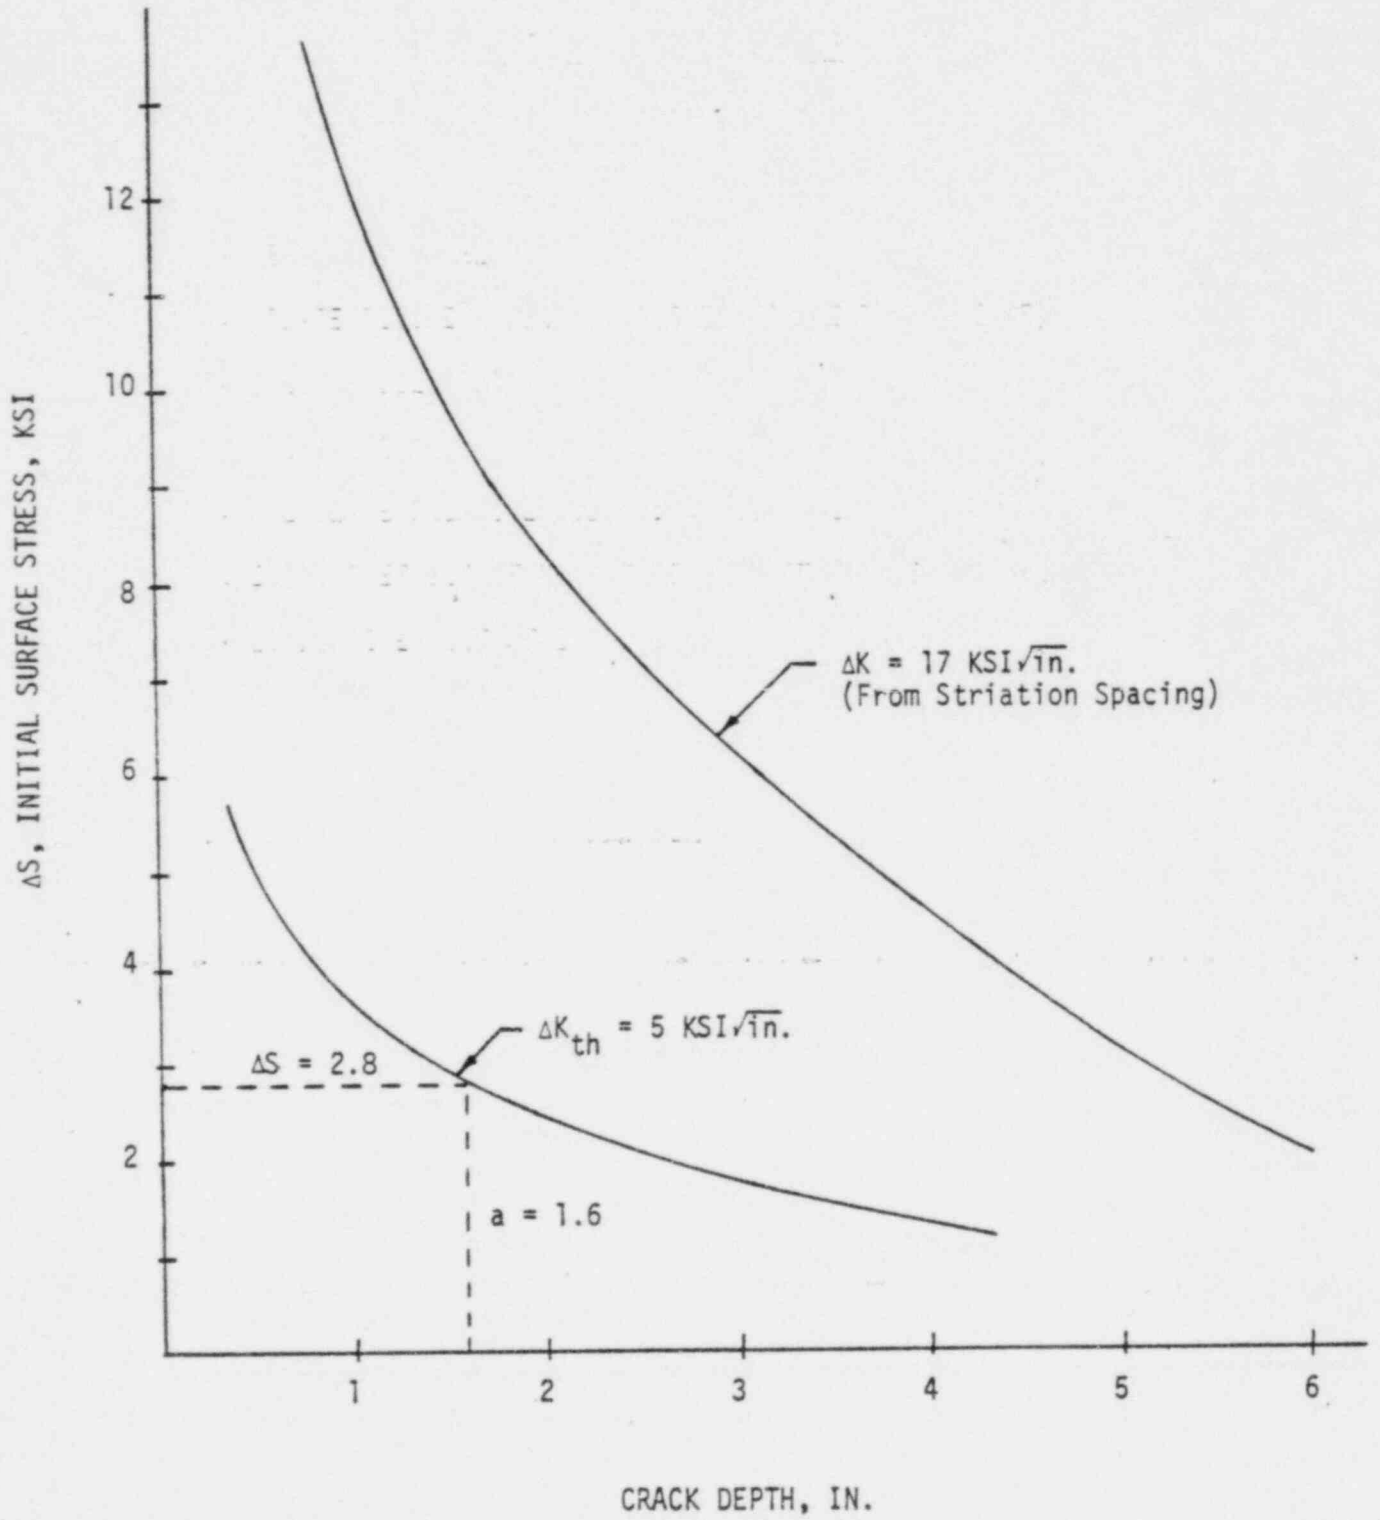
STRESS VERSUS CRACK DEPTH

- LOCALIZED HIGH STRESS DUE TO WELDING AT PIN HOLE - NO CRACK.
- PIN FRETTING PRODUCES ADDITIONAL HIGH LOCAL STRESS WHICH INITIATES AND PROPAGATES SMALL CRACK WITHIN HIGH CONTACT STRESS FIELD. CRACK ARRESTS AS IT LEAVES HIGH CONTACT STRESS FIELD (0.1 IN.).
- NO KNOWN LOADS OF MAGNITUDE REQUIRED TO PROPAGATE CRACK TO FAILURE.

(NEED TWO TO THREE TIMES KNOWN LOADS)

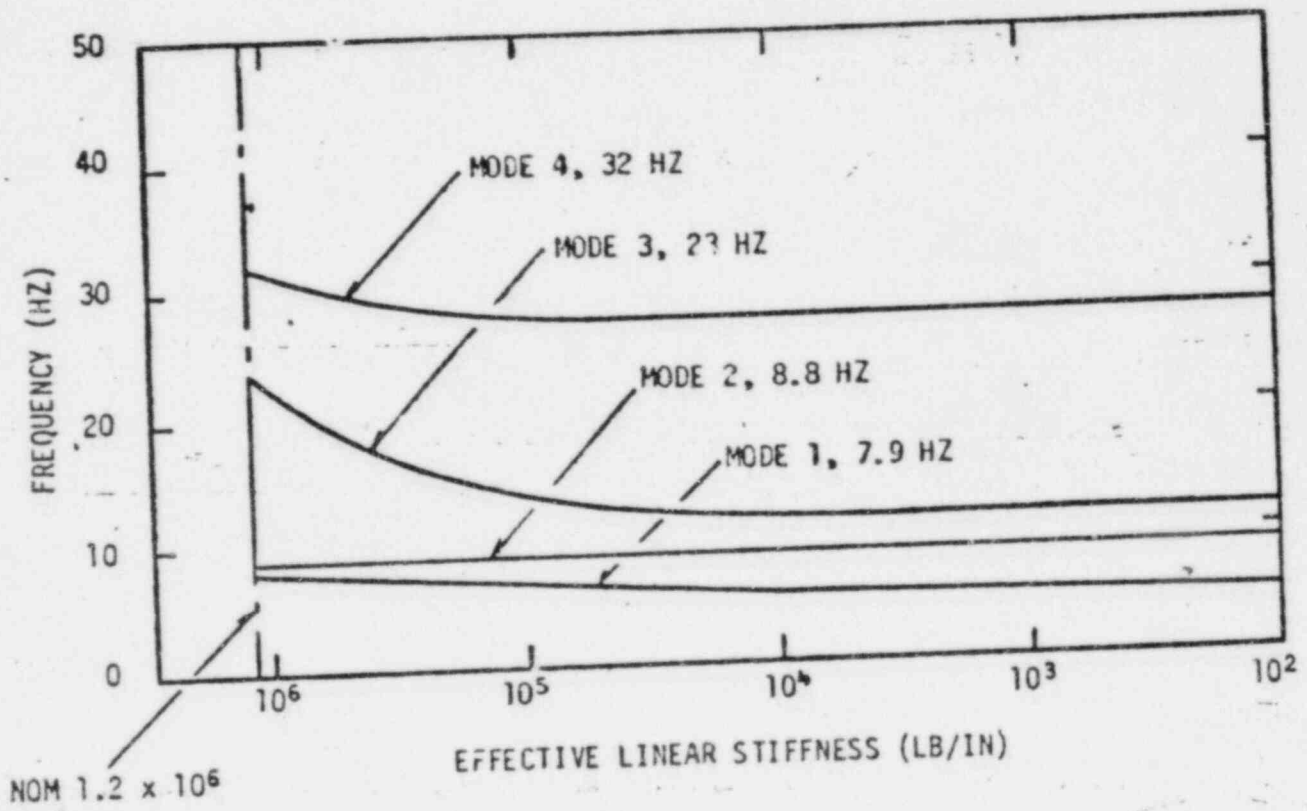
EFFECT OF LOOSE LOWER MOTOR BEARING  
ON LATERAL MODES

- AXIAL AND TORSIONAL MODES DO NOT APPEAR TO BE POTENTIAL SOURCES OF THE PROBLEM
- THE LATERAL MODE WHICH PRODUCES THE HIGHEST RELATIVE VIBRATION RESPONSE IS THE 7.9 HZ BENDING MODE
- THE ALTERNATING STRESSES ASSOCIATED WITH THIS MODE ARE SMALL
- THERE IS ALSO NO EVIDENCE OF LARGE DEFLECTIONS ASSOCIATED WITH THIS MODE IN PUMPS WHICH ARE IN NORMAL CONDITION

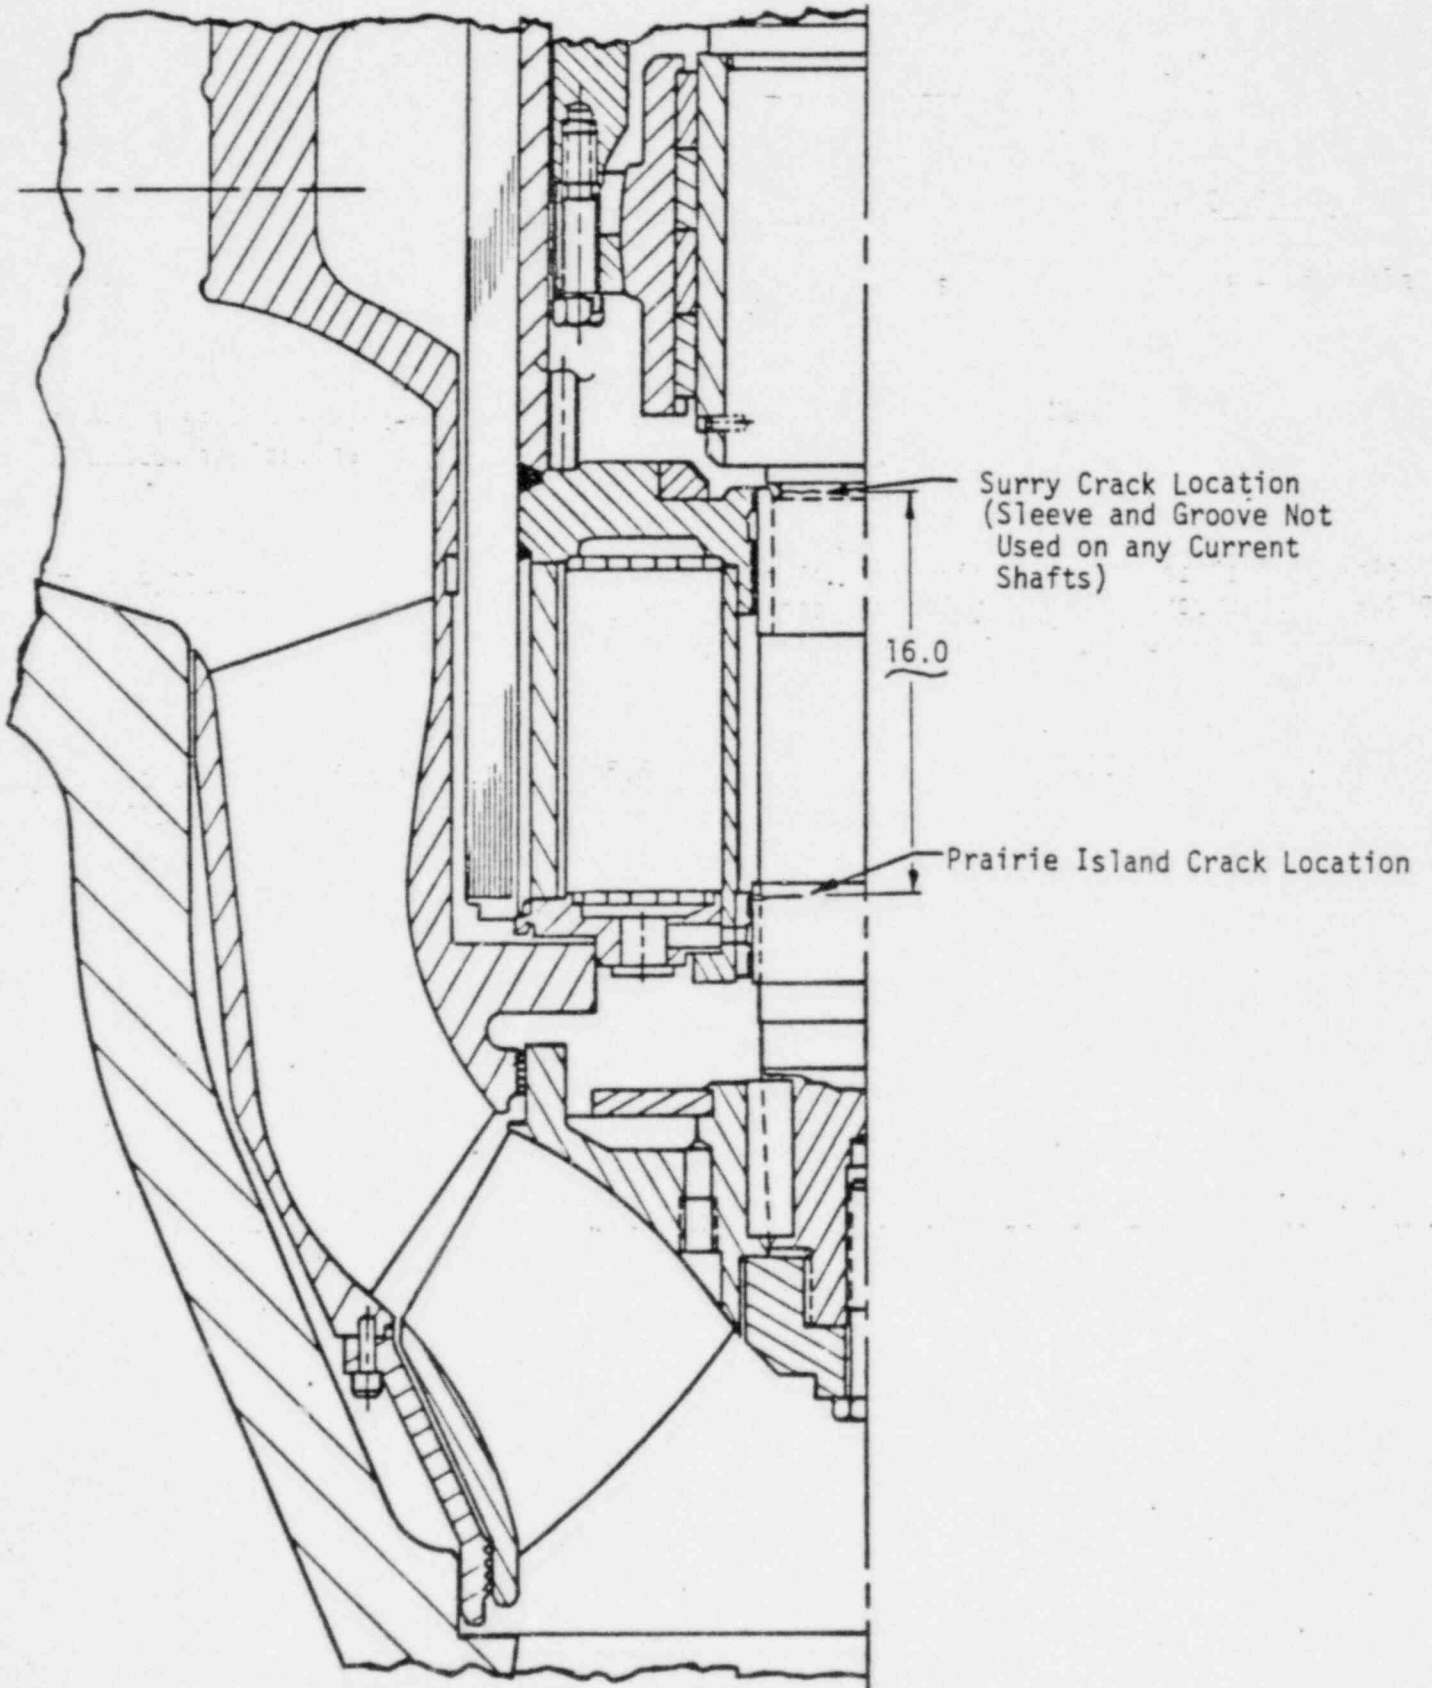
SURRY VERSUS PRAIRIE ISLAND CRACK LOCATION

<u>SURRY</u>	<u>PRAIRIE ISLAND</u>
Failure Location	Upper Sleeve - Grooves	Lower Sleeve - Pin Hole
Thermal Sleeve Shrink-Fit Expected in Service	Yes	No
Type Failure	High Stress Concentration, Low Overstress, Rotating Bending	No Stress Concentration, Low Overstress, Rotating Bending
Stress Concentration in Bending, $K_t$	5.5	2.88
Hydraulic Radial Thrust (lbs.)	5300	5104
Maximum Bending Stress (psi)	2850	1425
Pin Weld Residual Stress	Yes	Yes
Number of Times Weld Applied	1	2
Shaft Material	347 SST	347 SST

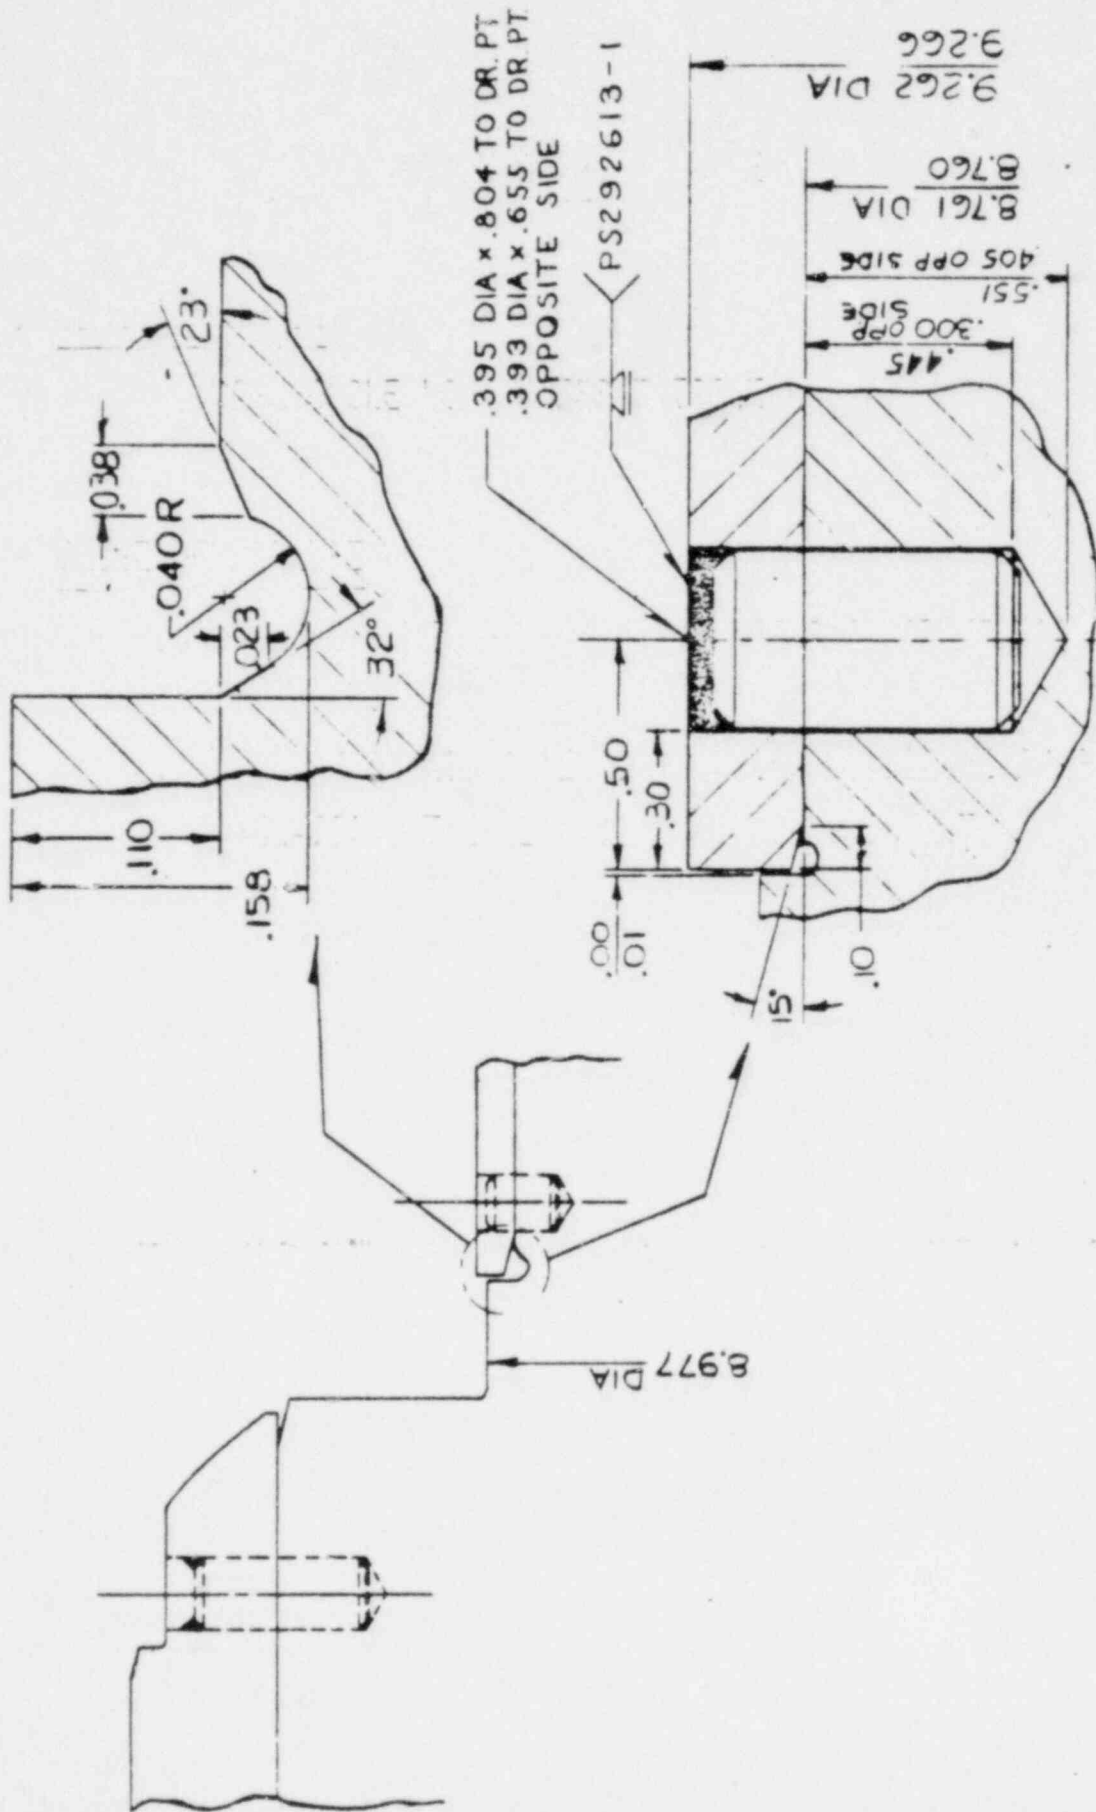
FAILURE LOCATION DETAILS  
SURRY

SURRY SHAFT FAILURE

HIGH CYCLE LOW STRESS FATIGUE

- . SHARP GROOVE -- VERY HIGH STRESS CONCENTRATION

- . MAXIMUM ROTATING BENDING STRESS AT SINGLE PUMP OPERATION AT COLD SYSTEM CONDITIONS JUST SUFFICIENT TO PROPAGATE CRACK ONCE INITIATED

- . HIGH LOCALIZED TENSILE RESIDUAL STRESS AT PIN WELDS PROVIDED SITES OF PRIMARY CRACK INITIATION

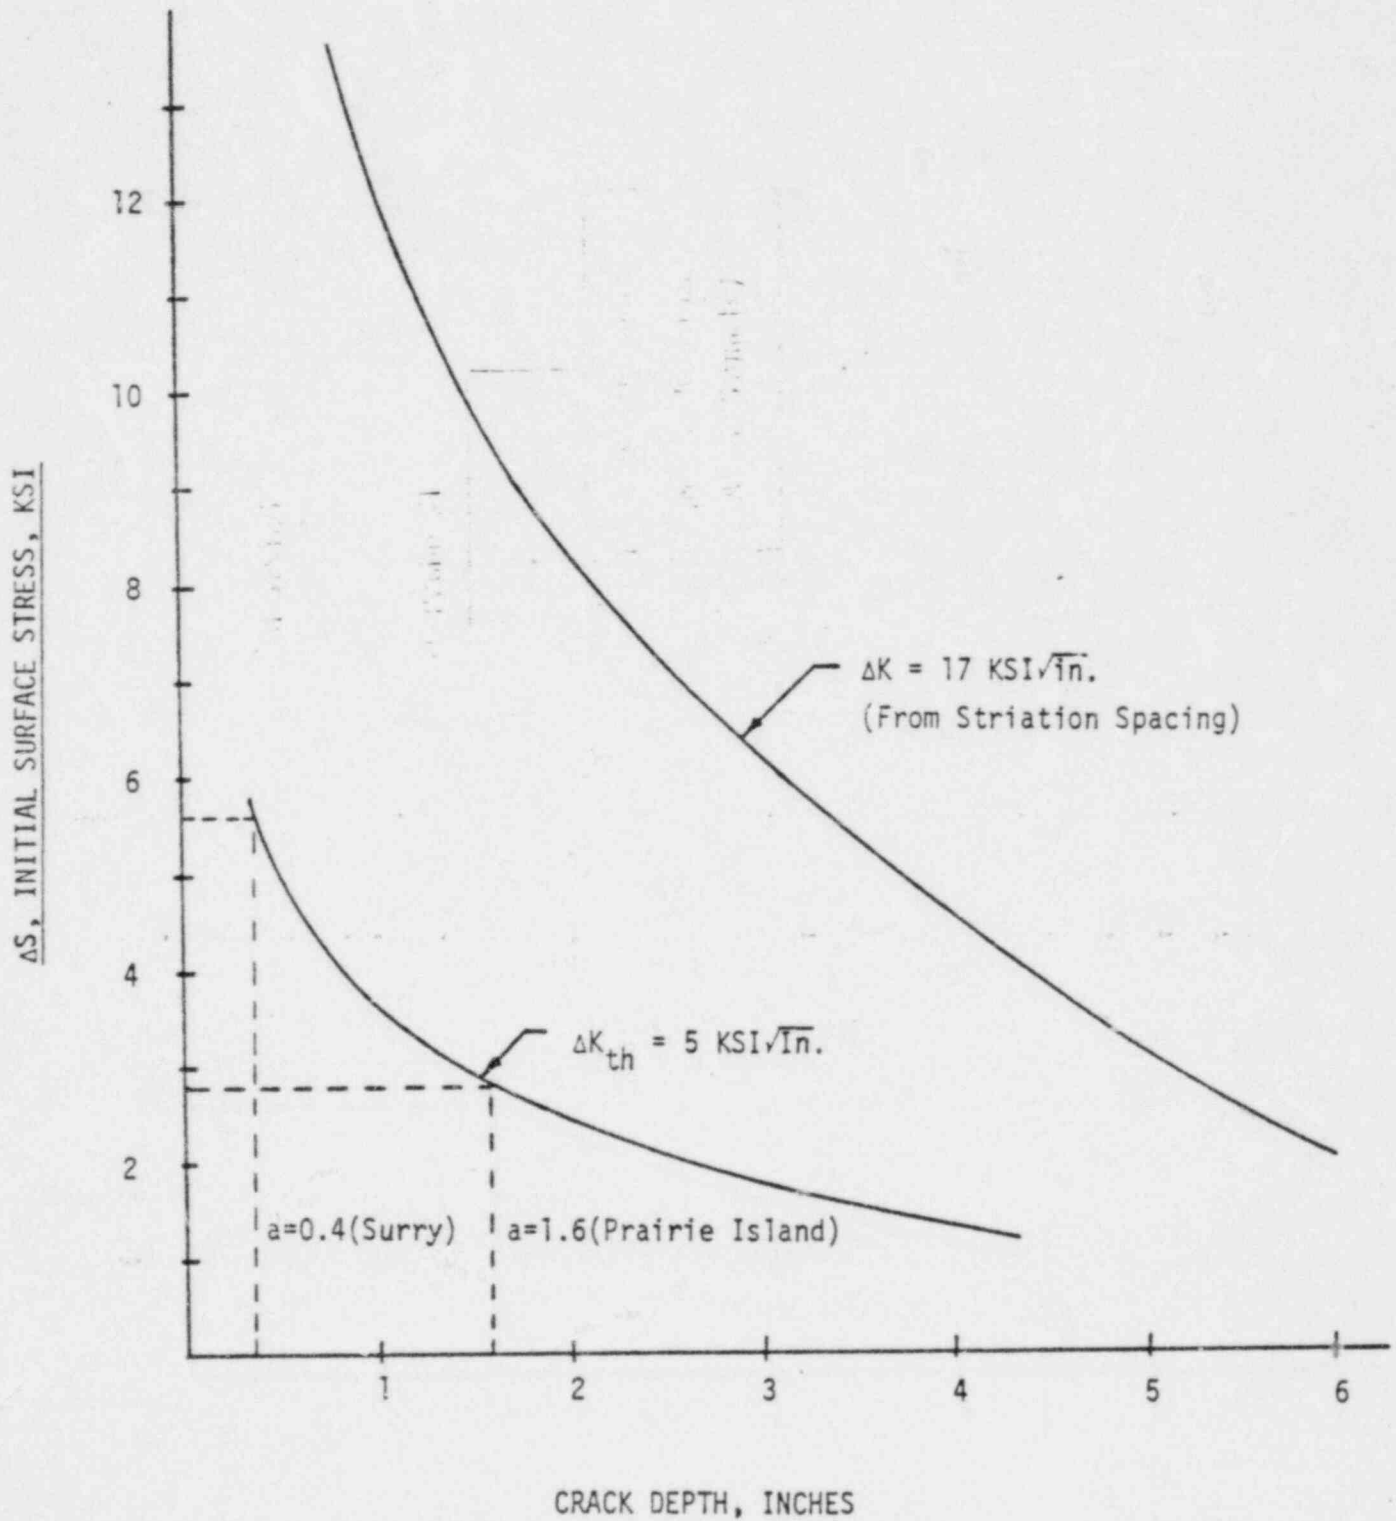
STRESS VERSUS CRACK DEPTH

$$\sigma_a = 2850 \text{ psi}$$

$$k_f = Q(K_t - 1) + 1 = 4.6$$

$$\text{F.S.} = \frac{1}{1.07} = .93 \text{ No Margin}$$
