Public Service  
Company of Colorado  
P.O. Box 840  
Denver CO 80201-0840

February 23, 1990  
Fort St. Vrain  
Unit No. 1  
P-90035

SUBJECT: NRC Inspection  
Report 89-20

Failure to Follow Procedure

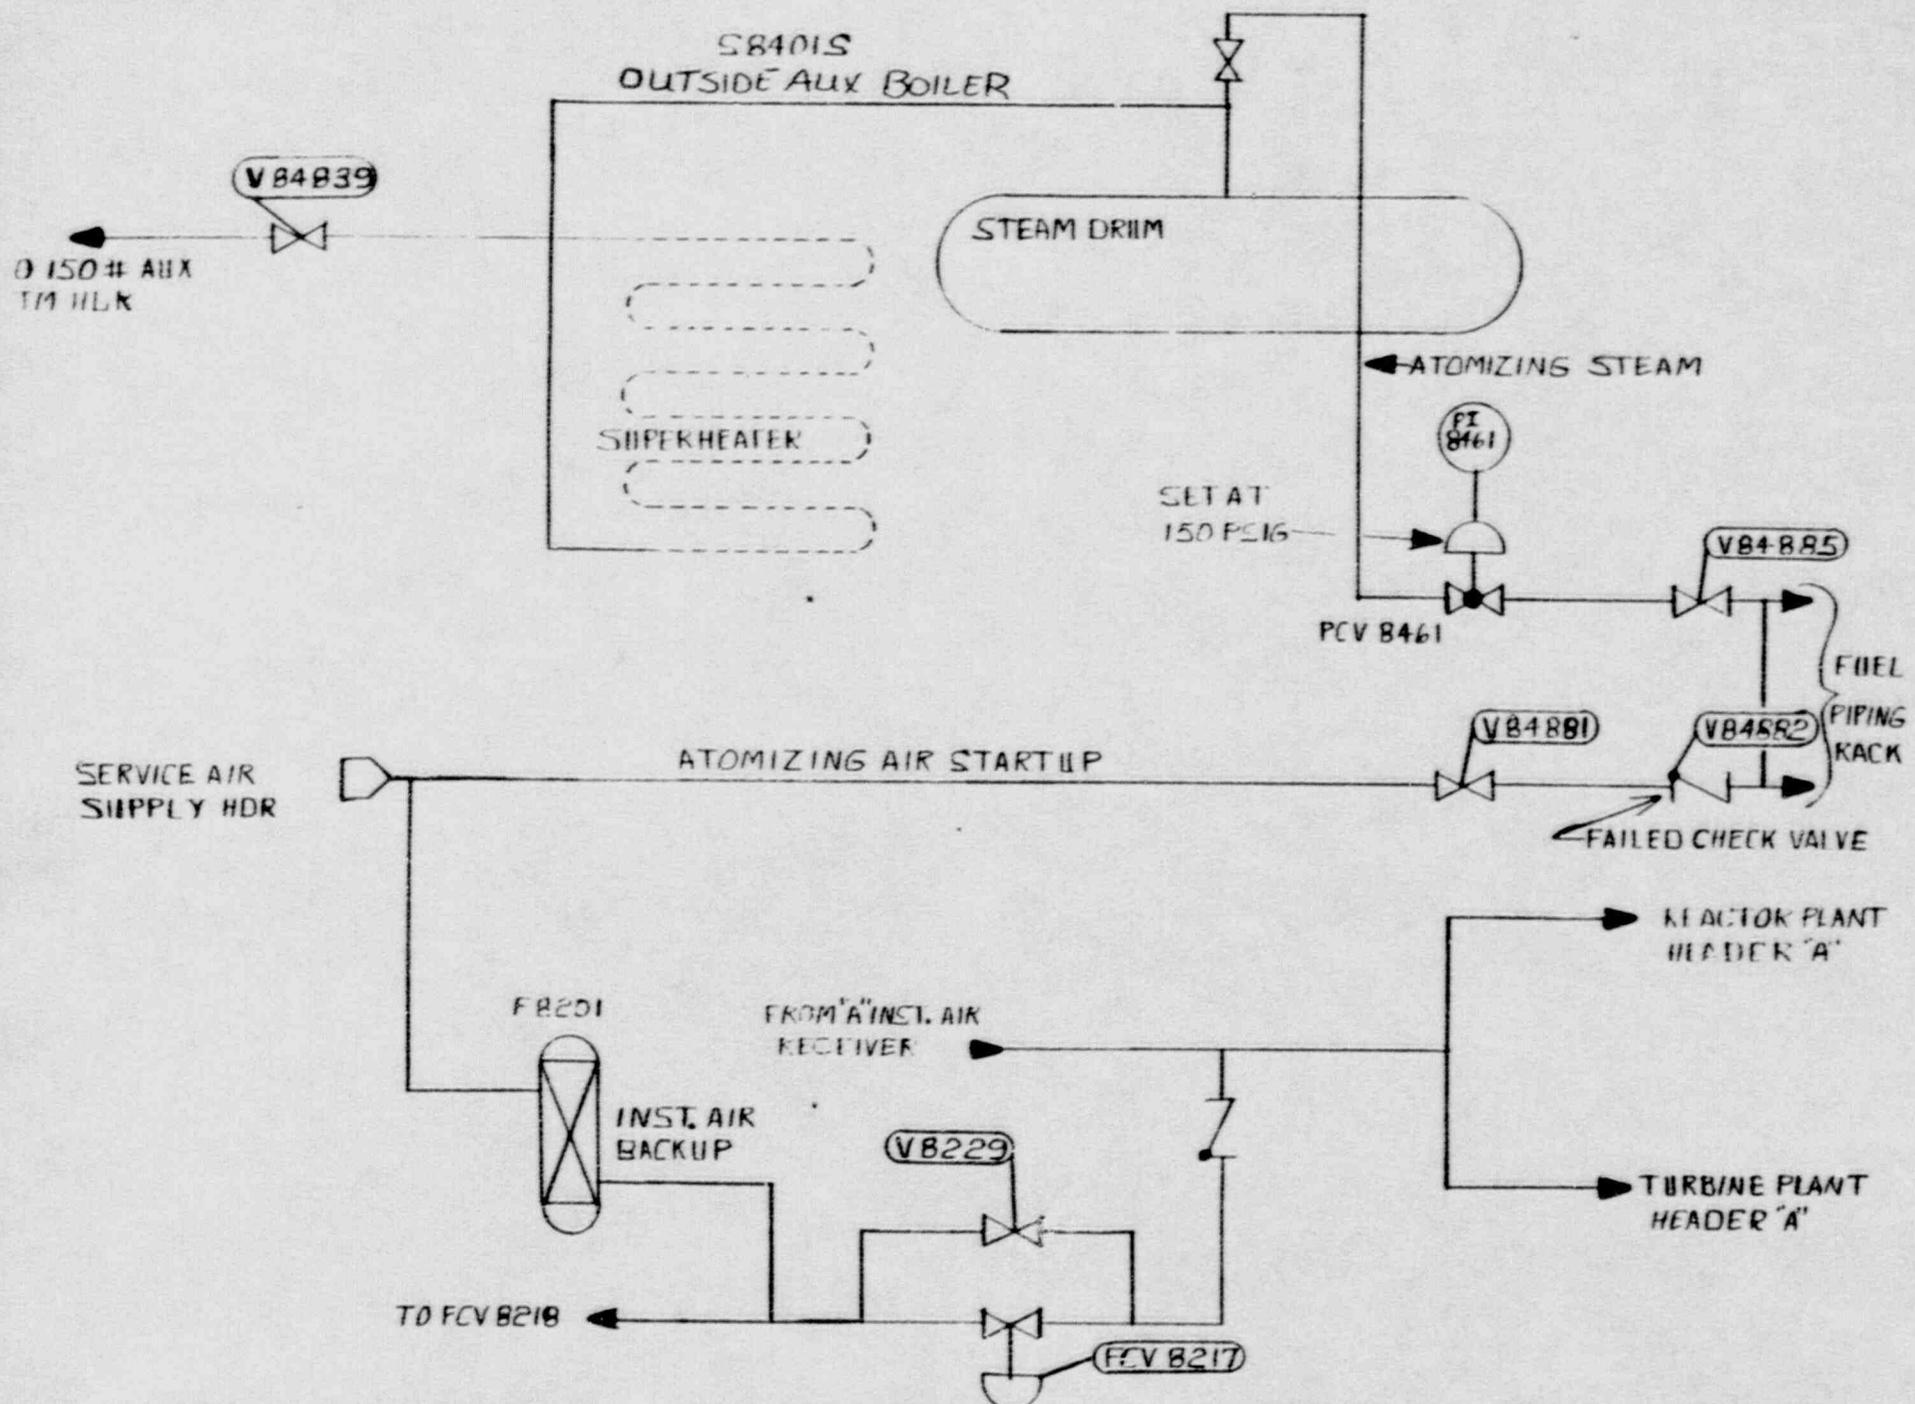
FIGURE 1

Contrary to the above, on September 6, 1989, Valve V-84881 was not closed, which allowed steam to enter the service air system which then entered the "A" Instrument Air System.

The valve lineup error was compounded by multiple equipment malfunctions. It was determined that steam from the IAB had been entering the service air system (reference figure 1) via the open super heater isolation valve (V-84839) on the OAB, which was supplying steam through the open steam atomizing valve (V-84855), then through a failed check valve (V-84882), and finally through an open service air atomizing valve (V-84881). Once the (150 psig) steam entered the service air header (90 psig) it continued on to the normal service air header users. The largest user is the sewage pond. The temperature in this line was increased by the steam sufficient to cause a failure of the PVC piping near the chemical building. Operations personnel also noted that the service air piping near the "A" instrument air dryer was very hot. The heat (reference figure 1) extended through FCV 8217 into "A" reactor and "A" turbine building instrument air headers with the "A" turbine building header being the hottest. FCV 8217 is normally closed and is opened only when abnormally low pressures are detected in the "A" instrument air header. FCV 8217 and its bypass V-8229 were closed when checked which indicated leakage through one or both valves.

V-84882 was cut out of the line and replaced due to gross leakage. FCV-8217 was disassembled and inspected. The valve was dirty and not seating correctly. It was cleaned and tested for leak tightness. V-8229 was disassembled and blue checked which verified the proper seating of the disc with the seating surface.
