Subject: McGuire Nuclear Station Units 1 and 2
Docket No. 50-369
Licensee Event Report 369/90-05

LICENSEE EVENT REPORT (LER)

TITLE (4) Technical Specification Required Flow Rate Verification And Equipment Staging Building Ventilation System Samples Were Not Performed Properly Because Of Inappropriate Actions

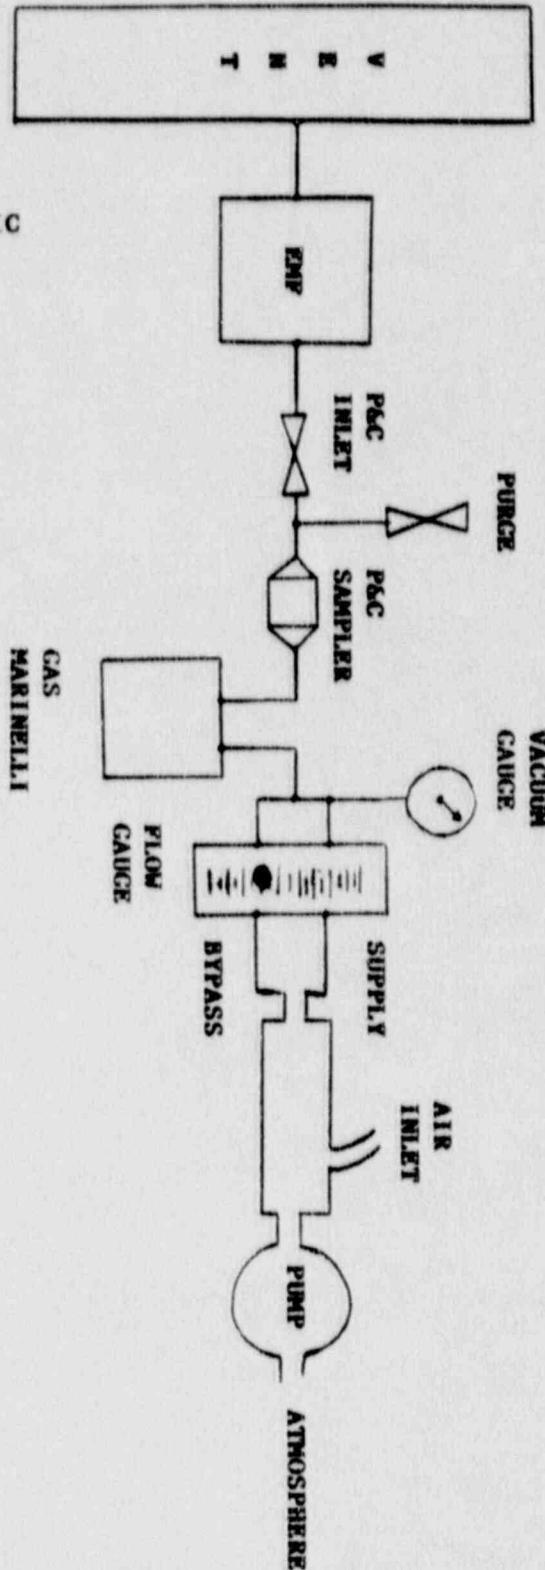
FLOW SAMPLE DEVICE SCHEMATIC

In order to satisfy the TS requirements for inoperable gaseous effluent monitoring and sampler minimum flow devices RP personnel began making 4 hour estimations of flow through the continuous P&C sampler and obtaining radioactive gas samples every 12 hours. (Reference illustration of Sample Device on page 6 of 6.)

At 2000, an RP technician from the next shift performed the 4 hour estimation of flow. He found that the sample pump was off and turned it back on. Upon turning the sample pump on the RP technician thought flow was re-established through the P&C Sampler but the sample valve was still closed and the flow the Technician saw was caused by a leaky fitting on the supply tubing to the pump.

At 2341 on February 21, 1990, RP personnel attempted to perform the required 12 hour sample. At this time, they found that the sample valve was closed indicating that the continuous P&C Sampler had not been receiving flow since the previous 12 hour sample at 1139. The RP personnel then took appropriate measures to restore the continuous sample flow. Appropriate RP staff personnel were informed and Problem Investigation Report (PIR) 0-M90-0057 was initiated to investigate the incident.

At 1600, RP Technician A was to perform the second part of the procedure for inoperable components which is an estimation of flow. RP Technician A stated that he had performed this step; however, he did not approach the EMF closer than 10 to 15 feet and failed to see that the sample pump was off and the sample valve was misaligned. Therefore, he did not verify flow properly.

At 2000, an RP technician from the following shift attempted to perform the estimation of flow. At that time, he noticed that no flow was present and turned the pump back on. Upon doing this, he thought flow had been re-established, but the indication was false since the sample valve was still misaligned. The false indication was caused by leaky fittings on the sample rig. The problem with these fittings was subsequently repaired. All effluent sampling devices were inspected to ensure all tubing fittings were tight. At 2341, RP personnel again went to perform the 12 hour sample and at that time flow was re-established.

- Immediate: RP personnel restored flow through the continuous Particulate and Charcoal Sampler.
- Subsequent:
 - 1) RP personnel inspected the sample device for 2EMF59 and made appropriate repairs and modifications to prevent recurrence of similar events.

- 2) RP personnel inspected all effluent sampling devices to ensure all tubing fittings were tight.
- Planned:
 - 1) RP Staff and Management personnel will review procedure HP/O/B/1009/14, Health Physics Actions For Inoperable Gaseous Effluent Monitoring and Flow Rate Measurement Devices, and make changes requiring the logging of flow readings.
