SUBJECT: Arkansas Nuclear One - Unit 1
Docket No. 50-313
License No. DPR-51
Licensee Event Report No. 50-313/89-007-01

TITLE (4) Inadequate Design Change Process Results in Failure to Identify a High Pressure Injection System Line Break Scenario Which Could Cause the System to be Incapable of Supplying Adequate Core Cooling

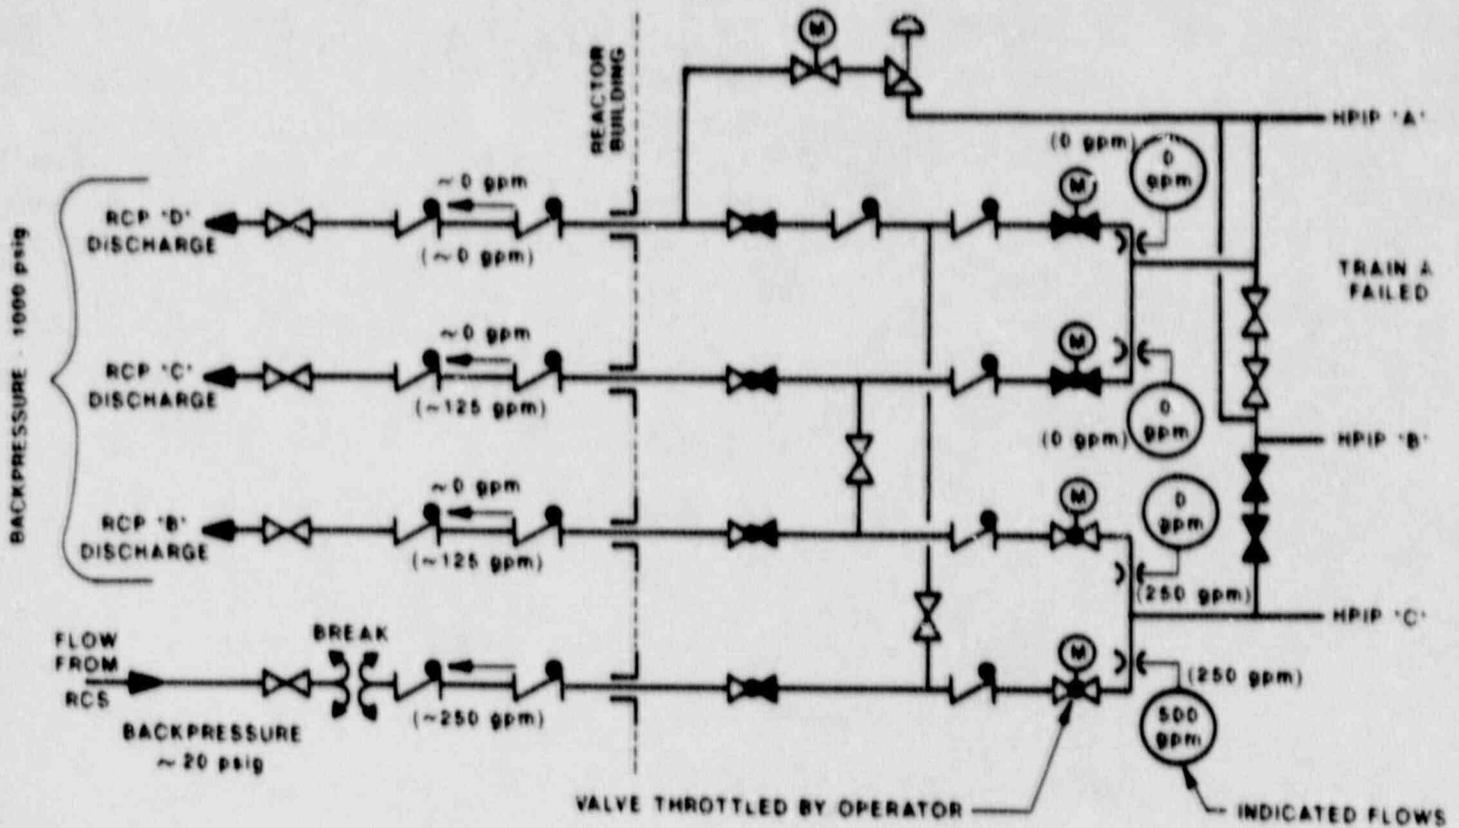
As a result of a January 1989 transient, reported in LER 50-313/89-002-00, a review of the plant's Emergency Core Cooling System (ECCS) analysis was conducted which included a reevaluation of the qualification and functional capability of the High Pressure Injection (HPI) System [BJ]. During this review it was discovered that a postulated break of a HPI line could result in a small break Loss of Coolant Accident (LOCA) which was not enveloped by the plant's existing design basis. The hypothetical break location is upstream of the HPI/Reactor Coolant System (RCS) [AB] cold leg connection and downstream of the first RCS/HPI system boundary check valve. (See Figure 1 for the general system layout).

During performance of the ECCS review, it was determined that a potential break of any one of the HPI lines upstream of the RCS cold leg connection and downstream of the first RCS/HPI system boundary check valve was not enveloped by prior analysis and could, assuming a worst case single failure (i.e., an emergency diesel generator failure rendering a HPI pump inoperable), result in significant HPI flow exiting the break with little flow reaching the core. This would occur because back pressure on the broken line would essentially be Containment Building pressure while back pressure on the other lines would be RCS pressure. This condition would continue until a Control Room Operator took action to throttle the excessive HPI flows as stipulated in the existing Emergency Operating Procedure (EOP). After flow balancing was achieved (analyzed to occur ten minutes following a break due to the action of the Operator), approximately 50 percent of the flow from the one running HPI pump would reach the core with the remaining flow exiting the break.

An investigation of the impact of this postulated break on current ECCS evaluations determined that the break did not appear to be enveloped by previously postulated breaks. For breaks which had been considered in the ECCS analysis, approximately 50 percent of HPI flow was assumed to initially reach the core and approximately 70 percent of HPI flow was assumed to reach the core following Control Room Operator action to throttle excessive HPI flow (analyzed to occur ten minutes following a break due to the action of the Operator). Based on the differences in the HPI flows for the postulated break versus the analyzed breaks, it was determined that the HPI system might not be capable of supplying adequate core cooling should the break occur during high power operation.

High Pressure Injection System Line Break

A design change was implemented during outage 1MB9 (December, 1989) which installed break flow limiting cavitating venturis in each of the four HPI lines upstream of the two check valves which isolate this piping from the RCS. However, during post-modification testing of the venturis, excessive vibration was experienced in the piping downstream of the venturis which necessitated their removal. The venturis were replaced with welded spool pieces which restored the system to its original configuration with the exception of a minor piping reroute on the 'D' HPI line.

Evaluations are presently in progress which are considering two possible permanent corrective actions which will allow resumption of full power operation. The first consideration involves reinstalling the cavitating venturis with a modified piping support configuration. The second consideration involves the installation of motor operated valves in each of the HPI lines as well as additional flow instrumentation which would allow the operators to more readily identify and compensate for a pipe break in the location discussed in this report. After determination of the permanent corrective action, a Design Change will be developed and implemented during refueling outage 1R9, which is scheduled to begin in October, 1990.
