In Reply Refer To: Docket: 50-267/89-20

SUBJECT: NRC Inspection Report 89-20

February 23, 1990 Fort St. Vrain Unit No. 1 P-90035

# Failure to Follow Procedure

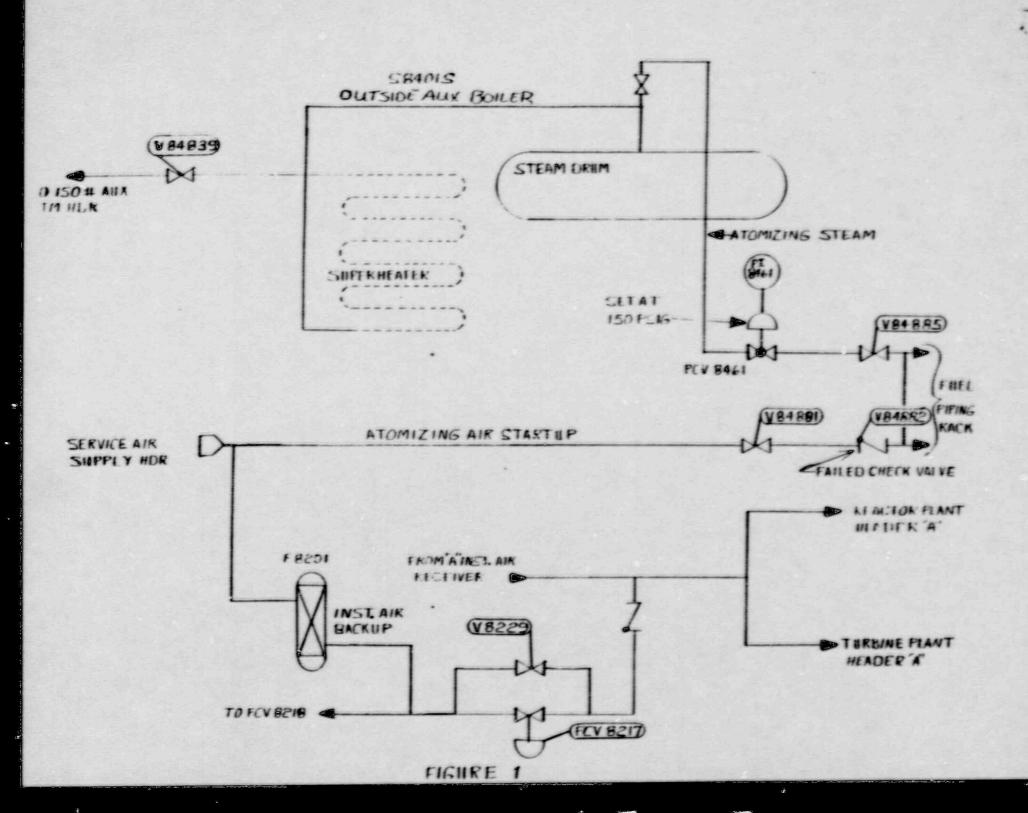
The valve lineup error was compounded by multiple equipment malfunctions. It was determined that steam from the IAB had been entering the service air system (reference figure 1) via the open super heater isolation valve (V-84839) on the OAB, which was supplying steam through the open steam atomizing valve (V-84855), then through a failed check valve (V-84882), and finally through an open service air atomizing valve (V-84881). Once the (150 psig) steam entered the service air header (90 psig) it continued on to the normal service air header users. The largest user is the sewage pond. The temperature in this line was increased by the steam sufficient to cause a failure of the PVC piping near the chemical building. Operations personnel also noted that the service air piping near the "A" instrument air dryer was very hot. The heat (reference figure 1) extended through FCV 8217 into "A" reactor and "A" turbine building instrument air headers with the "A" turbine building header being the hottest. FCV 8217 is normally closed and is opened only when abnormally low pressures are detected in the "A" instrument air header. FCV 8217 and its bypass V-8229 were closed when checked which indicated leakage through one or both valves.

V-84882 was cut out of the line and replaced due to gross leakage. FCV-8217 was disassembled and inspected. The valve was dirty and not seating correctly. It was cleaned and tested for leak tightness. V-8229 was disassembled and blue checked which verified the proper seating of the disc with the seating surface.
