April 19, 1990

Mr. Julian Wells
Quality Assistance Manager
Eberline Instrument Corporation
504 Airport Road
P.O. Box 210F
Santa Fe, New Mexico 87504-21-8

NRC INFORMATION NOTICE No. 90-XX: Dose-rate Survey
Instruments Underresponding To The True Radiation Fields

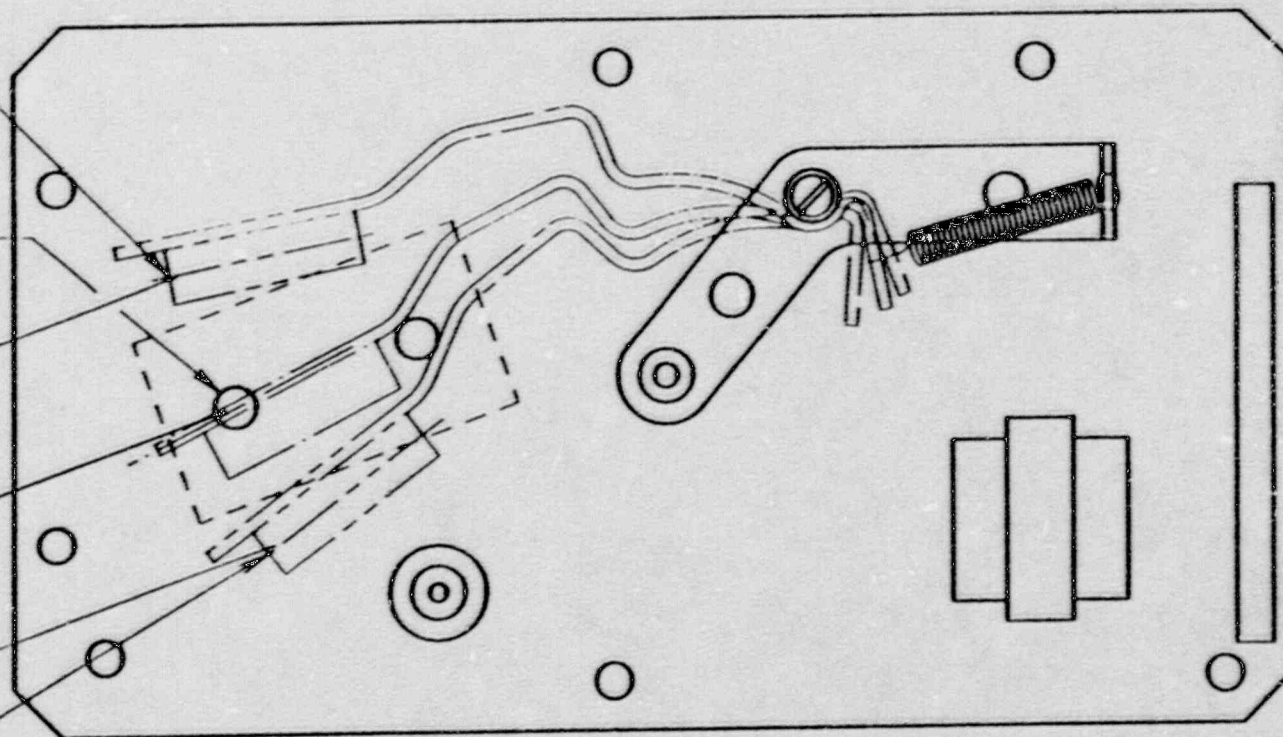
Typical Magnet Arm Position

The instruments were taken out of service and returned to the manufacturer. Bicron's examination confirmed the effect and found the cause of the failure to be improper positioning of the magnet which activates reed switches in the ion chamber. This magnet moves on a cam actuated arm attached to the range switch. Figure 1 gives typical magnet arm positions for the Bicron RSO series of instruments. At the zero position (one end) of the range switch rotation, the arm moves the magnet over the zero reed switch and shorts the electronics input for zeroing. Switching from zero to the first (0-5 mR/h) and second (0-50 mR/h) ranges, the cam moves the end of the magnet arm to the center position between the zero and high range reed switches, and neither reed switch is closed. If the magnet arm is not properly aligned with the cam at the point of contact, the extra room allowed (play) for movement of the

magnet arm with respect to the cam can result in the magnet at the other end of the magnet arm to be placed sufficiently past the center position to close the high range reed switch upon range switching between the first (0-5 mR/h) and the second (0-50 mR/h) lower two ranges even though the magnet arm is not supposedly to move.

Because of the possibility for the above mechanical problem, severe underresponse to the true radiation fields for these dose-rate survey instruments can occur as a result of switching between these lower two ranges. This is because when the high range reed switch is in the closed position, a different electronic circuit is actuated which reduces the sensitivity on these ranges by a factor of about 100, requiring a true dose-rate of 5,000 mR/h to produce a full scale deflection on the (0-50 mR/h) scale or a true dose-rate of 500 mR/h to produce a full scale deflection on the (0-5 mR/h) scale.

The Instrument Engineering Department of Bicron has added an additional quality assurance test to ensure the proper alignment of the magnet arm with respect to the reed switch. This test is to be performed during the final acceptance test of a new instrument and again prior to calibrating the new instrument for shipment.

The Department of Energy Safety Action Notice has recommended that all magnet arm switching dose-rate instruments be inspected for proper alignment of the magnet arm and the presence of set screws to maintain the proper positioning of the magnet arm. For copies of revised maintenance procedures and other technical information concerning their instruments, contact the appropriate manufacturer at:
