TENNESSEE VALLEY AUTHORITY

SEQUOYAH NUCLEAR PLANT (SQN) UNITS 1 AND 2 - DOCKET NOS. 50-327 AND 50-328 -  
FACILITY OPERATING LICENSES DPR-77 AND 79 - SPECIAL REPORT 90-06 - FIRE  
PROTECTION PLAN

ENCLOSURE  
14-Day Follow-Up Report  
Special Report 90-06

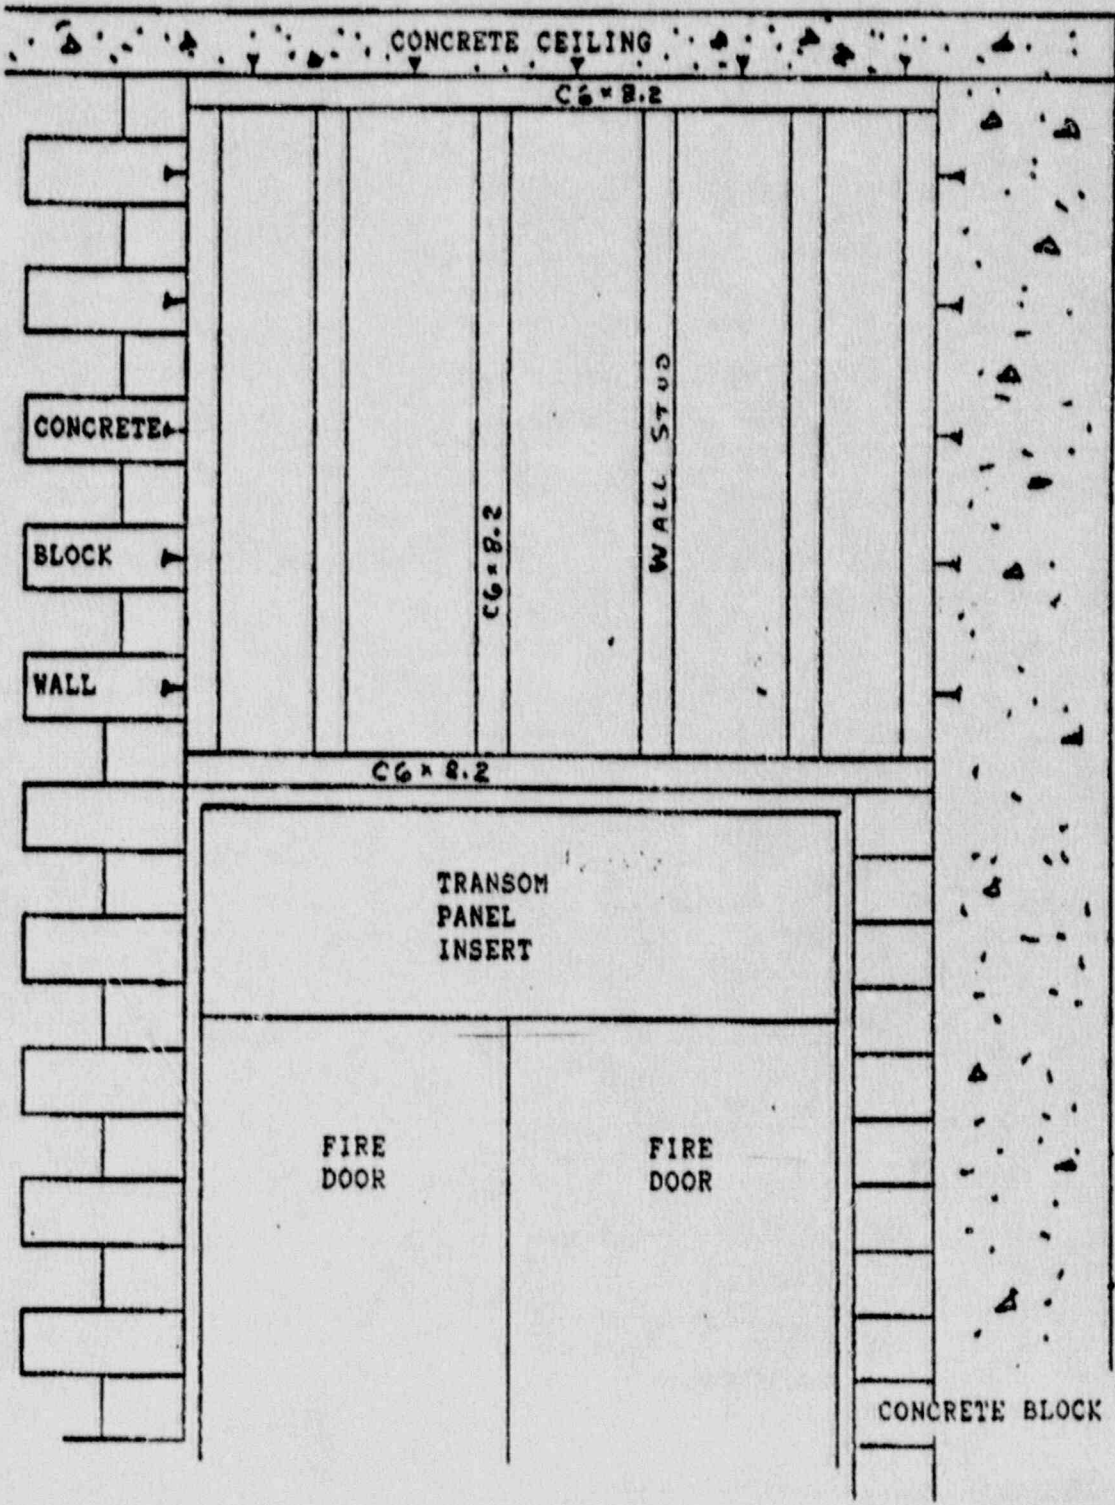
SKETCH  
(NOT TO SCALE)

The noncompliance with Unit 2 License Condition 2.C.13.a was identified as a potential problem on April 10, 1990, and was confirmed on April 11, 1990. Unit 2 License Condition 2.C.13.a requires TVA to maintain and implement all provisions of the approved fire protection plan which, in part, committed to a 1.5-hour rated fire wall between each unit's auxiliary instrument room and the corridor outside the computer room on control building Elevation 685. These walls together provide fire separation between the auxiliary instrument room for each respective unit. While preparing a design change to route new phone lines through the subject wall, a technical problem was discovered with the original design and installation of the walls, which are above the transom panel of Fire Doors C22 and C24.

Each wall consists of four 5/8-inch, fire-rated gypsum wallboards, two attached to each side of metal wall studs. The 1.5-hour fire rating of each wall is based upon the similarity of its design to an Underwriters Laboratory fire-tested wall configuration fire-rated at 1.5 hours or longer. The fire-tested wall configuration consisted of four 5/8-inch, fire-rated gypsum wallboards, two attached to each side of metal wall studs. The wall studs in the tested configuration were made of galvanized sheet metal and were bolted to upper and lower runners with a free space at the stud ends to allow thermal expansion of the metal wall studs during a fire. In the subject walls at SQN, the wall studs are made of heavier-gauge steel channels that are welded to the upper and lower runners. There was no provision made in the original design for thermal expansion of the wall studs during a fire.

The root cause of this condition has been attributed to a design deficiency in the original wall design in that allowance was not made for thermal expansion of the wall studs during a fire. A contributing cause of the condition is that the as-built configuration of the concrete block wall is different than shown on plant drawings.

The affected areas have been included in the surveillance of hourly, roving fire watch patrols as of 1055 Eastern daylight time on April 10, 1990. A design change has been issued consisting of adding two additional half-inch, fire-rated gypsum wallboards to each side of both walls. This addition would lower the expected wall stud temperature during a fire and consequently reduce the wall-stud thermal expansion to an acceptable value. This design change will be implemented by July 12, 1990. The hourly, roving fire watch patrol coverage will be maintained until the design change is implemented. In addition, the design and construction of other gypsum fire walls will be reviewed to determine whether similar problems exist in any other plant locations. This review will be completed by June 1, 1990. A drawing deviation has been issued to revise the affected plant drawing to reflect the as-built configuration of the concrete block wall.
