Subject: Crystal River Unit 3  
Docket No. 50-302  
Operating License No. DPR-72  
Licensee Event Report No. 89-039-01

**LICENSEE EVENT REPORT (LER)**

TITLE (4) **Personnel Error Results in Operation Outside the 10 CFR 50 Appendix R Separation Design Basis**

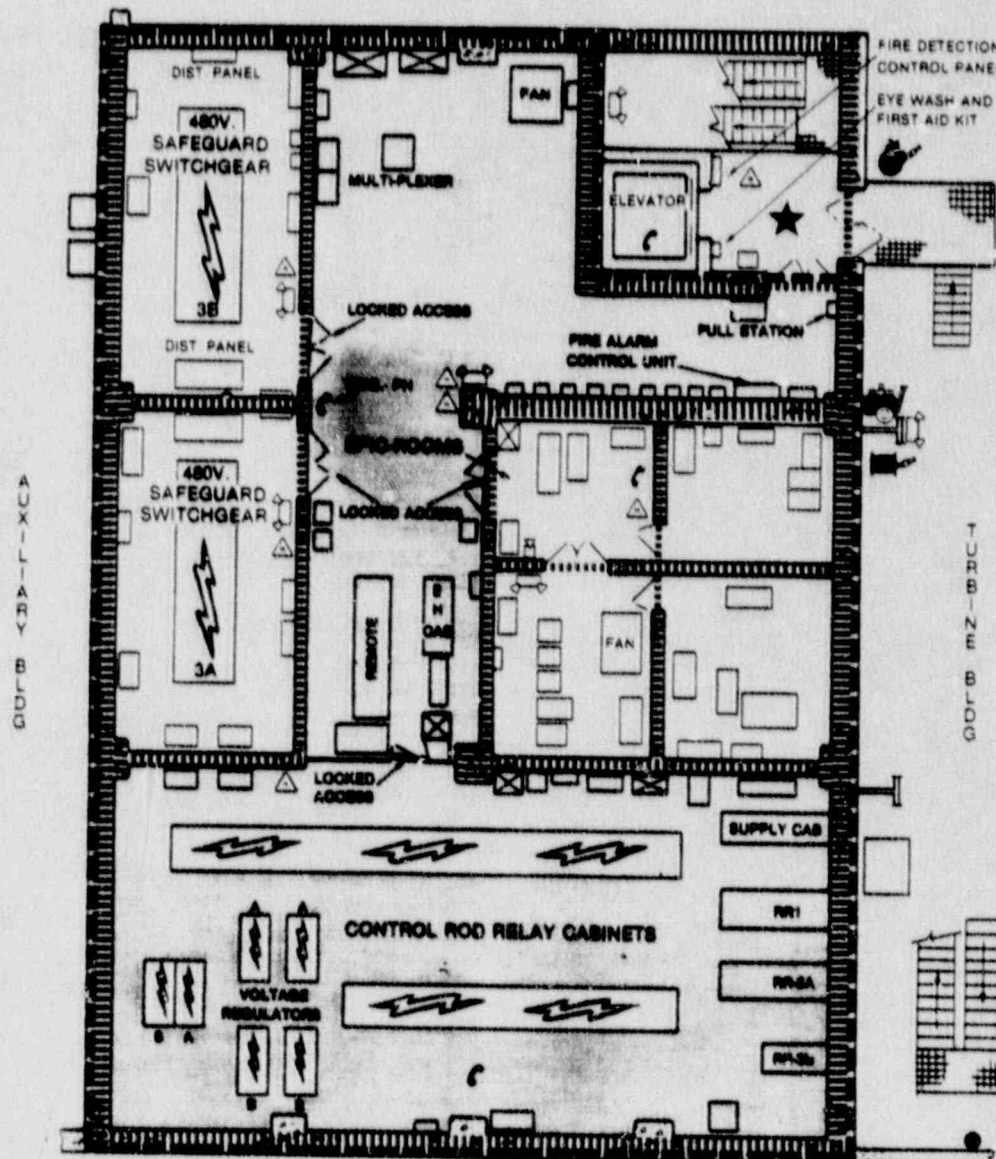
FIGURE 2

Each of the listed components (SWP-1A[CC,P], SWP-1B [CC,P] and RWP-2B [KG,P]) utilizes contacts from relays located in the CRD/Relay Room in their breaker closing control circuits. There are several fire areas on the 124' elevation of the control complex, shown on Figure 2. Each of the switchgear rooms and each of the Emergency Feedwater Initiation and Control (EFIC) [BA] rooms constitute a separate fire area. The remaining area, the corridors and CRD/Relay Room, shown shaded on Figure 2, constitute the seventh area. The Fire Study assumes that a fire in this shaded area would disable all equipment in that area. The relay circuits are presently listed as "Fail Safe" and thus not impact the pump operability. However, the current review revealed that certain hot shorts in these circuits could blow the fuse in the breaker closing control circuit rendering the pumps inoperable from the Main Control Room.

In the event of a concurrent loss of offsite power, RWP-2B [KG,P] and SWP-1B [CC,P] are considered the only reliable pumps because there is a potential for losing the "A" EDG [EK,DG] due to fire damage to relays and circuits.

Control of equipment required to shut down the plant might not be available from the main control room for a fire in the shaded area of Figure 2. This does not put the plant into an unrecoverable condition because the pumps could be started locally from the 4160 volt ESB switchgear.

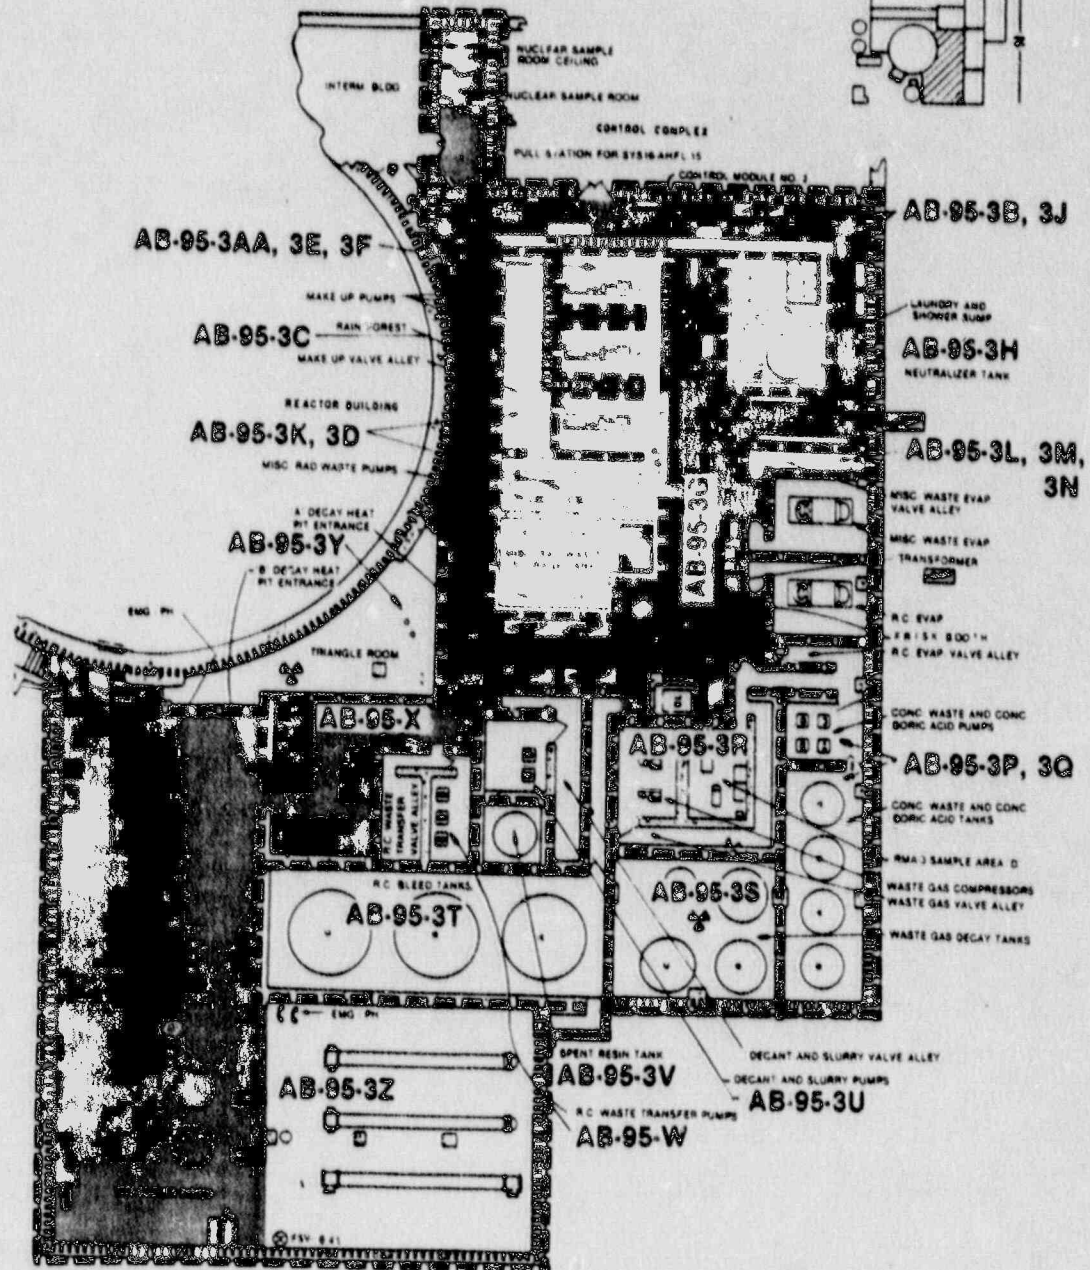
### FIGURE 3

Figure 3 shows the Auxiliary Building 95' elevation. Most of this elevation is treated as a single fire area. This area includes the seawater room that contains both the A and B trains of the Emergency Nuclear Services Closed Cycle Cooling Water Pumps (SW pumps [CC,P]) and the Nuclear Services Seawater Pumps (RW pumps [KG,P]). It was assumed that one train would be operable, opposite the end of the room that the fire was in. This was acceptable because a fire on the 95' elevation of the Auxiliary Building would not affect the Emergency Diesel Generators (EDG's). The current review found a circuit for the power feed to ES MCC 3B1, which powers the fuel oil transfer pump for the "B" EDG, being routed through the seawater room. The fire could also disable the "B" train battery charger, making the DC powered backup fuel oil transfer pump unreliable.

This creates a situation where it is possible to postulate the loss of the "A" SW and RW pumps and the "B" EDG, a condition where it is not completely assured that at least one train of safe shutdown equipment is available in a common fire area.

Compensatory operator actions can prevent this situation from degenerating to an unrecoverable condition. The amount of fuel in the day tank for the "B" EDG allows enough time for the operators to cross-tie the ES 4160 volt busses. This evolution involves stripping all non-safe shutdown loads from the busses. This would allow the "B" SW and RW pumps to be powered by the "A" EDG.

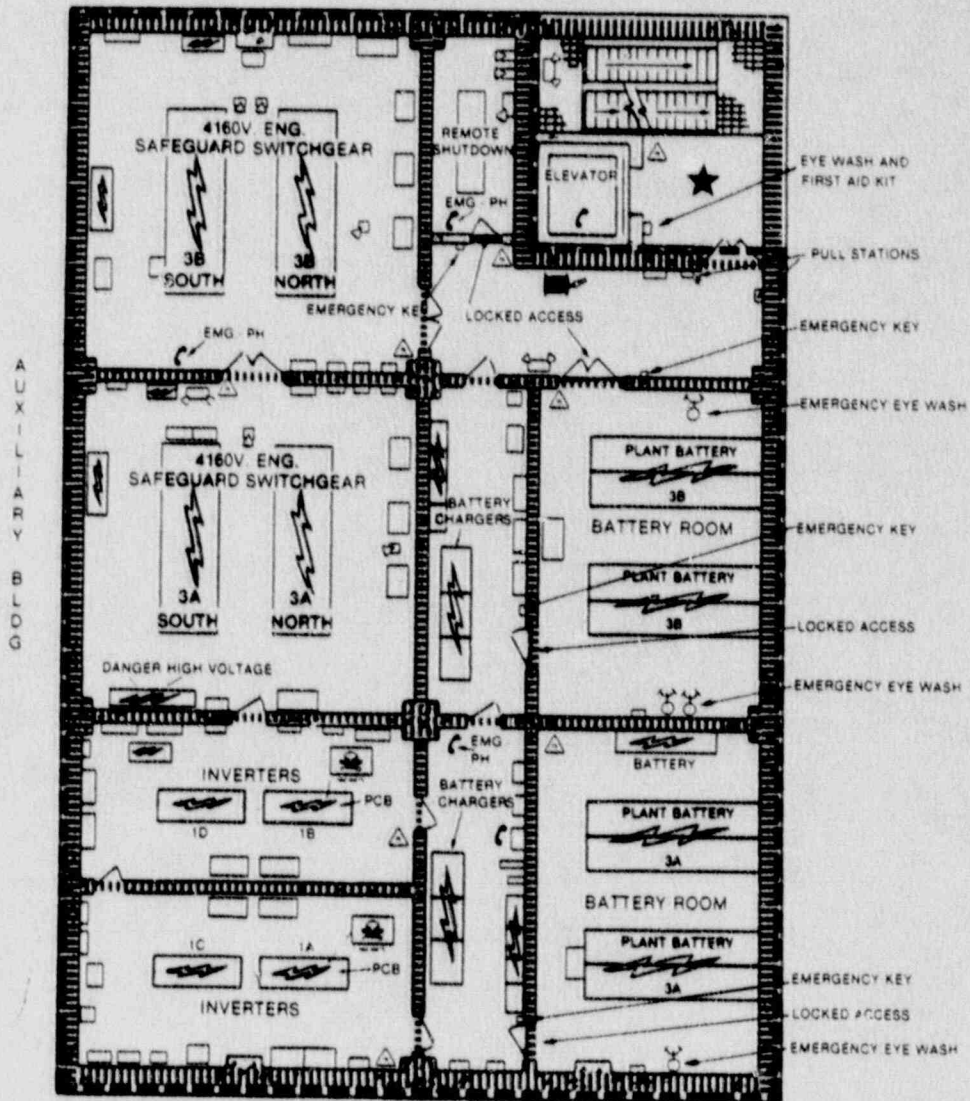
FIGURE 4

The circuits for the Train 1 indicators, RC-1-LT1, RC-4A-TE1 and SP-6A-PT1, are routed through the 4160 volt and 480 volt "B" ES switchgear rooms. See Figures 4 and 2 for layout showing the ES switchgear rooms. Since the indicators listed are Train 1 and the fire is in the "B" ES switchgear rooms, the Train 2 indicators must be assumed lost due to loss of all "B" power. Thus, both redundant trains of indication are lost.

The Regulatory Guide 1.97 indicators of these parameters are not affected by a fire in the "B" ES switchgear rooms. The operators would not lose all indication in the Main Control Room since the Regulatory Guide 1.97 indications were installed.
