MEMORANDUM FOR FILE

April 10, 2014

SUBJECT: Assessment of Radiological Events at the Mesa

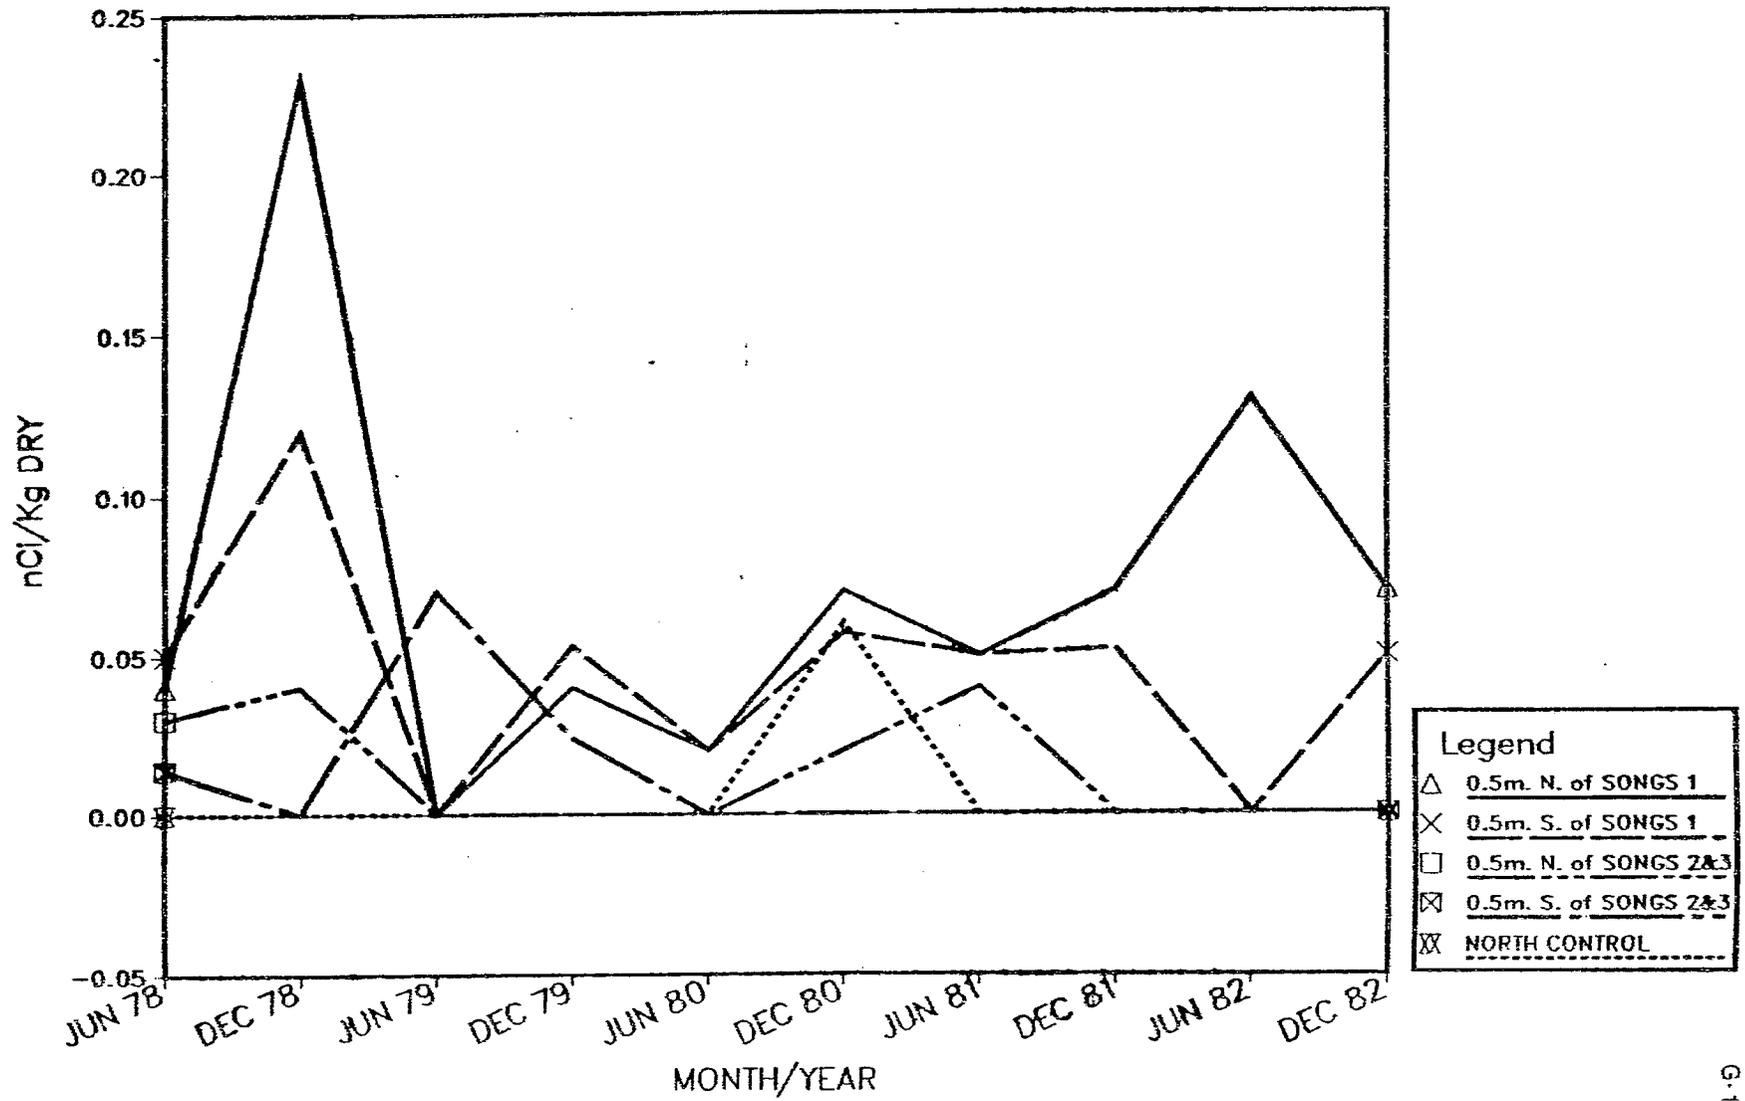
MONTH/YEAR
Figure 16

CESIUM-137 Activity in Ocean Bottom Sediment

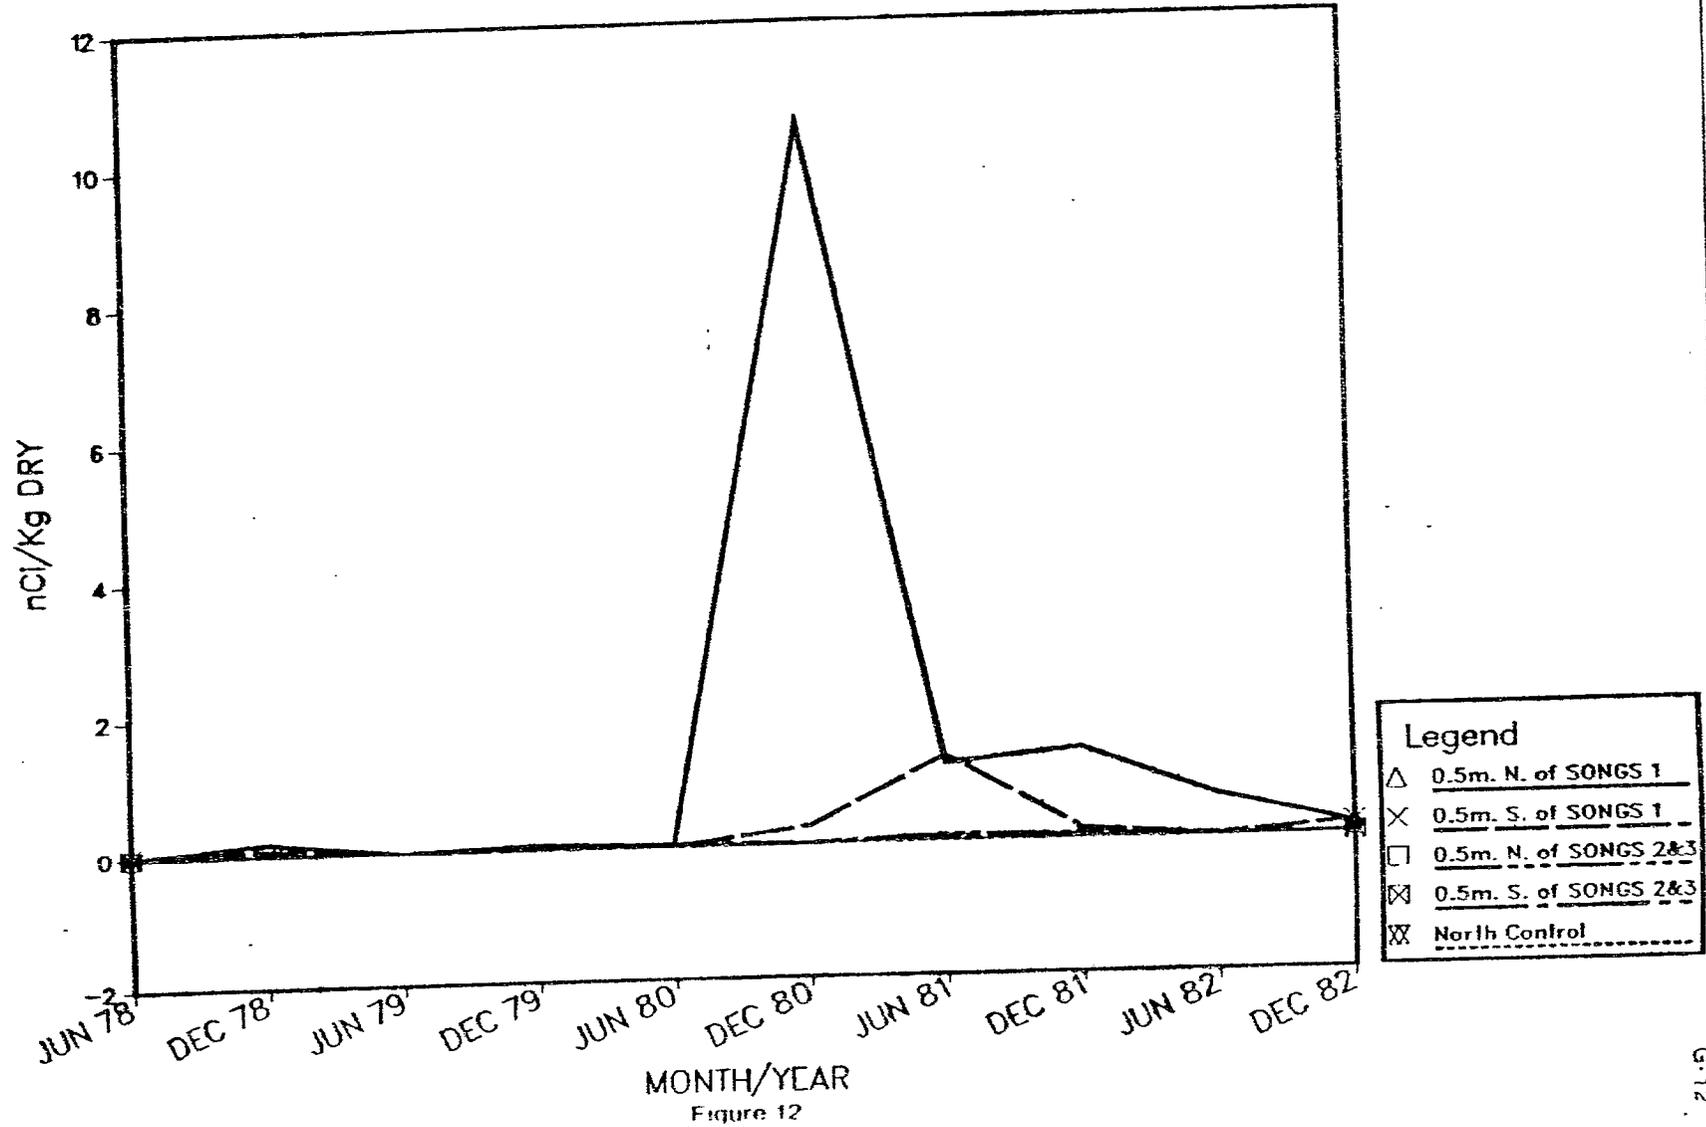
MONTH/YEAR
Figure 12

COBALT-60 ACTIVITY IN OCEAN BOTTOM SEDIMENT

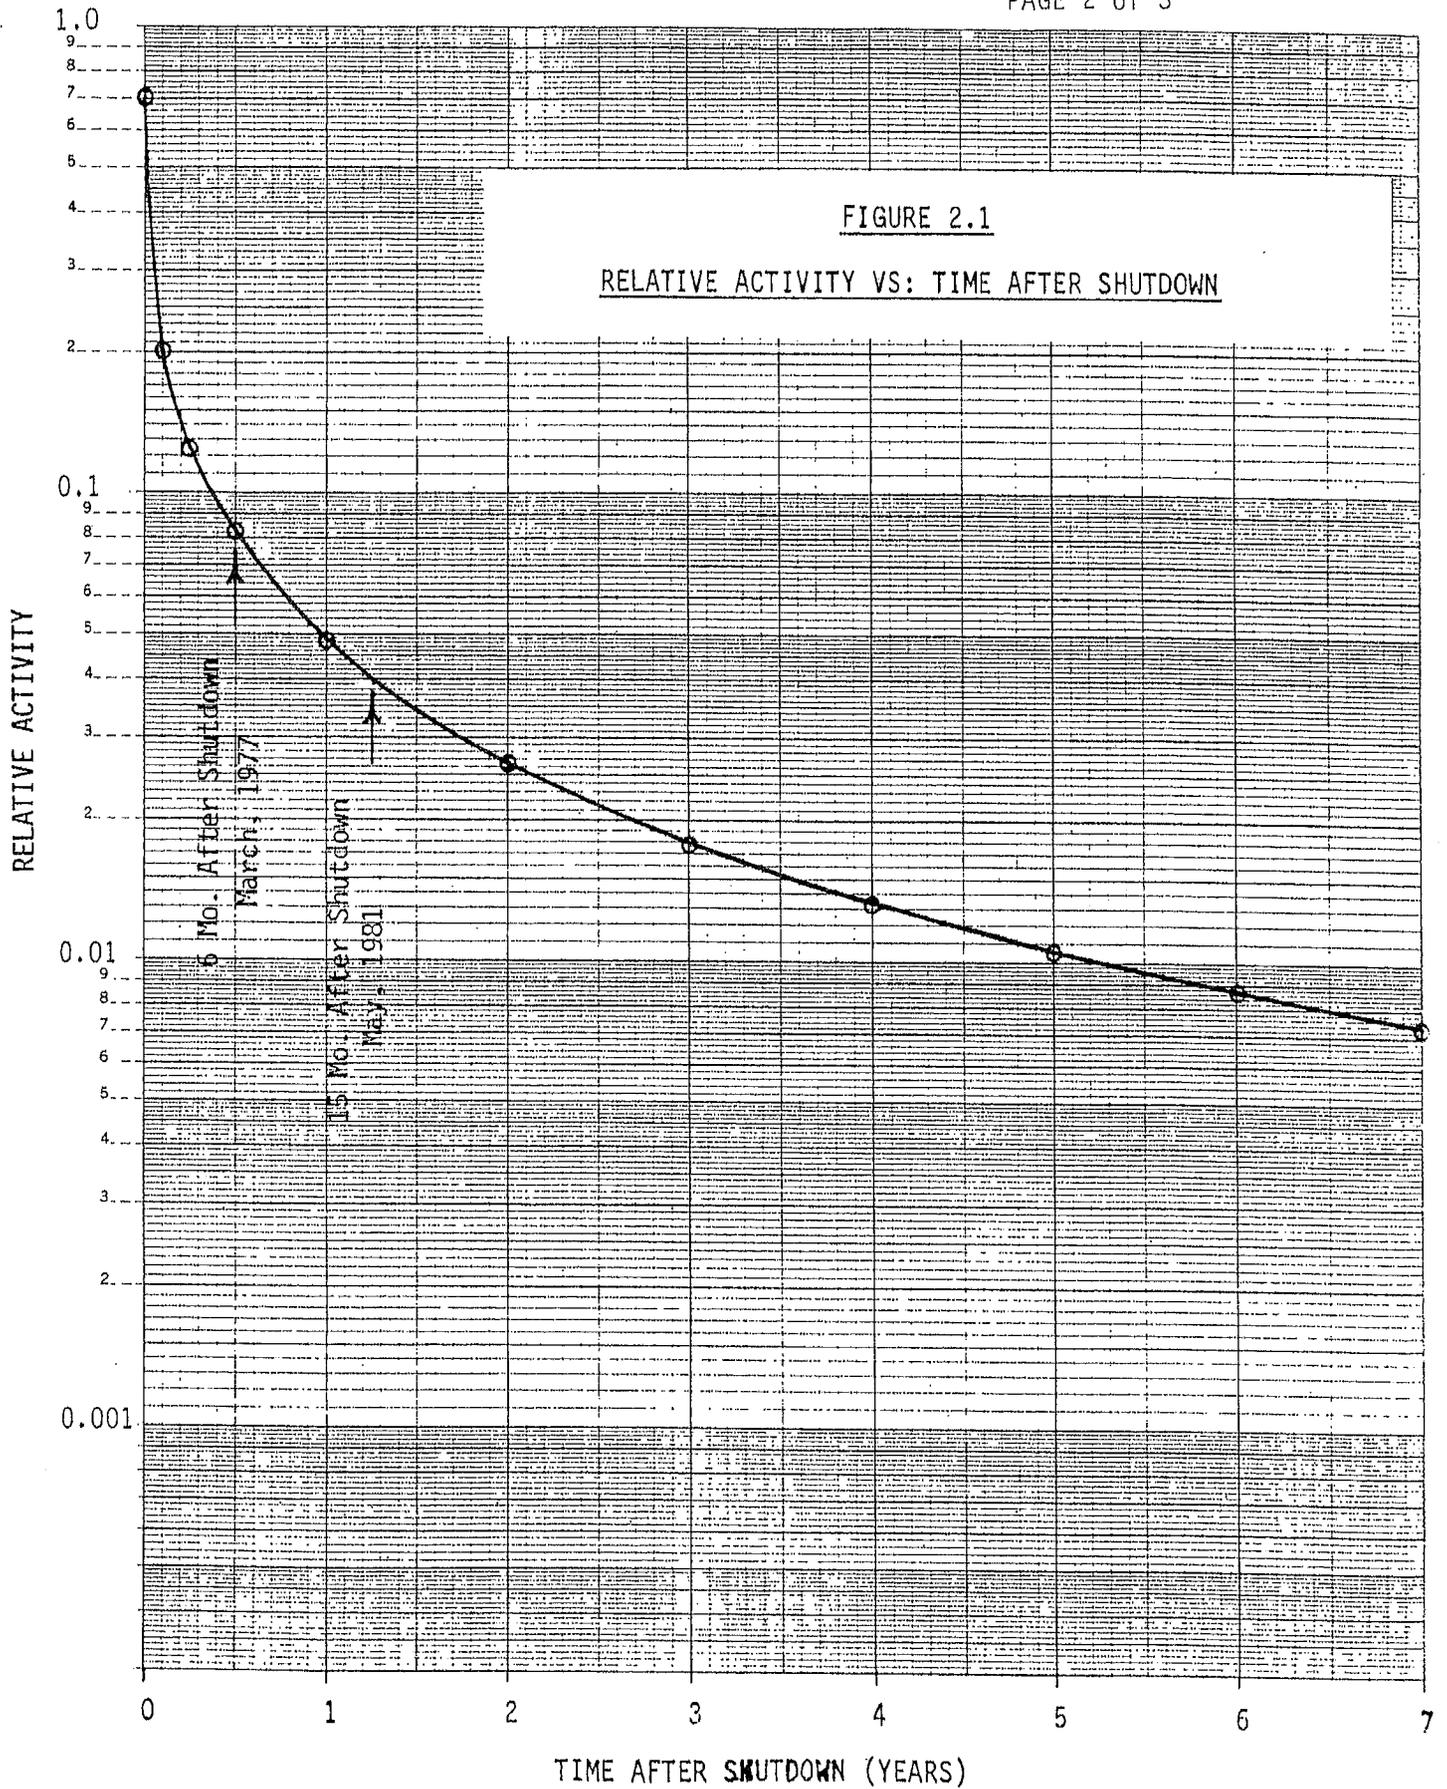
Figure 2.1 provides a graph of A versus time after shutdown for a reactor which has operated for 500 days. That operating time is a reasonable approximation of one fuel cycle for SONGS 1.

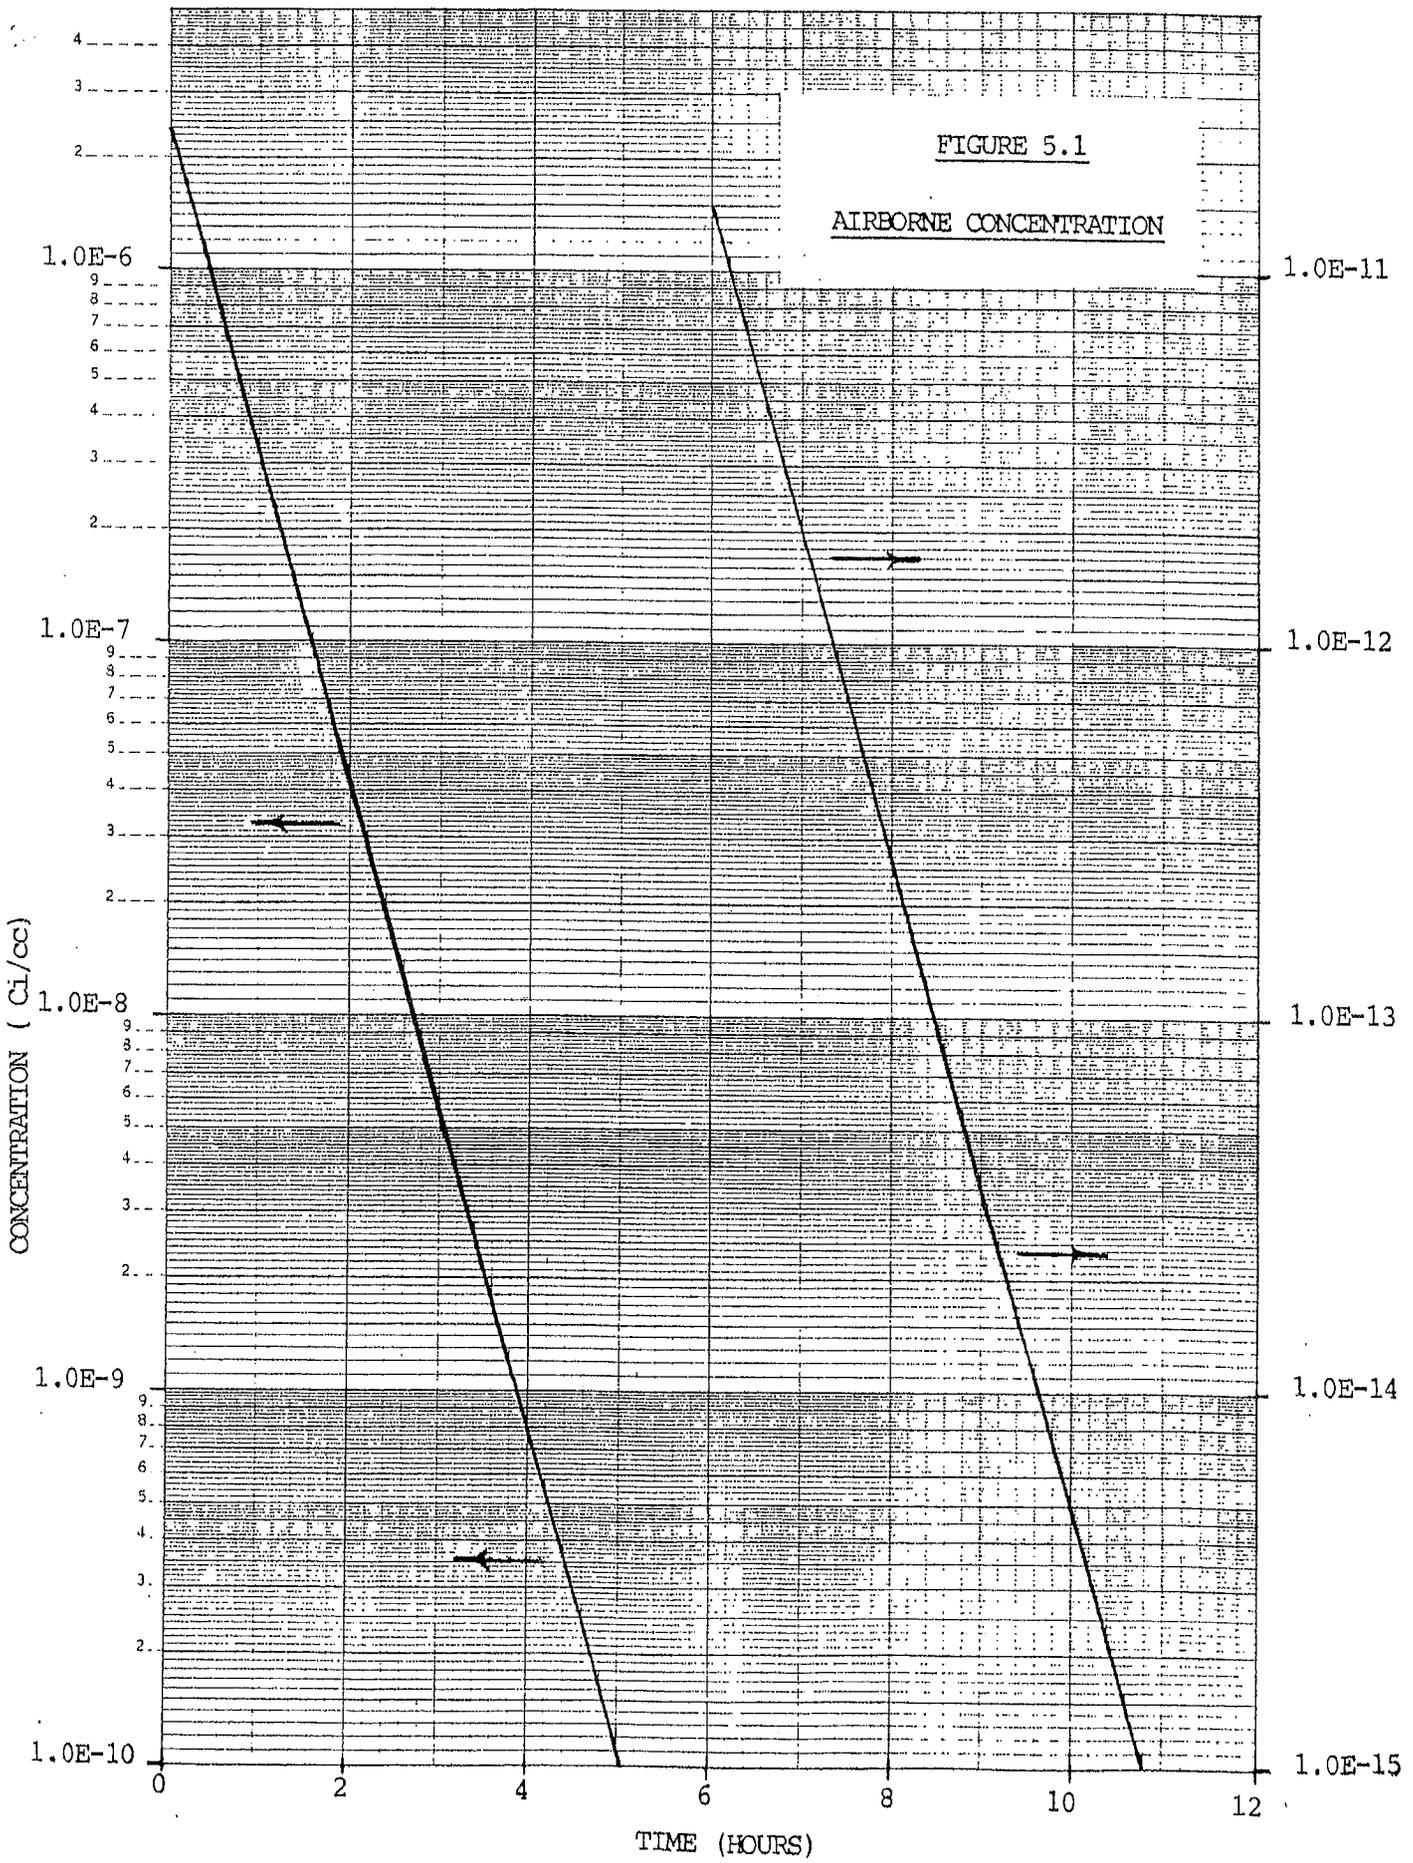
A plot (Figure 5.1) of airborne radioactive material present in the room vs time shows that the airborne concentration decreases very rapidly.

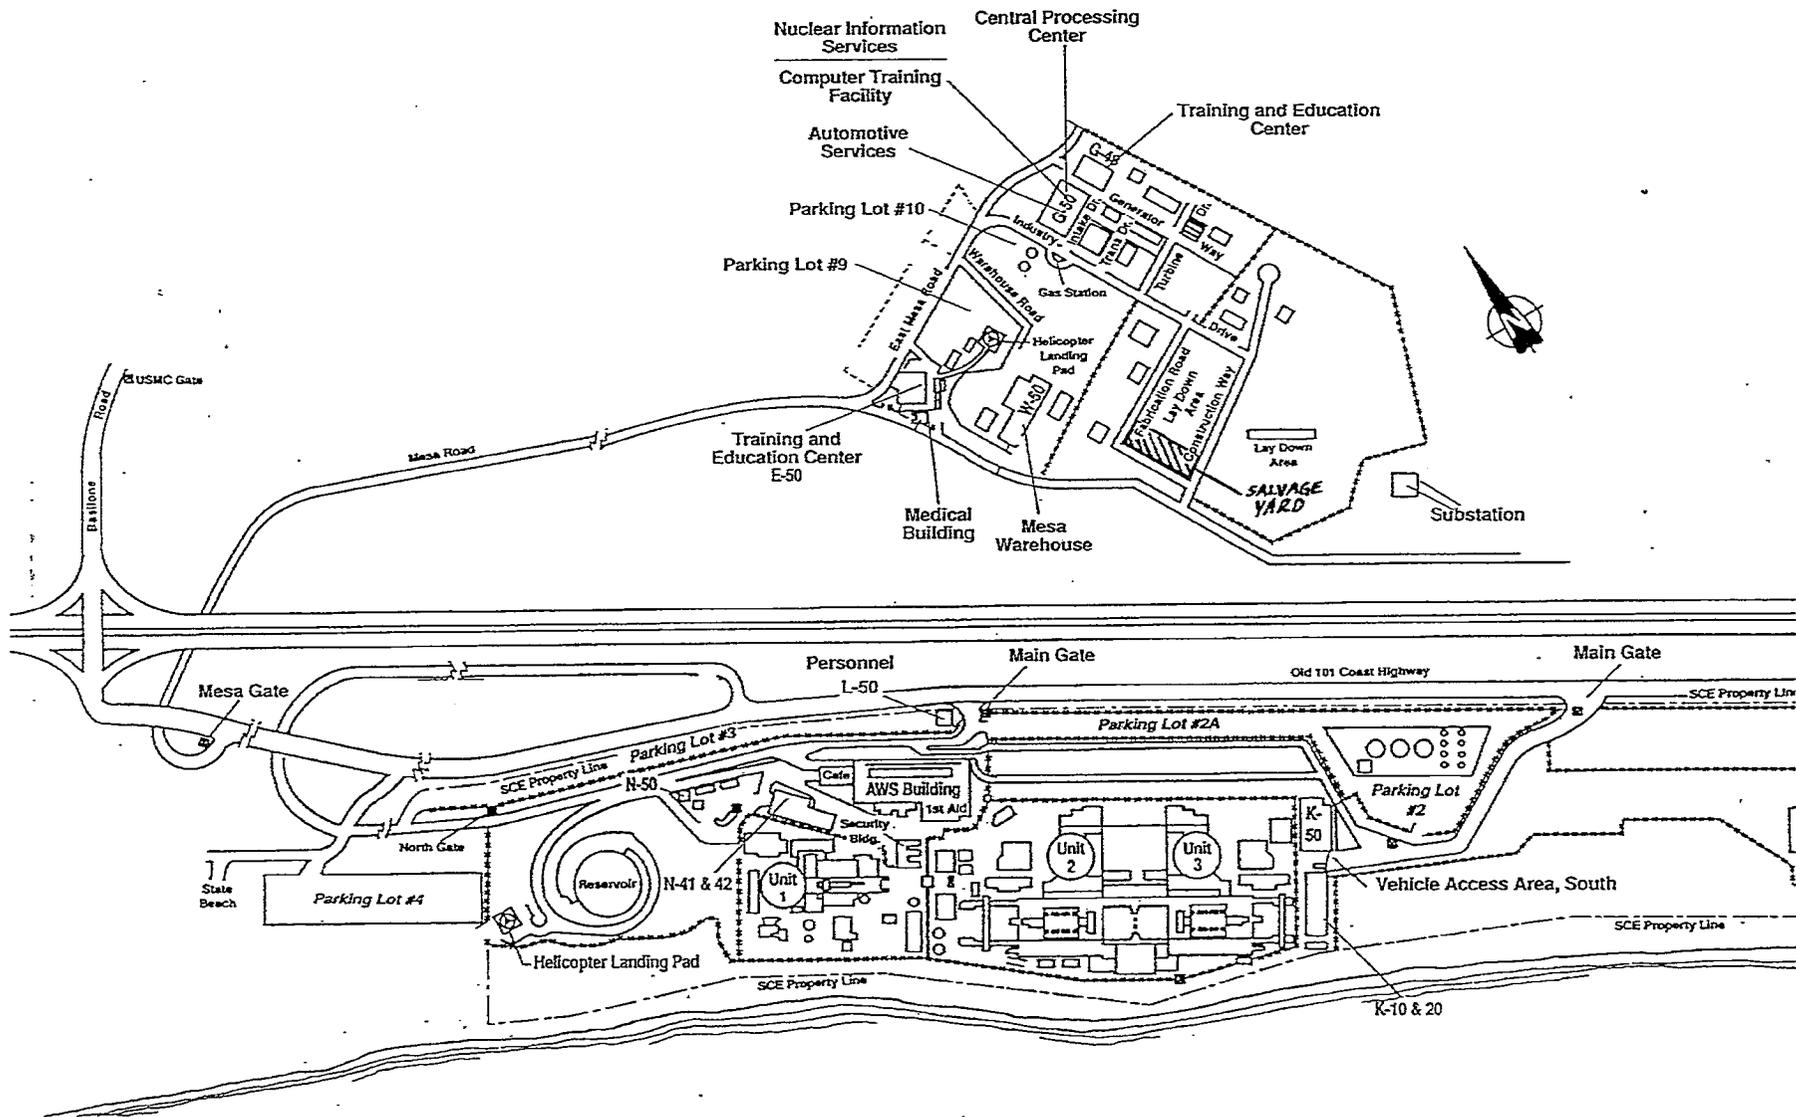
SALVAGE YARD CLEANUP

The Salvage Yard was located in the west end of what was most recently Camp Mesa. A large fenced area, approximately 150 yards by 25 yards, contained scrap materials. During a 1992 radiological survey effort to qualify the material for release, the following items were found to be slightly contaminated: two four-inch pipe sections, two wheels, and one Flexiatallic gasket.

Only three items were found in the Salvage Yard. The items demonstrated low level fixed contamination and no removable activity. The area was verified free of residual contamination by direct frisk following removal of the items. This area is considered to have a very low probability for detectable residual radioactive contamination.
