February 25, 1993
Fort St. Vrain
Unit No. 1
P-93017

LICENSEE EVENT REPORT (LER)

Fort St. Vrain Unit No. 1

Overflow of Radioactive Liquid Effluent Line

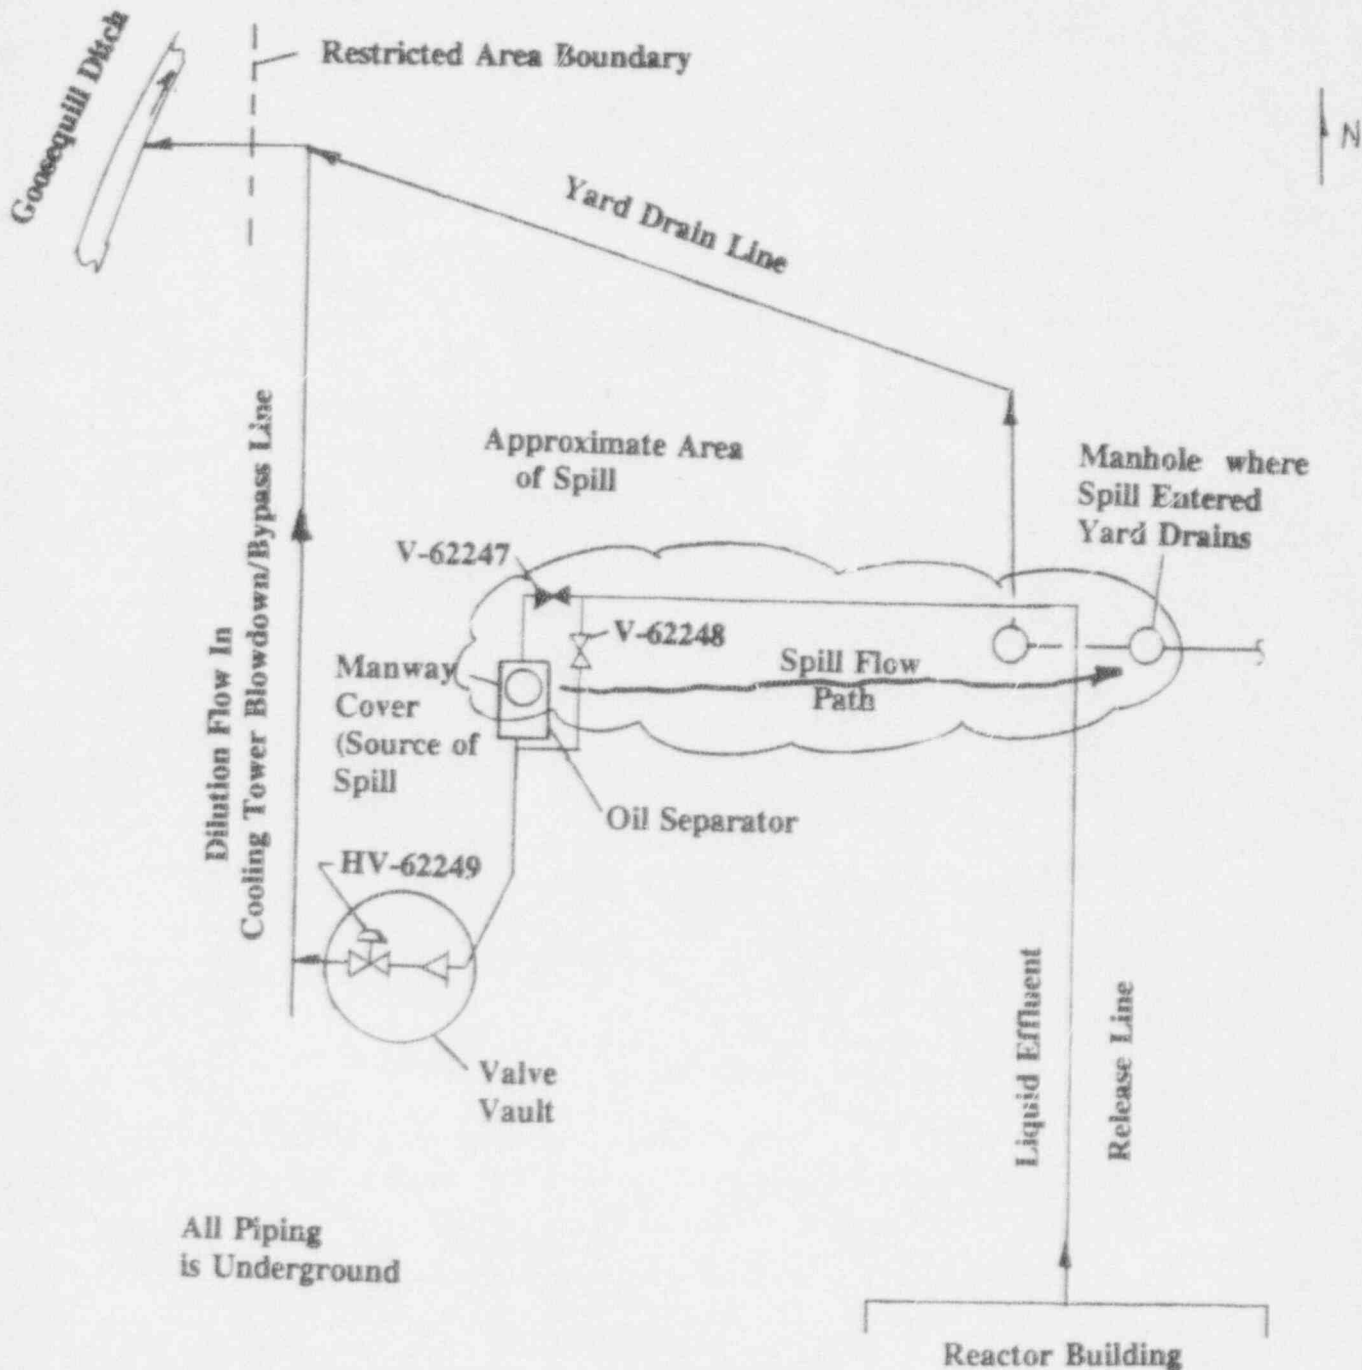
FIGURE SHOWING SPILL
FROM OIL SEPARATOR TO
YARD DRAINS

At approximately 0120 hours on January 27, 1993, an FSV Equipment Operator discovered that the oil separator in the radioactive liquid effluent release line had overflowed and water had spilled onto the ground, in an area within the FSV restricted area. Water flowed out of the underground oil separator through a vented manway cover, and flowed east for a total distance of about 110 feet. Along the way this water could have entered an alternate portion of the yard drain system through a vented manhole cover. It then would have flowed approximately 400 feet through this alternate underground yard drain before being diluted by cooling tower blowdown flow, which was being discharged through the normal connecting drain line. From that point, it flowed through the normal release path out of the restricted area, into the Goosequill Ditch, and eventually offsite.

The cause of the oil separator overflow is believed to have been an ice plug that blocked the downstream release line and caused the release to back up into the oil separator. The release line downstream of the oil separator is a 6-inch line that reduces to a 3-inch line just before entering the yard drain system at the cooling tower blowdown/ bypass line. This 3-inch section includes a remote operated isolation valve (HV-62249), located about 8 feet underground in a concrete vault/manway, about 40 feet downstream of the oil separator.

The cause or location of the blockage was not evident, especially since this has never happened before at Fort St. Vrain. Engineering and maintenance personnel suspected that the blockage was located at the isolation valve (HV-62249), because it is located in the smallest part of the line. During an inspection of the valve, ice was observed around its position indicating limit switches, and an ice plug in the line was suspected, even though the line is 8 feet underground and was thought to be sufficiently protected.

The area had experienced sub-freezing weather for an extended period before the spill, and the location of the valve in the vault/manway could have exposed it to these low temperatures. Also, HV-62249 is normally closed after a liquid effluent release and the line slopes down from the oil separator to the valve, potentially trapping a volume of water on the upstream side of the closed valve. A portable heater was lowered into the valve vault, and by the next morning the release line was flowing freely. Based on this, PSC considers that an ice plug in the 3-inch section of the release line downstream of the oil separator is the most likely cause of the blockage described above. PSC also considers it likely that this blockage existed, to at least a partial extent, before radioactive liquid waste release number 1575 was initiated, and that some of this release was probably made through the manway into the yard drain system.

The immediate corrective action was to dam the manholes into the yard drain system to prevent any further drainage. Also, the ice plug was thawed by use of a heater and a free release path was restored.

The 3-inch valve (HV-62249) and piping in the valve vault area have been heat-traced to prevent future freezing. This is the most likely place for ice to form, since the remainder of this release line is a 6-inch line that is buried 8 feet underground.
