Southern Nuclear Operating Company

Joseph M. Farley Nuclear Plant - Unit 1  
Steam Generator Tube Analysis Results

SUMMARY OF EXAMINATION CONDUCTED ON FARLEY UNIT 1  
STEAM GENERATOR TUBING

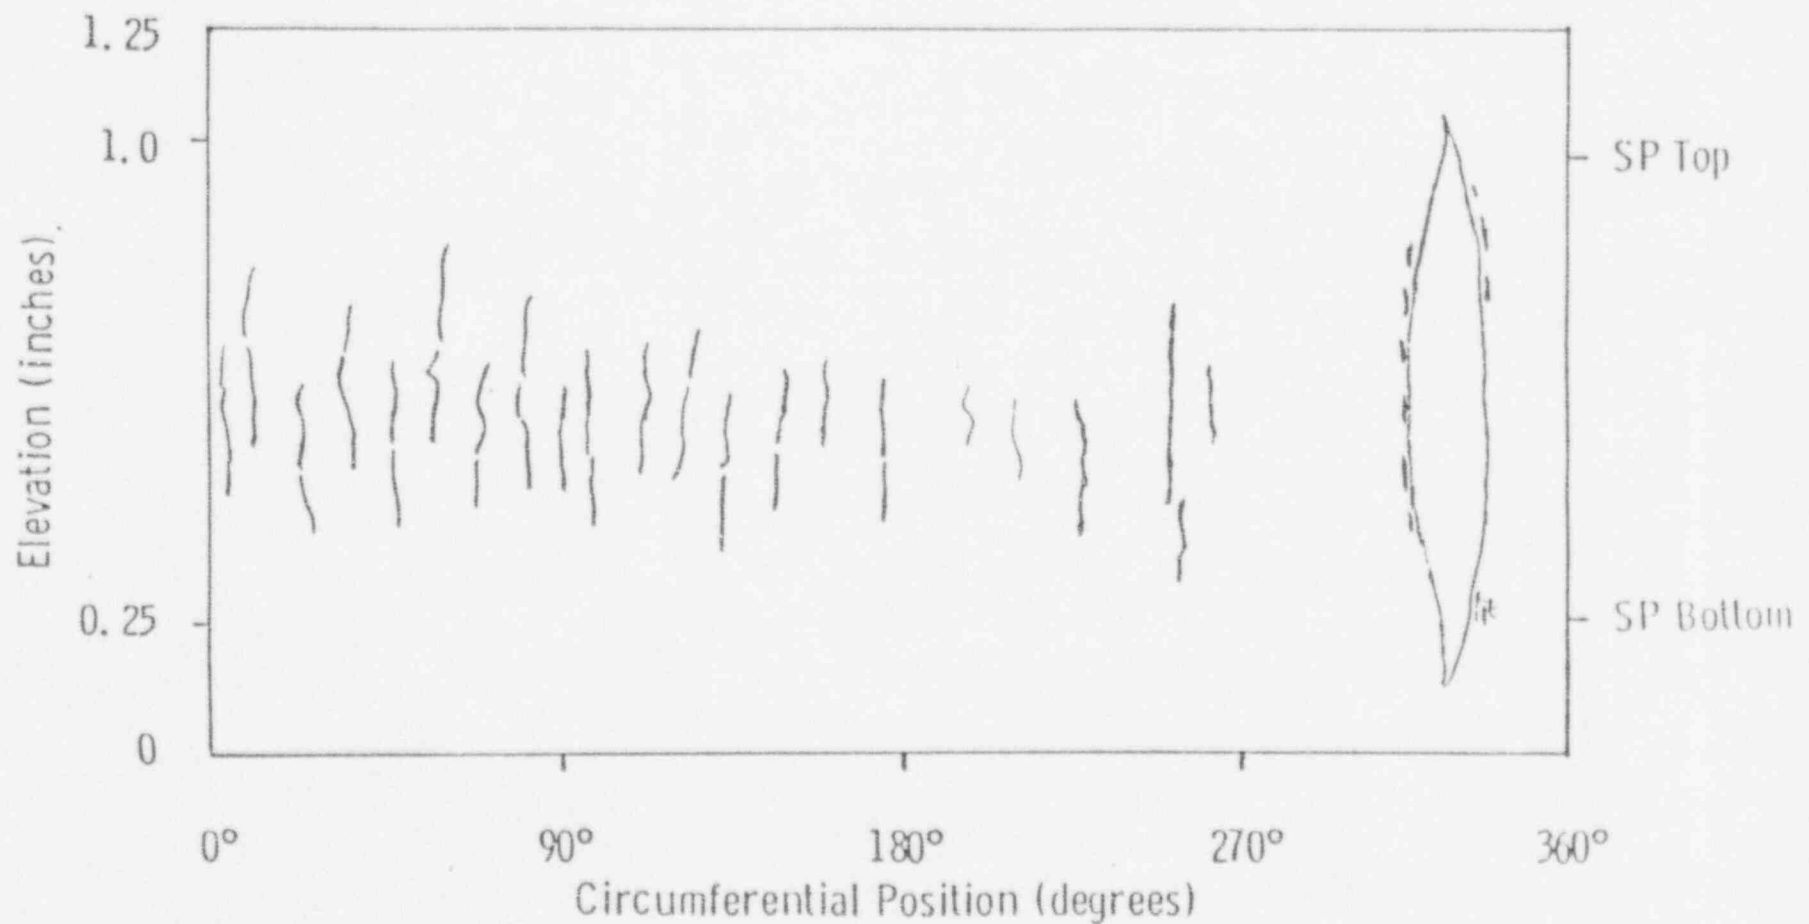
The burst fracture faces of the crevice region specimens were opened for SEM fractographic examinations. Table 3 presents a summary of the fractographic data. The burst openings occurred in axial macrocracks that were composed of numerous axially oriented intergranular microcracks of OD origin. In the case of the SP2 region of Tube R14-C80, the burst fracture microcracks

were confined to a narrow axial band. In the case of the SP1 region of Tube R19-C41, the burst fracture microcracks occurred in a large patch of microcracks within the crevice region.

Figure 1 Sketch of the crack distribution found at the second support plate crevice region of Tube R14-C80. Included is the location of the burst test fracture face opening. The OD origin intergranular corrosion was confined to the crevice region, including that found on the burst fracture face.

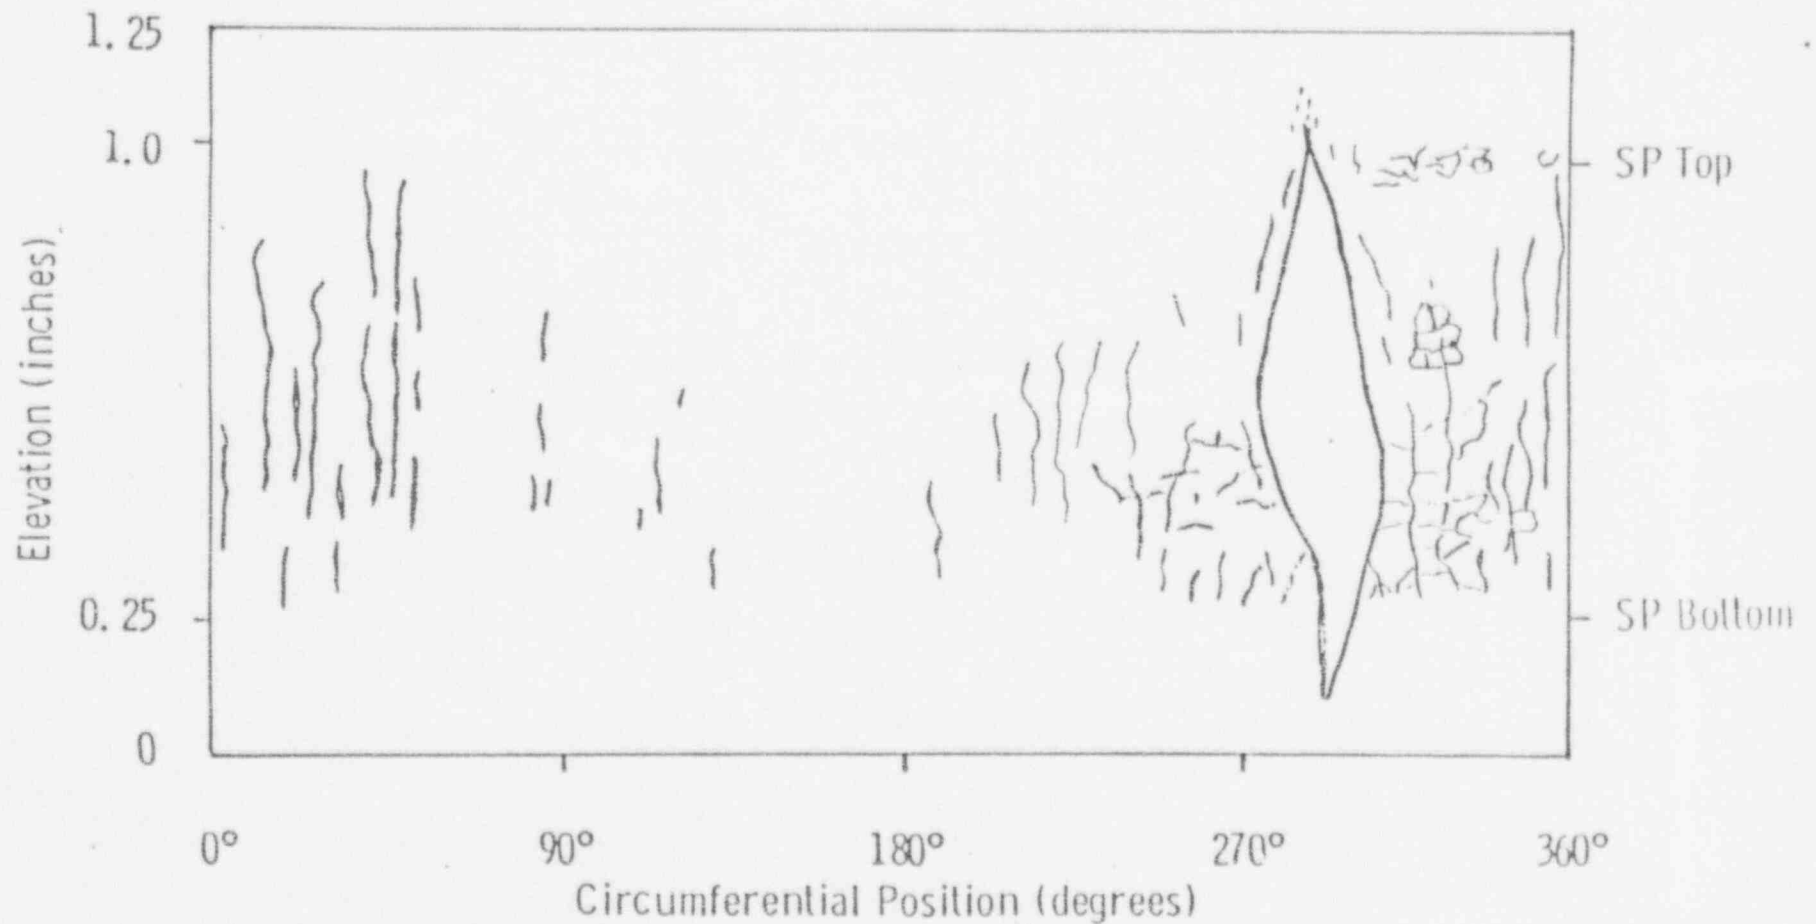
Figure 2

From the metallographic examinations, it was concluded that the dominant corrosion morphology was axial intergranular stress corrosion cracking (IGSCC). In the case of the SP1 region of Tube R19-C41, there was significant intergranular cellular corrosion (ICC) found in association with the axial IGSCC. With an ICC morphology, a complex mixture of short axial, circumferential and oblique angled cracks interact to form cell-like structures. Only a very minor amount of ICC was found in association with the axial IGSCC in the case of the SP2 region of Tube R14-C80. The ICC in SP1 of Tube R19-C41 occurred in one large patch (approximately 0.6 inch wide by 0.4 inch high) with two much smaller patches just above this large patch. Figure 3 presents a photographic montage of a portion of a radial metallographic section at a depth of approximately 10% that shows some of the ICC found in the SP1 region of Tube R19-C41. With progressive radial grinding, it was shown that the axial IGSCC was deeper than the associated ICC. The ICC disappeared at a

depth of 30 to 50% throughwall. The remaining crevice region of SP1 of Tube R19-C41, i.e., that without ICC, had axial IGSCC similar to that found in the SP2 region of Tube R14-C80.

Sketch of the crack distribution found at the first support plate crevice region of Tube R19-C41. Included is the location of the burst test fracture face opening. All deep OD origin intergranular corrosion was confined to the crevice region, including that found on the burst fracture face. Some minor intergranular corrosion was observed up to 0.2 inch above the crevice top.

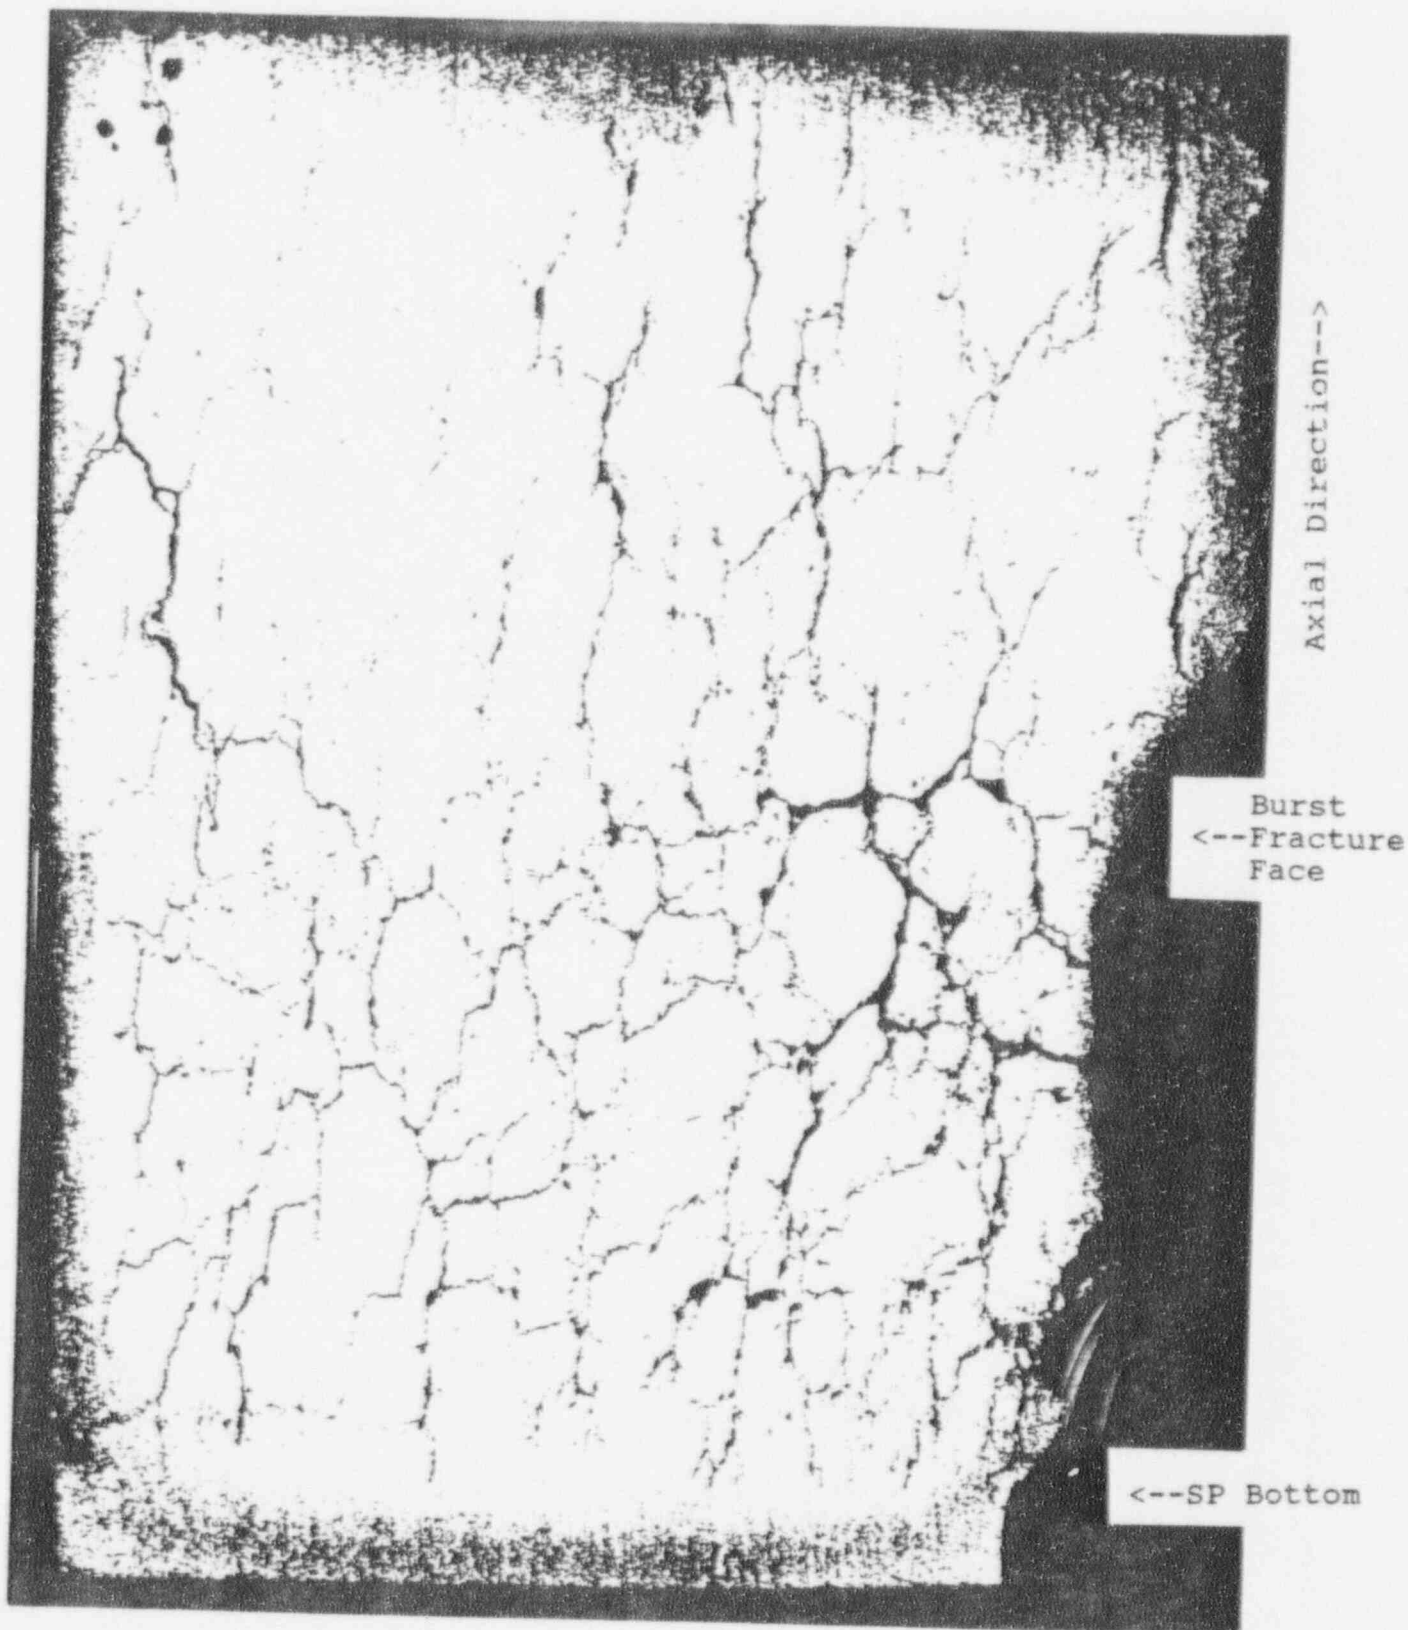
Figure 3 Radial metallography of the SP1 region of Tube R19-C41 showing intergranular cellular corrosion (ICC).
