SUBJECT: Calvert Cliffs Nuclear Power Plant
Unit Nos. 1 and 2; Docket Nos. 50-317 and 50-318;
License Nos. DPR 53 and DPR 69
Licensee Event Report 93-001
Technical Specification 3.0.3 Entry; Loss of Control Room
Air Conditioning

LICENSEE EVENT REPORT (LER)

TITLE (4)
Technical Specification 3.0.3 Entry; Loss of Control Room Air Conditioning

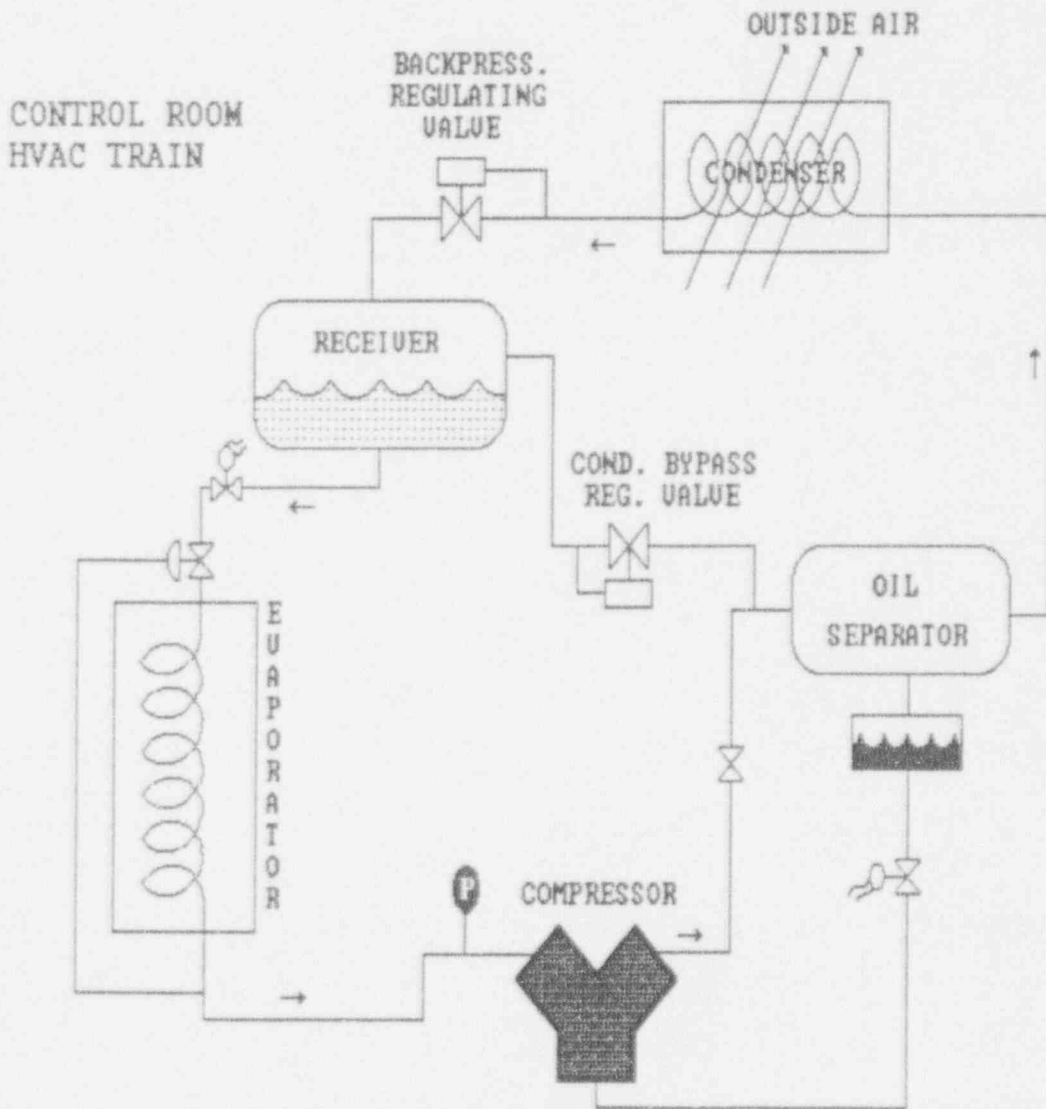
FIGURE 1

Each CR HVAC train has an air handling unit, evaporator, liquid receiver, air-cooled condenser, compressor, and a head pressure control system that permits operation during low outdoor air temperatures (Figure 1). Low ambient temperature operation prevents excessive heat rejection capacity in the air-cooled condenser and the condenser backpressure regulating valve closes allowing liquid refrigerant to backup or "stack" in the condenser coils. To maintain adequate compressor suction pressure, a condenser bypass regulating valve opens bypassing hot refrigerant gas directly to the receiver.

The immediate cause of No. 12 compressor becoming inoperable was insufficient refrigerant level to support a compressor start at extremely low outside temperatures. During cold outdoor temperature conditions, sufficient refrigerant inventory must be maintained in the air conditioning unit to compensate for density changes and stacking of liquid refrigerant in the condenser while maintaining adequate refrigerant inventory in the receiver. Insufficient refrigerant in the receiver can induce a low compressor suction pressure resulting in a compressor trip during starting. At the time of the event, outside air temperature was approximately 16 degrees Fahrenheit. This caused a significant amount of refrigerant to migrate to the condenser resulting in a low suction pressure at the compressor.

CONTROL ROOM HVAC TRAIN
