LIMERICK GENERATING STATION

SUBJECT: Licensee Event Report
Limerick Generating Station - Unit 2

Reference:	Docket No. 50-353
Report Number:	2-93-003
Revision Number:	00
Event Date:	February 13, 1993
Report Date:	March 11, 1993
Facility:	Limerick Generating Station P.O. Box 2300, Sanatoga, PA 19464-2300

TITLE (4) **Engineered Safety Feature Actuations Resulting From a Spurious Division 2 Loss of Coolant Accident Signal due to Personnel Error.**

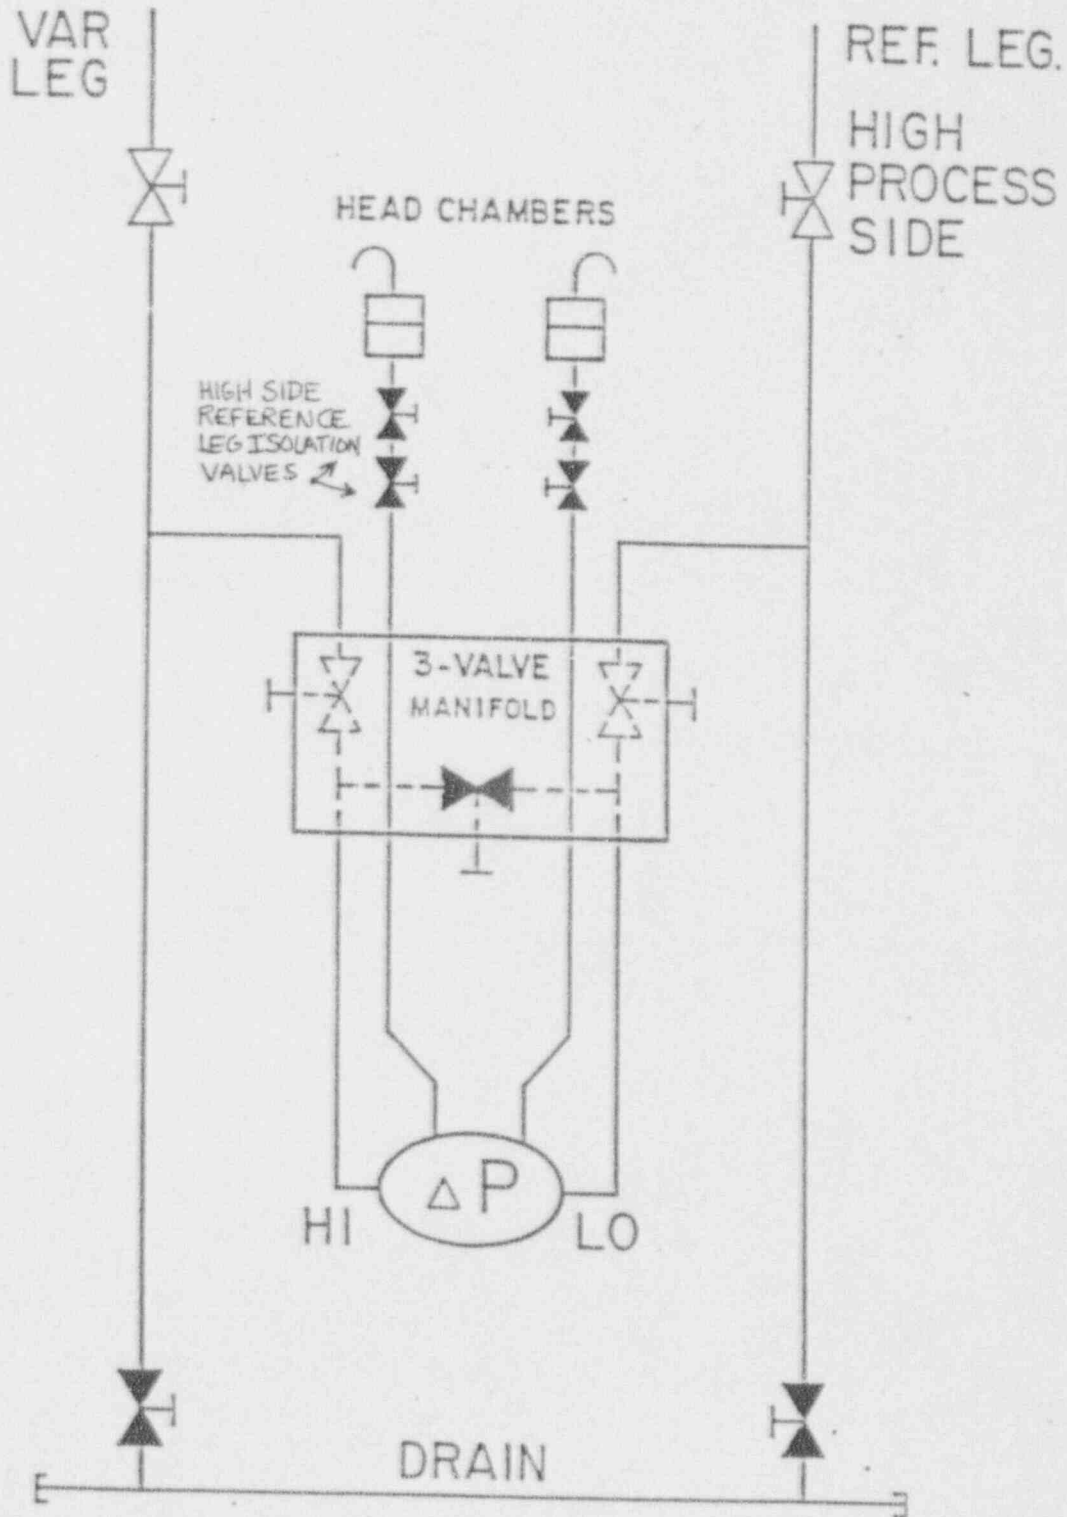
FIGURE 1

The cause of this event was cognitive personnel error. The normal positions of the two high pressure side reference leg head chamber isolation valves (see Figure 1) are correctly indicated in the ST procedure. The I&C technician had successfully completed the calibration/functional sections of the ST procedure and was performing a self-verification of his 'as left' valve positions. The I&C technician believed that he had incorrectly left the two isolation valves in the closed positions following the performance of the ST procedure. Instead of rechecking the normal positions of the isolation valves (i.e., closed), the I&C technician mistakenly re-opened, then quickly reclosed, the isolation valves causing the spurious Division 2 LOCA signal to initiate.
