MONTICELLO NUCLEAR GENERATING PLANT		3004	
TITLE: SRI REVIEW AND APPROVAL FORM	Revision 12	06/02/92	
	Page 1 of 2

TITLE: BASIS FOR CONTINUED OPERATION WITH CRACK IN CORE SPRAY HEADER

SRI #93-006  
Basis for Continued Operation  
with Crack in Core Spray Header  
Page 9 of 9.

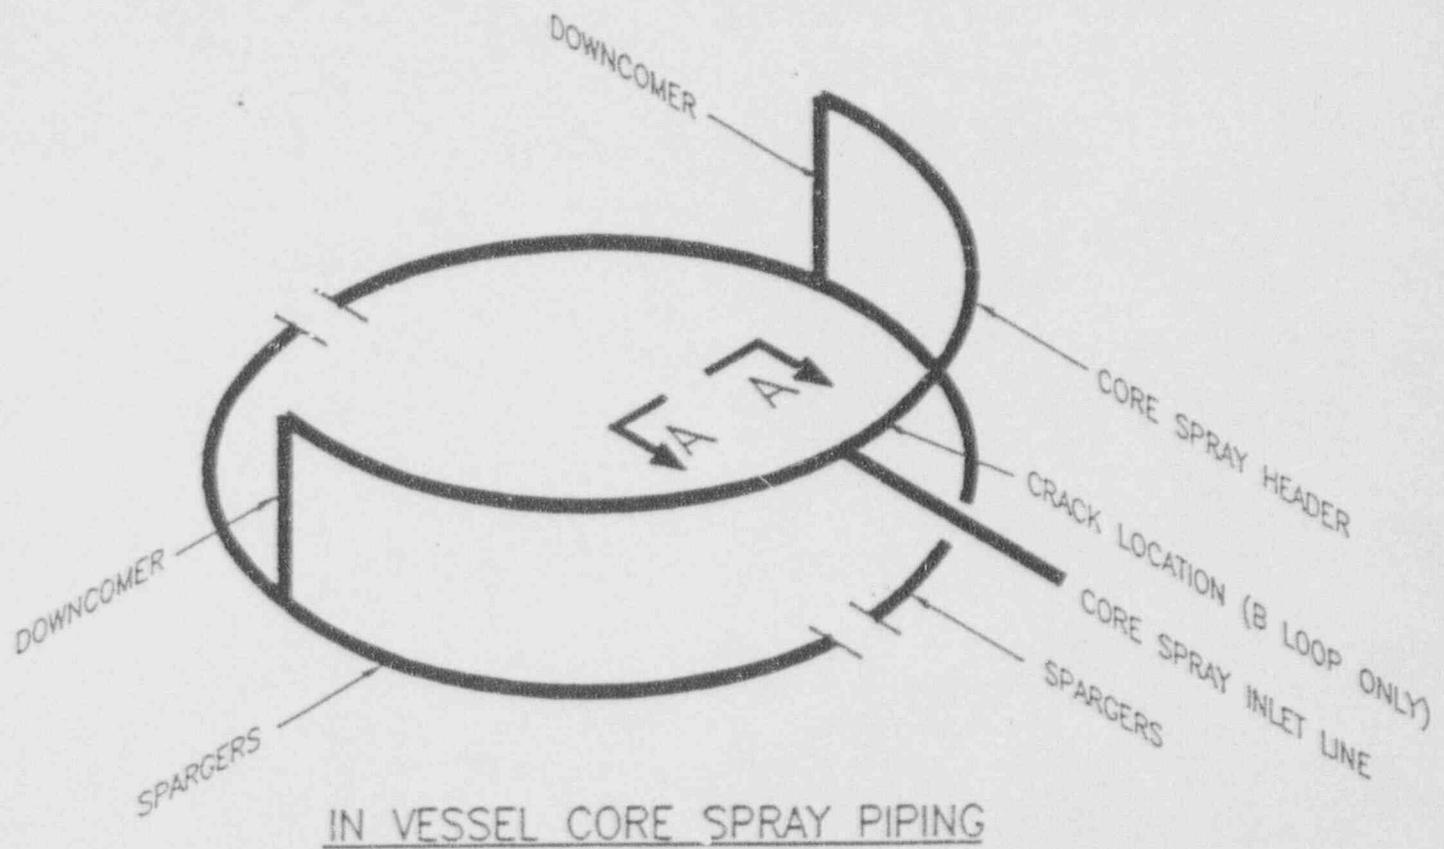
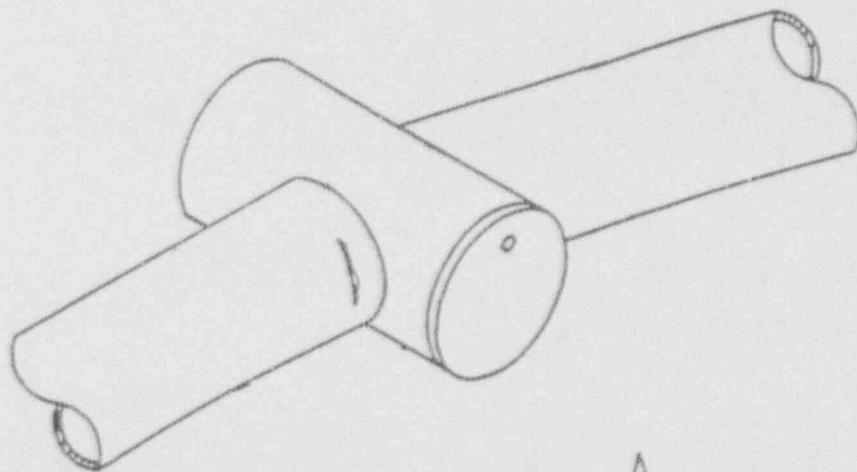
FIGURE #1  
 E# 93Q170

The in-vessel visual inspection performed during the 1993 refueling outage identified a small crack indication on the 'B' core spray header where the piping and the tee box meet as shown in figure 1. The function of the junction box and the attached distribution pipes is to direct core spray flow from the vessel inlet nozzle through the annulus area to the spargers inside the shroud. The integrity of this safety related piping system must be maintained to ensure that core spray flow can be delivered to the core to achieve its design function. The purpose for this SRI is to evaluate the acceptability of operating with this crack through one fuel cycle with no operational changes or restrictions.

The crack is located on the left arm of the 'B' core spray distribution pipe adjacent to the junction box weld. It is concluded that the crack is most likely caused by intergranular stress corrosion cracking (IGSCC) for the following reasons:

The crack is located at the 3:00 position (viewing the pipe axially towards the tee box) about 1/4" from the weld. Initial estimates of crack length based on video camera surveys was about 3". A later measurement with a reference scale placed at the crack location indicated the circumferential crack length was actually closer to 2 1/4". In addition, an underwater UT examination of the crack area using NSP's approved method for IGSCC detection revealed that the crack was through wall, did not appear to have major ID origin and no ID or OD cracking was evident at the 12:00 and 6:00 positions.

**SECTION A-A**  
 DETAIL OF CRACK IN  
 CORE SPRAY PIPING

NOTE:  
 CRACK ON B LOOP  
 ONLY AT 90° (N-5A)
