SUBJECT: Arkansas Nuclear One - Unit 1
Docket No. 50-313
License No. DPR-51
Licensee Event Report 50-313/91-003-01

L I C E N S E E E V E N T R E P O R T (L E R)

TITLE (4) Actuation of the Emergency Feedwater System During Plant Heatup due to Low Once Through Steam Generator Level Which Resulted From Inadequate Feedwater Flow Caused by a Degraded Auxiliary Feedwater Pump

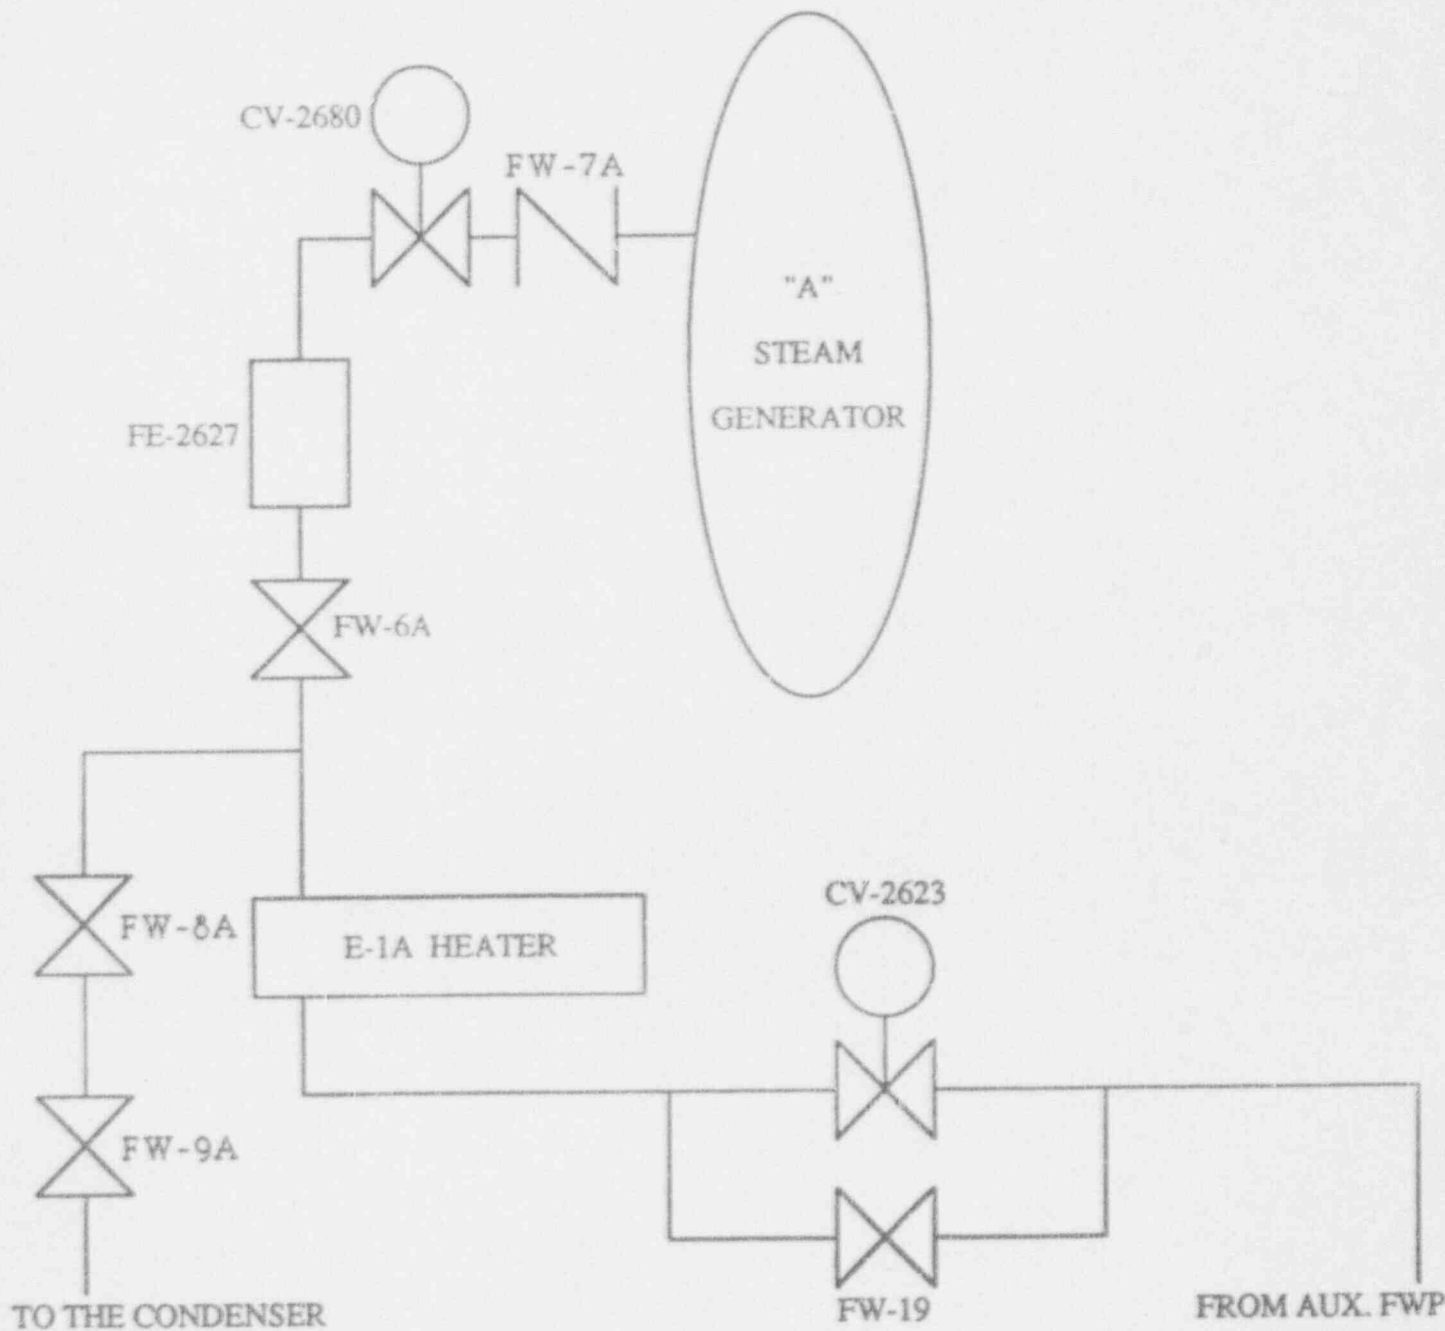
ATTACHMENT

The cause of this event was originally determined to be leakage past the seat of FW-3A (feedwater recirculation line) which was closed at the time of this event, and through FW-9A, which was open, to the condenser (see attachment). This leakage, over a period of time when OTSG feedwater was not required, resulted in the feedwater line between CV-2623 and FW-7A becoming voided. When the 'A' OTSG reached its lower limit, CV-2623 began to open as designed. However, since flow was entering a partially voided line, the OTSG level continued to drop and CV-2623 continued to ramp open in response to the decreasing level. As CV-2623 continued to open, P-75 discharge pressure dropped below OTSG pressure and 'B' OTSG level began to decrease, resulting in the 'B' startup valve (CV-2673) beginning to open farther. It was believed that P-75 pumping into the voided feedwater line had resulted in the pump reaching a 'runout' condition which rendered it incapable of supplying feedwater to the OTSGs. However, subsequent evaluations performed during refueling outage 1R10 (February - May, 1992) determined that, although leakage past the seat of FW-8A was a contributing factor to this event, it was not the root cause. Disassembly and inspection of P-75 during 1R10 revealed that the first stage channel ring bushing was loose and had caused abnormal wear on the second stage impeller. Conversation with the pump vendor (Ingersoll-Rand) verified that the loose bushing could move into the suction of the next stage impeller and effectively reduce the inlet area of that impeller. At increased flow rates, the restriction produced by the bushing could result in significant throttling. Therefore, it was concluded that the internal pump damage was the primary cause of this event.

- The 'Plant Startup' procedure (OP 1102.02) was revised to require that FW-9A and B be closed whenever FW-8A and B are required to be closed.
- The 'Plant Startup' procedure was also revised to include a requirement to verify the ability to feed the OTSGs with the auxiliary feedwater pump prior to reaching the low level limits when lowering OTSG levels during startup.
- A repetitive maintenance task was developed for FW-8A, FW-8B, FW-9A and FW-9B.
