UNITED STATES
NUCLEAR REGULATORY COMMISSION
WASHINGTON, D. C. 20555

NRC INFORMATION NOTICE 92-68: POTENTIALLY SUBSTANDARD SLIP-ON, WELDING NECK,
AND BLIND FLANGES

FAILURE ANALYSIS OF A SLIP-ON FLANGE

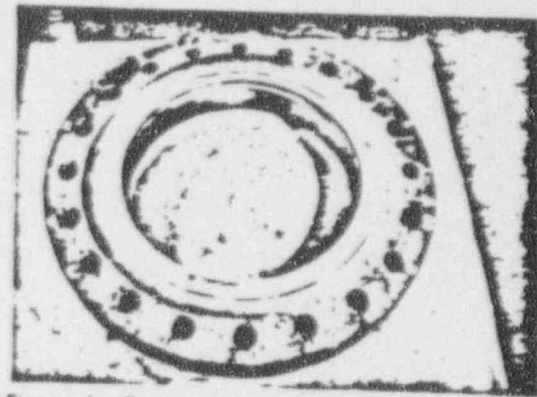
The installation of a 14" slip-on flange in a pipeline was recently witnessed by Al Justin, chief inspector for the State of Minnesota. The flange originally had a 14-3/4" inside diameter, which was reduced by welding a 3/4" ring and machine welding. The ring, however, separated from the flange, giving the appearance of a crack. The flange is reported to have been manufactured in the People's Republic of China.

Figure 1: Gasket side of flange

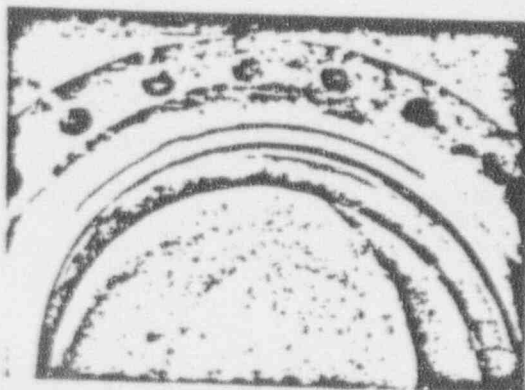
The subject slip-on flange is not an integral forging or a casting. It has been fabricated by welding and machining a ring insert within a large diameter flange. The flange "cracked" because the welds between the flange and the insert were inadequate to withstand the bolting pressures.

Figure 2: A close-up of the gasket side showing the "crack" indication.

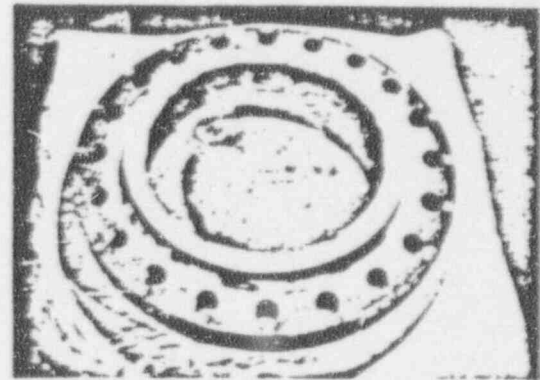
First, the flange was UT tested from the OD. The indications were rather puzzling because the reflections were consistently from a cylindrical surface about 3.75" from the OD. A dry magnetic particle examination confirmed that the cracks extended more or less continuously in a circular path. The NDT examination was concluded with dye penetrant tests as shown in the photographs in Figures 1 through 4. It was quite evident that the flange was not a single piece component. A large inside diameter (ID) flange was reduced to a 14" ID unit by welding a 0.75" thick ring. The welding faces had been machined.

Figure 3: Pipe side of flange

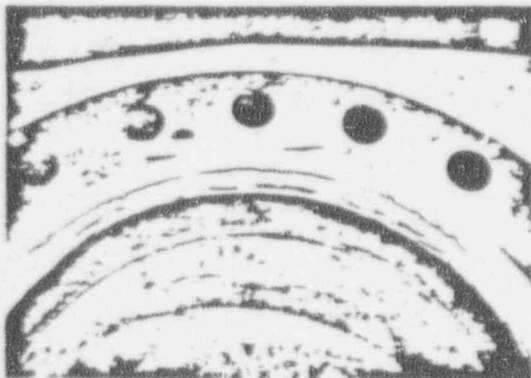
Figure 4: A close-up of the pipe side showing the "crack".

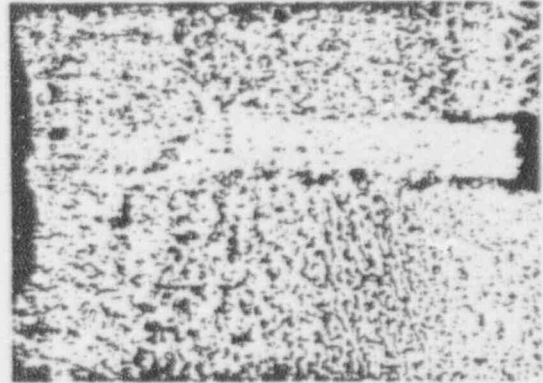
Figure 6: Photo showing general microstructure in the main flange (lower half), insert (upper half) and weld metal (left edge). 25X, Nital etch.
