U. S. NUCLEAR REGULATORY COMMISSION

Report No. 50-457/93013(DRP)

Type of Meeting: Enforcement Conference

BRAIDWOOD
REACTOR HEAD VENT VALVE
ENFORCEMENT CONFERENCE

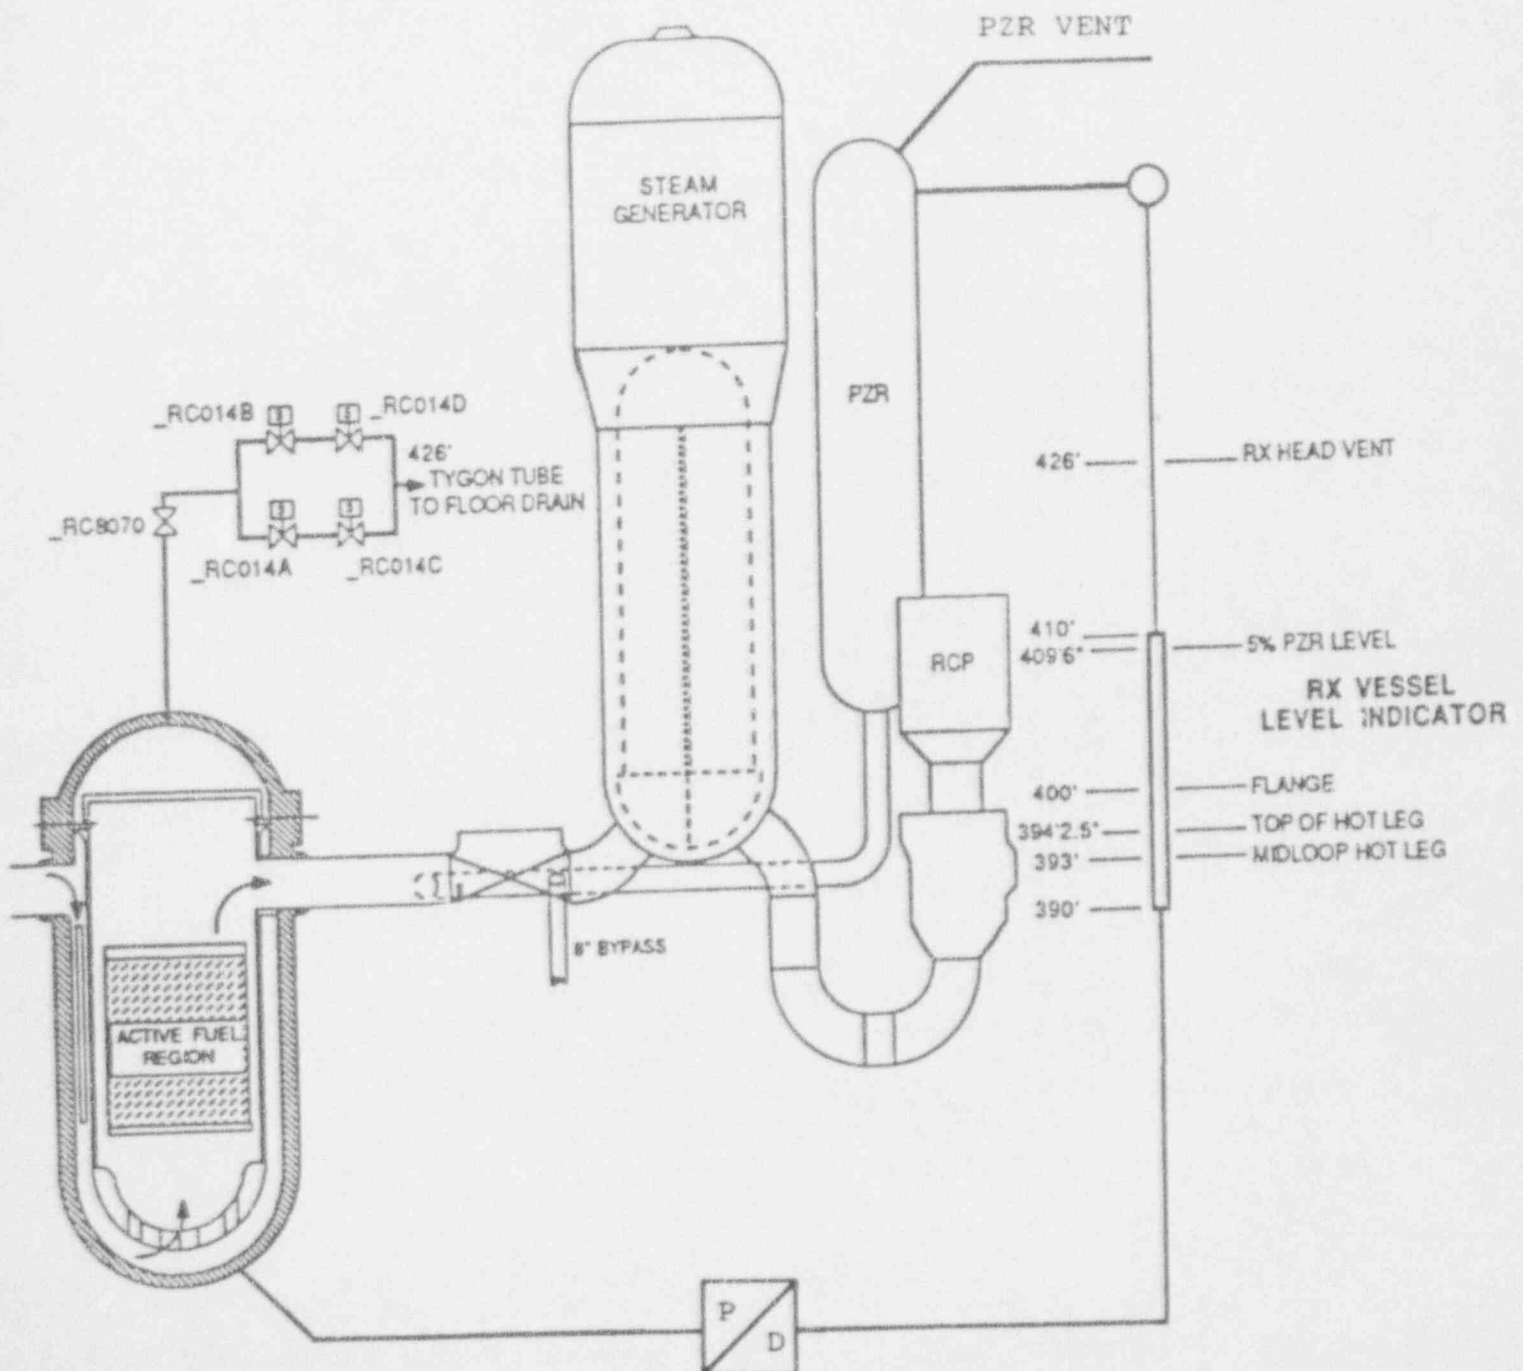
HEAD VENT SUBSYSTEM

- * The reactor head vent subsystem consists of a manual locked valve in series with two redundant sets of two solenoid-operated vent valves. The manual valve (2RC8070) is required to be maintained in the locked open position when the unit is in Modes 1 thru 4.
- * During RCS draining, the RC 014 solenoids are opened to provide a vent path (in addition to PZR vent path).
- * This path must also be maintained open for the level indicator to be accurate. (Modes 5 and 6)
- * The head vents are also used during RCS fill and during surveillances to vent non-condensable gases.
