Re: Pacific Gas and Electric Co. (Diablo Canyon Nuclear
Power Plant, Units 1 and 2), Docket Nos. 50-275-
OLA, 50-323-OLA (Construction Period Recapture)

Re: Docket No. 50-275, OL-DPR-80
Docket No. 50-323, OL-DPR-82
Diablo Canyon Units 1 and 2
Licensee Event Report 1-93-005-00
Medium Voltage Cable Failures

LICENSEE EVENT REPORT (LER)

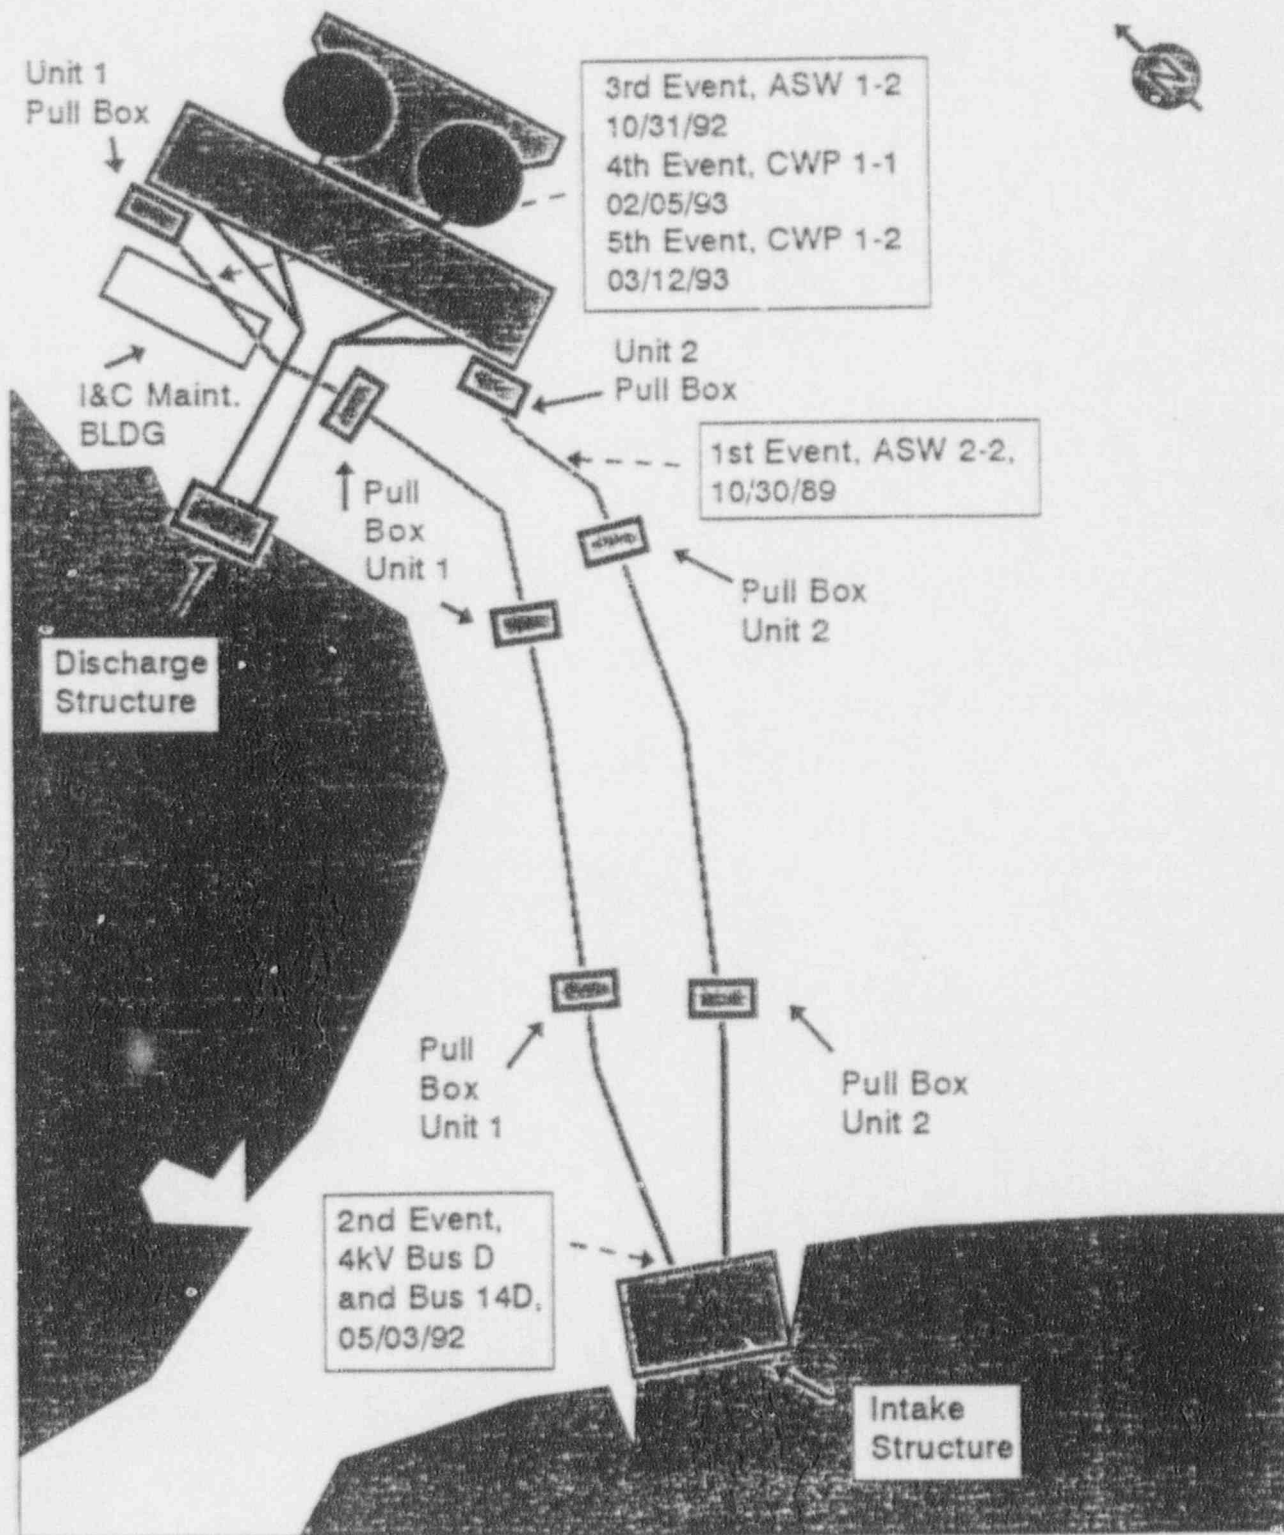
Figure 1: Site Overview of Conduit Trench for Units 1 & 2

Diablo Canyon Power Plant (DCPP) has experienced three 4kV and two 12kV circuit cable (EA)(CBL) failures. These failures have occurred only in underground duct bank conduits (FA)(DUCT)(CND) between the turbine building (NM) and the intake structure (NN) (see Figure 1). Both 12kV cable failures occurred on Unit 1 between the first pull box outside the turbine building and the next pull box toward the discharge structure elevation.

The subject cables are routed in two separate sets of duct bank conduits, one for each unit, between the turbine building and the intake structure. Concrete vaults are located at various intervals to serve as pull boxes for the circuits. These duct bank conduits are directly buried in sand and are covered for their entire length by a six-inch thick concrete cap. The duct bank conduits include 12kV, 4kV, and 480V (CBL4) power cables, 120V ac control cables (EF)(CBL3), 125V dc control cables (EJ)(CBL3), and instrument cables (EF)(CBL1).

The Unit 1 and Unit 2 trenches are similar, except that the Unit 1 duct bank rises to cross over the circulating water discharge tunnel and then slopes downhill towards the intake structure. This design makes the Unit 1 section of cable conduits near the turbine building susceptible to submergence if the pull box sump pumps are not functional and if the water within the pull boxes rises above the conduit openings.

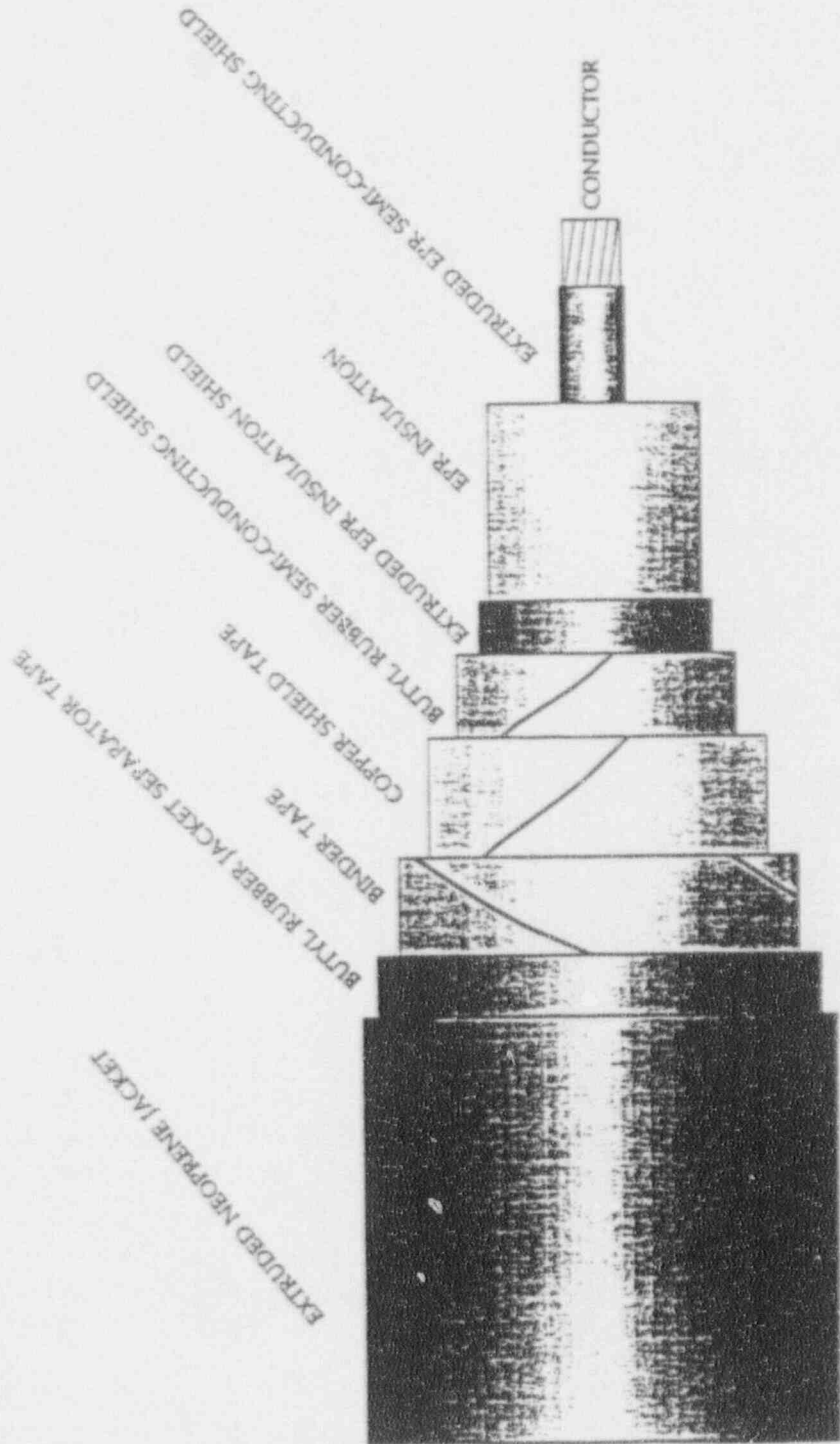
TEXT (17) FIGURE 2 : DESIGN OF 4KV AND 12KV OKONITE CABLES

The cable construction is similar for both the 4kV and 12kV cables. The cables are a shielded single-conductor cable design and are constructed in concentric layers (see Figure 2). There are four cable layers of interest for this LER: (1) the insulation (EA)(CBL)(INS) layer, which is approximately 115 mils of black EPR for the 4kV cables and approximately 220 mils of black EPR for the 12kV cables; (2) the tinned copper shield tape, which acts to equalize the electrical stress; (3) the wax coated synthetic binder tape, which holds the copper shield against the cable, thereby allowing the outer jacket to be extruded over the cable during manufacture; and (4) the outside layer, which is a neoprene jacket. The function of the outer neoprene jacket is to protect the cable during installation (impact and abrasion resistance) and to act as a physical barrier between the

outside environment and the shield once the cable is installed. The cable jackets are not bonded to the cable shield or insulation layers.
