WOLF CREEK

Subject: Docket No. 50-482: Licensee Event Report 93-008-00

LICENSEE EVENT REPORT (LER)

TITLE (4)
Flux Doubling circuit required for Modes 3, 4, and 5 was "blocked" for several days.

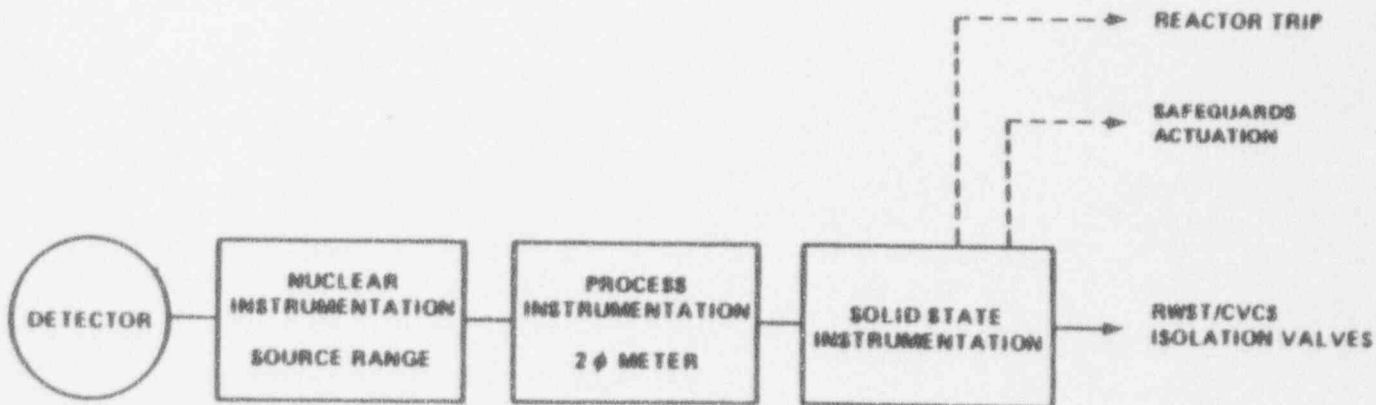
Figure 1

Instrumentation is provided to mitigate the consequences of an inadvertent addition of unborated, primary grade water into the RCS. The attached figure (Figure 1) is a simplified block diagram of the boron dilution control system at WCGS taken from USAR Figure 7.6-6. This figure shows the Flux Doubling detection system and the protection system output for the associated isolation valve actuations of RWST/CVCS.

In the event of a boron dilution transient, the Source Range Neutron Flux Instrumentation, in conjunction with the 2Φ meter, detects a doubling of the neutron flux. This information is sent to the solid state protection system which automatically initiates isolation valve movement to terminate the event. Also, an alarm is sounded in the Control Room for plant operators to indicate that Flux Doubling has occurred and isolation valve movement has started. In the analysis of a boron dilution event, credit is taken for the instrumentation to provide for operator alert and for automatically initiating appropriate isolation valve movement.
