UNITED STATES
NUCLEAR REGULATORY COMMISSION
WASHINGTON, D.C. 20555-0001

Docket Nos. 50-327
and 50-328

SUBJECT: PRELIMINARY ACCIDENT SEQUENCE PRECURSOR (ASP) ANALYSIS FOR
SEQUOYAH NUCLEAR PLANT UNITS 1 AND 2

B.18.1 Summary

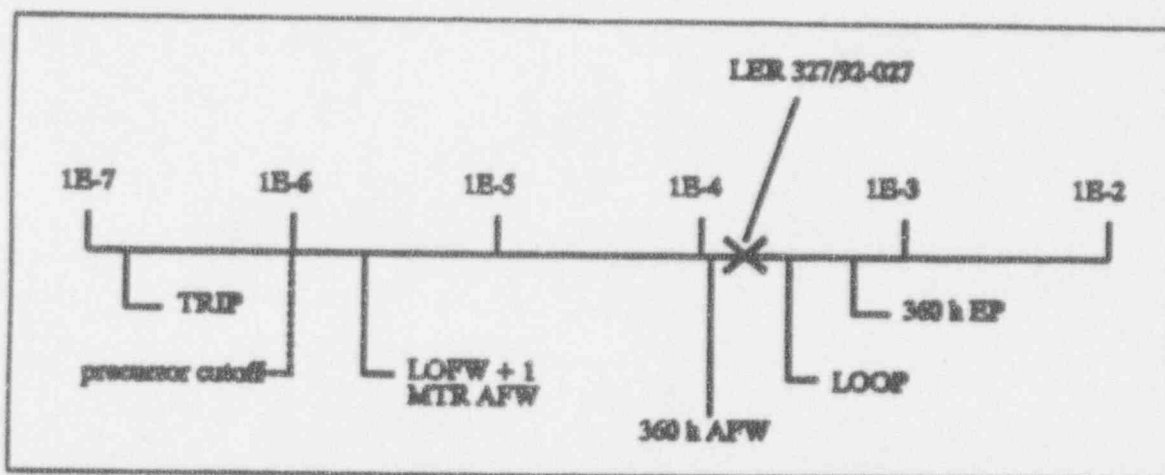
Shortly after a switchyard breaker was installed, it faulted and caused an undervoltage condition in the switchyard. This resulted in the tripping of both units from 100% power on loss of offsite power (LOOP). Because of the momentary undervoltage condition on the safeguards busses, the emergency diesel generators started and loaded. The conditional core damage probability estimated for this event is 1.8×10^{-4} per unit. The relative significance of this event compared to other postulated events at Sequoyah is shown in Fig. B.36.

Fig. B.36. Relative event significance of LER 327/92-027 compared with other Sequoyah 1 & 2 potential events.

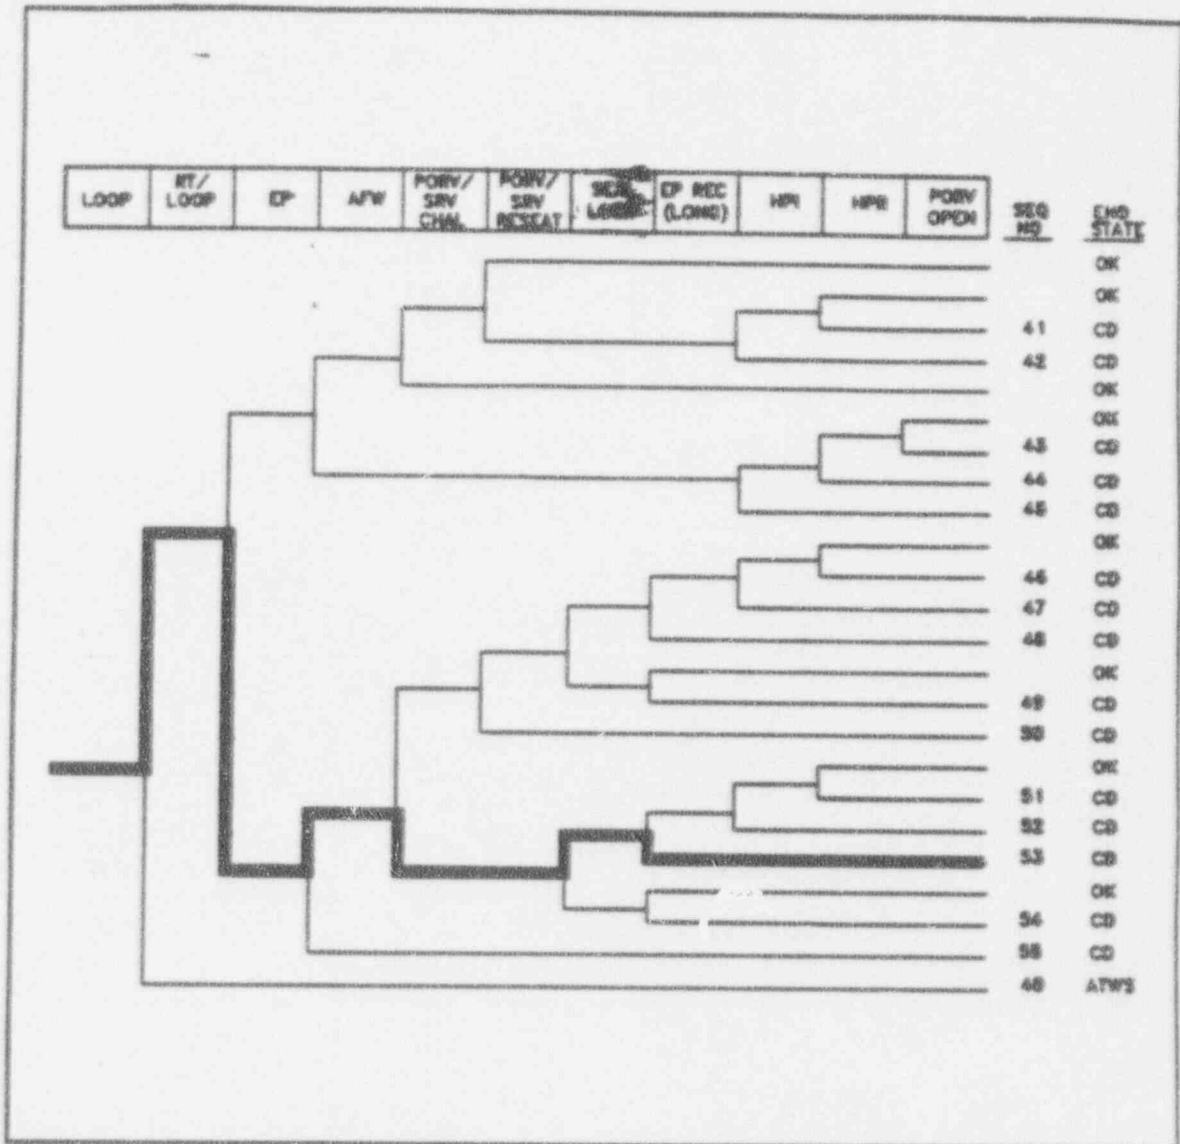
Since the LOOP was caused by a substation fault, this event was modeled as a plant-centered LOOP. Probabilities for LOOP nonrecovery (short term), failure to recover ac power prior to battery depletion, and reactor coolant pump seal LOCA probabilities were revised to reflect values associated with a plant-centered LOOP (see ORNL/NRC/LTR-89/11, *Revised LOOP Recovery and PWR Seal LOCA Modeling*, August 1989). The event was modeled for a single unit. The event sequence was essentially the same for both units.

The conditional probability of core damage estimated for this event is 1.8×10^{-4} per unit. The dominant core damage sequence, highlighted on the event tree in Fig. B.37, involves failure of emergency power restoration resulting in a reactor coolant pump seal LOCA.

Fig. B.37. Dominant core damage sequence for LER 327/92-027.

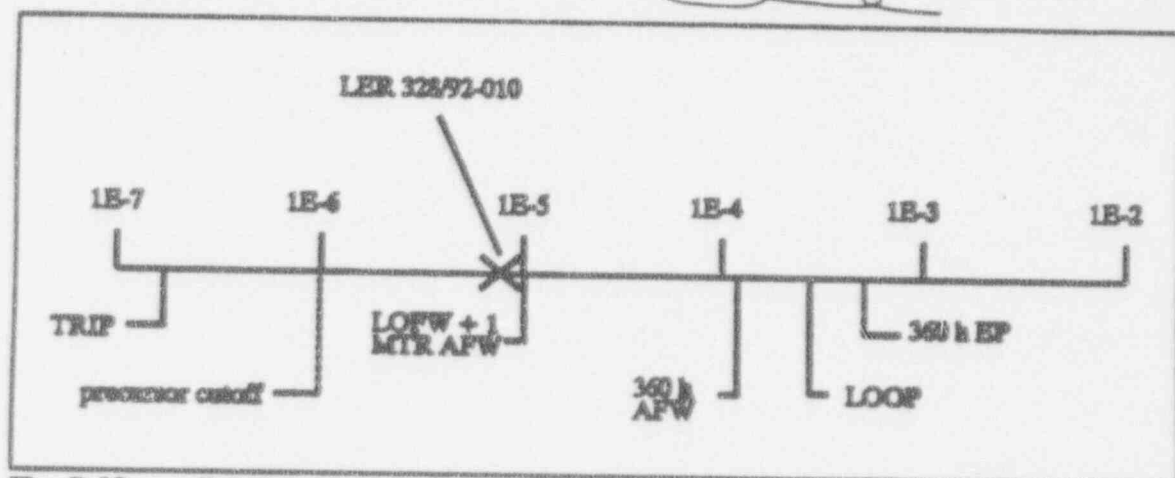
During performance of a surveillance procedure on the 2B-B Residual Heat Removal (RHR) pump, it was found that the miniflow control valve continuously cycled open and closed when it should have remained opened. While the pump was inoperable, the 2A-A emergency diesel generator (EDG) was inoperable for 17 h and the 2A-A centrifugal charging pump was inoperable for 6 h. The conditional core damage probability estimated for this event is 8.6×10^{-4} . The relative significance of this event compared to other postulated events at Sequoyah, Unit 2 is shown in Fig. B.37) Fig. B.38.

Fig. B.38. Relative event significance of LER 328/92-010 compared with other Sequoyah 2 events

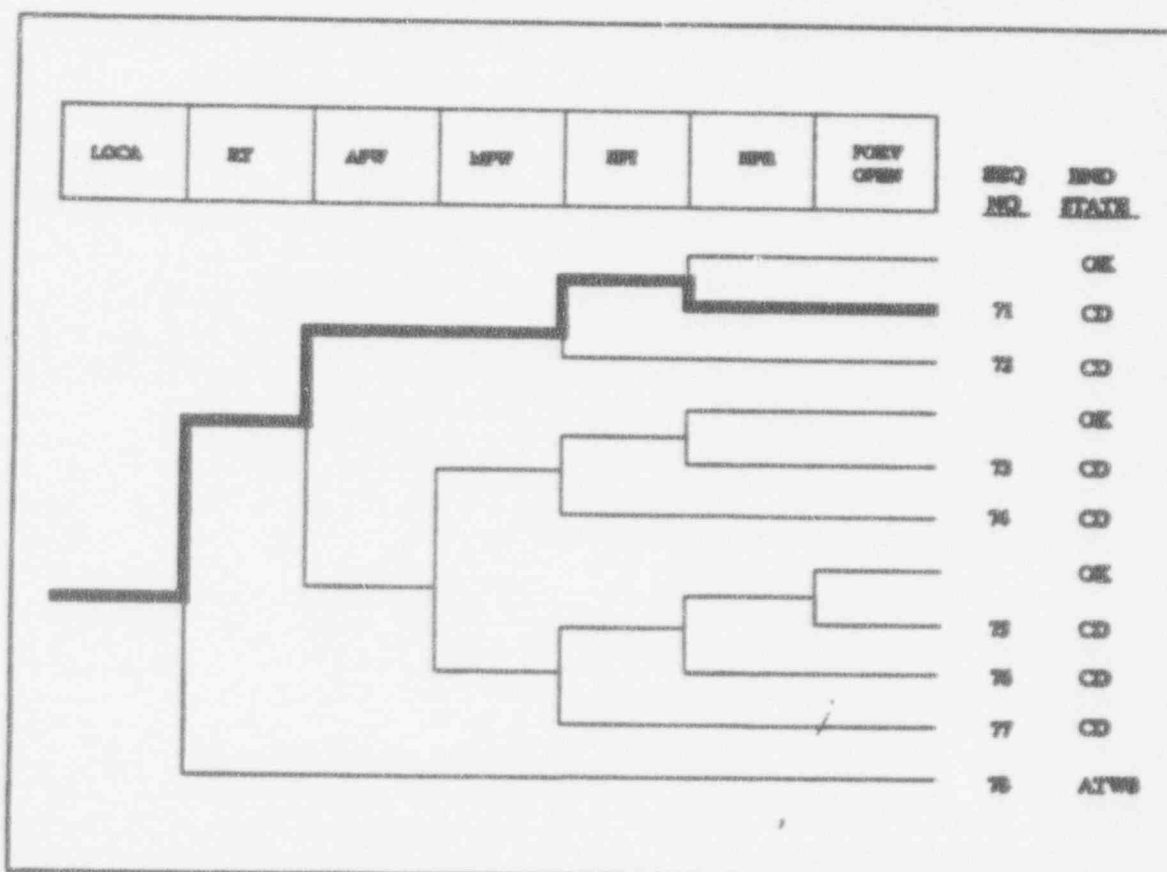
The conditional probability of core damage estimated for this event is 8.6×10^{-6} . This consists of 8.3×10^{-6} for the EDG inoperability and 6.3×10^{-6} for the CCP inoperability. It should be noted that since the CCP inoperability was modeled as an inoperability of both the CCP and HPSI pump in the same train, the result is very conservative for this case. The dominant sequence, highlighted on the event tree in Fig. B.39, involves a LOCA followed by the failure of high pressure recirculation.

Fig. B.39. Dominant core damage sequences for LER 328/92-010
