ENGINEERING EVALUATION OF THE WNP-2
SACRIFICIAL SHIELD WALL

SUPPLEMENT NO. 2

Washington Public Power Supply System
Richland, Washington 99352

Attachment to letter G02-81-556,
Supply System (RG Matlock) to
NRC (RH Engelken), dated
December 29, 1981

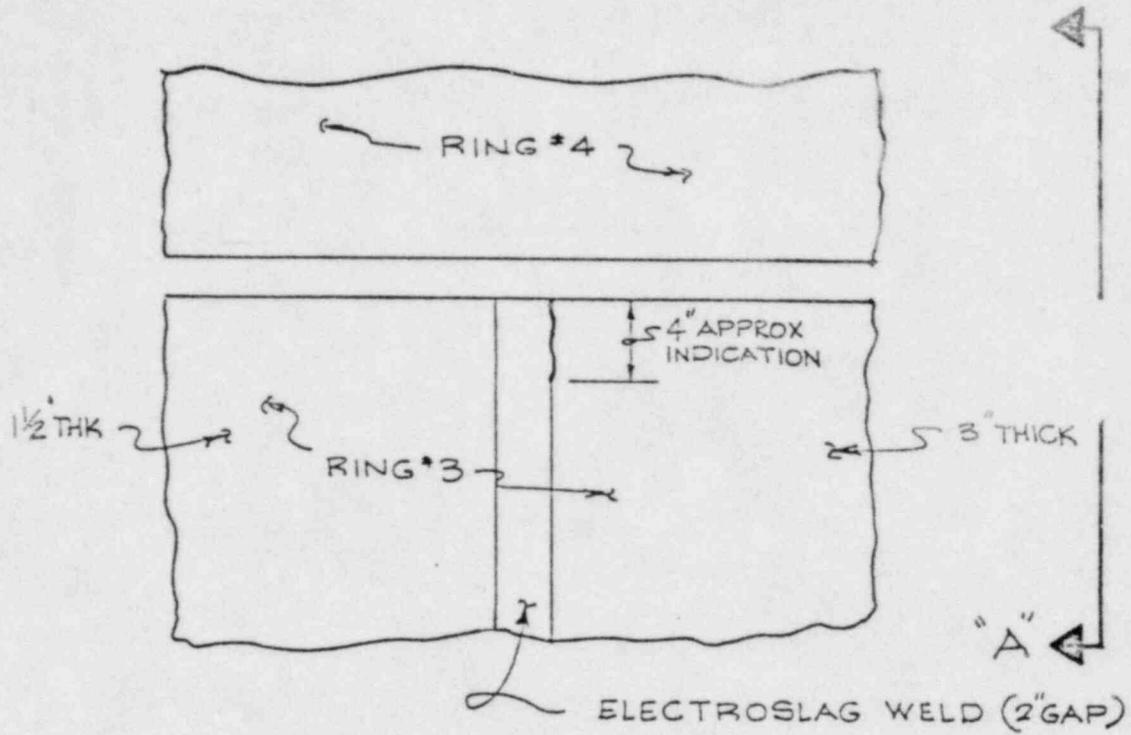
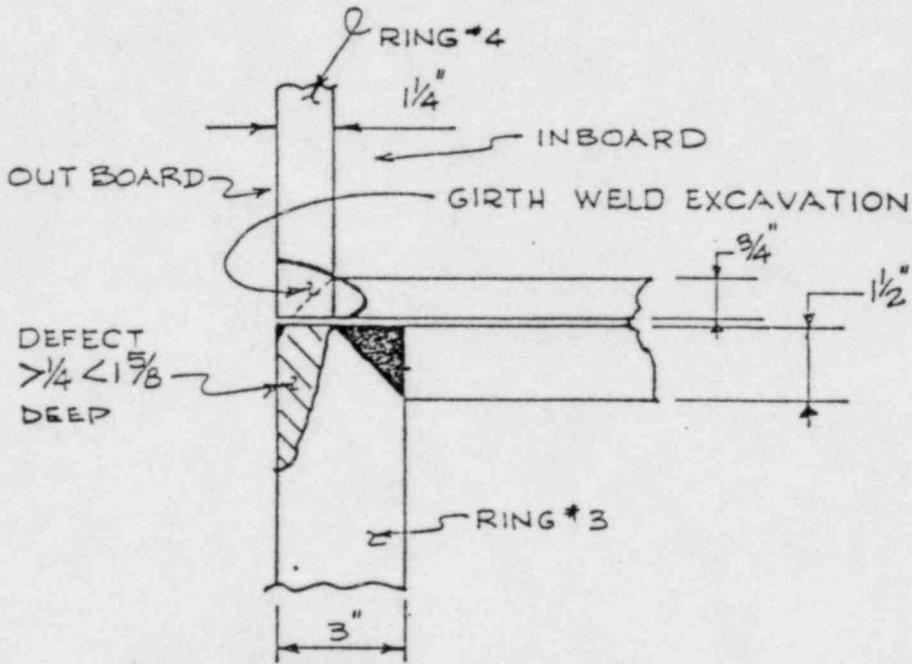
FIGURE 1 LINEAR INDICATION IN RING 3 AT 135 -150°AZ

a. Linear indications in ring beam #3 between 135 and 150°Az (NCR 6648):

The location of this defect was reported two feet from the 150°Az at the approximate location of an electroslag weld. The area was etched, but the results were not conclusive.

Figure 1 provides an estimate of the size and location of the defect.

Leckenby had experienced problems with lack of fusion in electroslag welds and it is concluded that this defect was of the same type.

Excavation, drilling and base metal repairs were performed as described above. The excavation was examined by the magnetic particle method prior to grinding to assure removal of the indication. The base metal repair was made using the approved shielded metal arc welding procedure to restore the SSW girth weld geometry and a MT examination was performed to accept the completed repair.

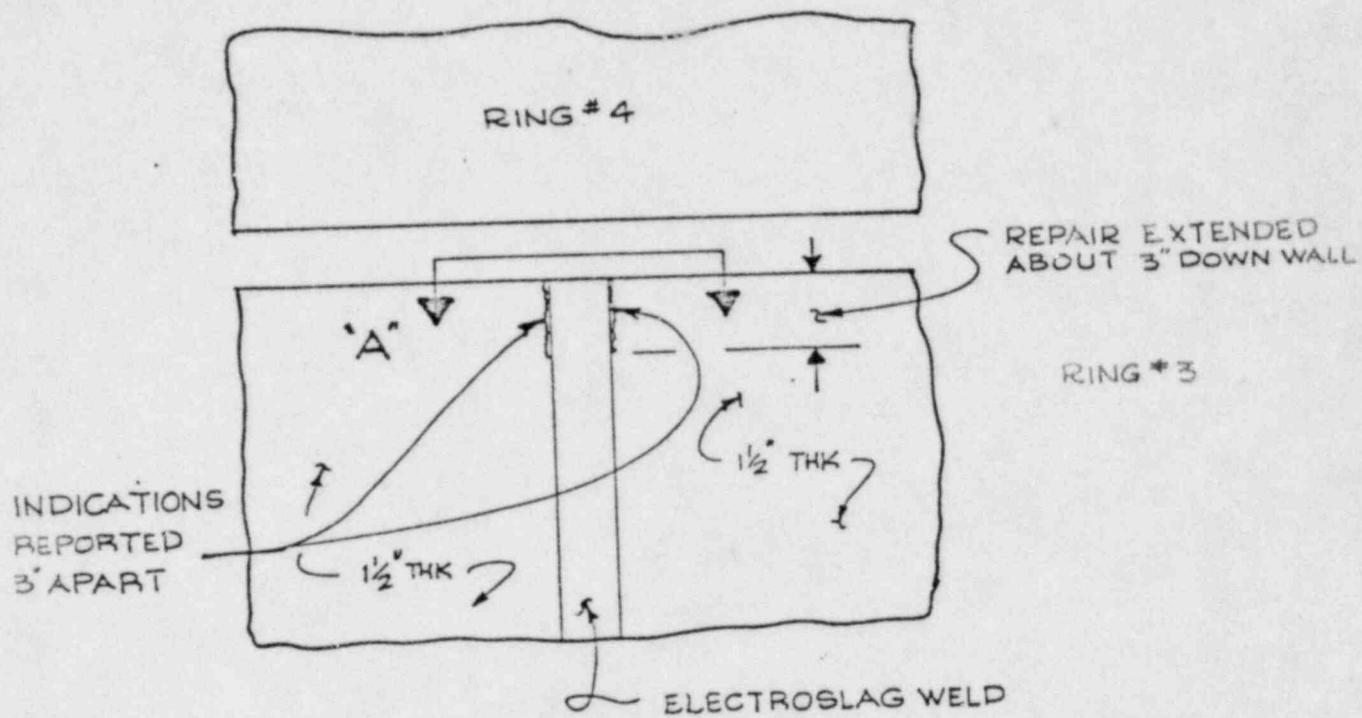
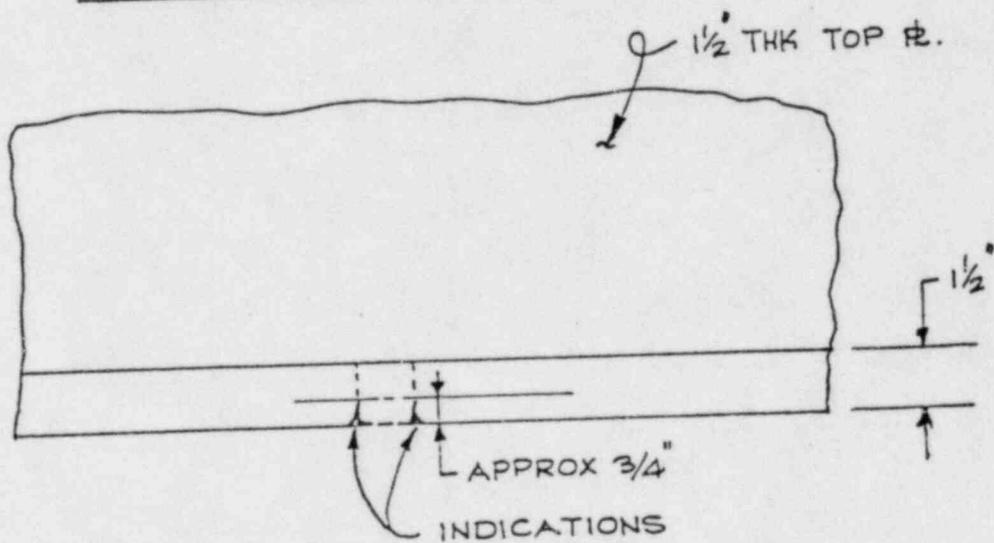
FIGURE 2 LINEAR INDICATIONS IN RING 3 AT 90-105°AZ

- b. Linear indications in ring beam #3, 90-105°Az (NCR's 6649 and 6652):

These indications were reported 2'3" from Az 105° in ring beam #3. The first indication was reported on NCR 6649 and the second on NCR 6652. The indications were about 3" apart.

The electroslag weld (ESW) at this location joins the front flange plates of ring beam #3 (Figure 2). The indications were probably at both edges of the ESW; the depth was approximately 3/4"; and the total length of repair down the face of the wall was about 3" (Figure 2).

It is probable that these indications were of the same type as discussed above.

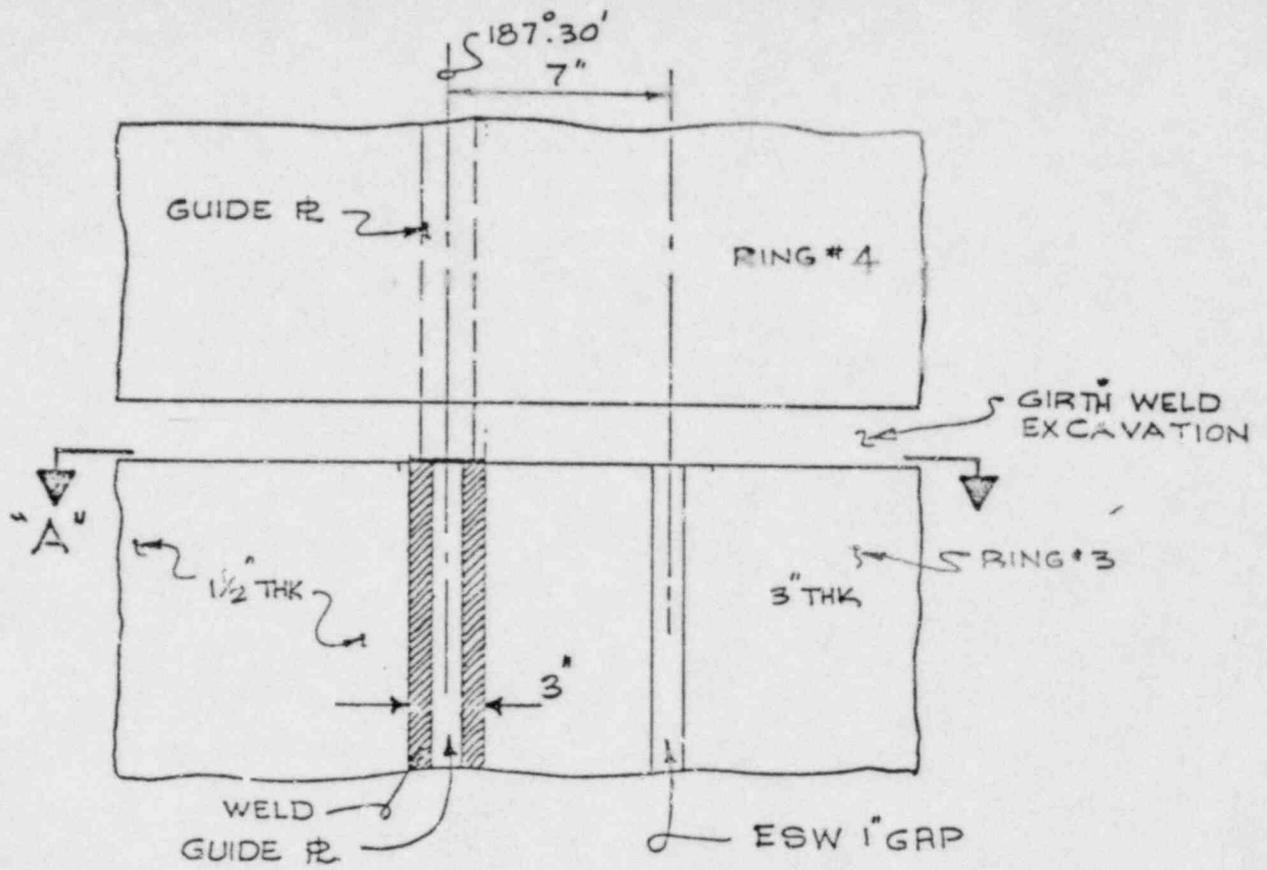
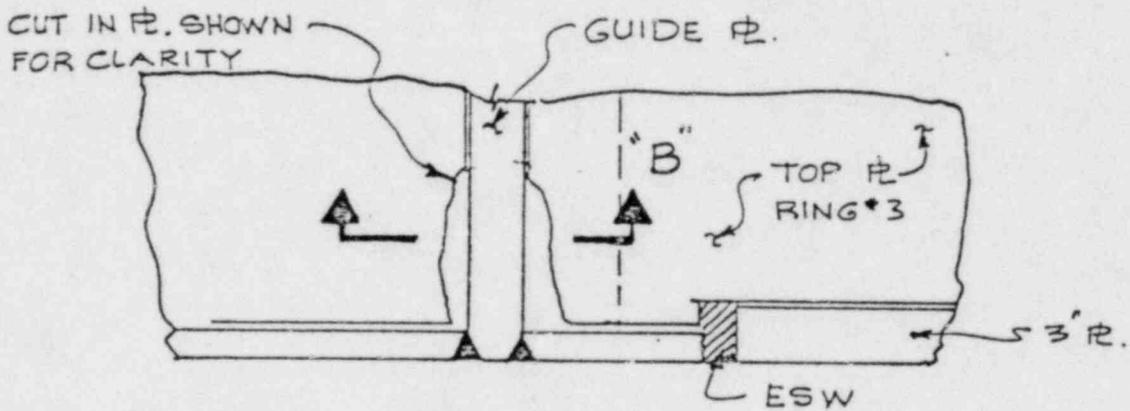
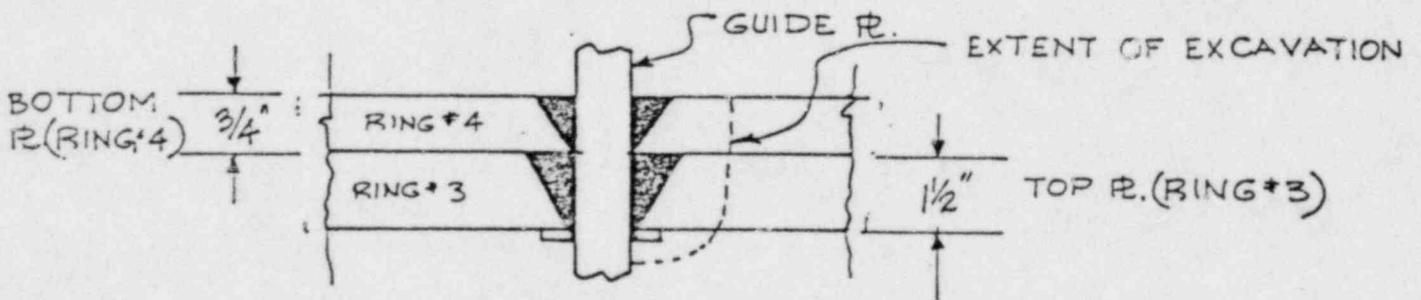
FIGURE 3 GUIDE PLATE WELDS AT AZ 187°-30' (SIMILAR AT 67° AND 300-315°)

Linear indications and inclusions were found during the girth weld excavation of the guide plate welds (Figure 3). These indications occurred at three locations: 67°, 187°, and 307°. Guide plates were installed during the SSW fabrication only at these locations and the indications were in the welds joining the guide plates to the ring beams.

Extensive excavation was required to repair these indications primarily because of the requirement for an MT examination of the excavation and the need to go beyond the end of an MT indication. The indications were slag porosity and linear indications (i.e. slag stringers and lack of fusion).

- a. Rounded and linear indications at 67°Az (NCR 5640): the structure at this location is as shown in Figure 3. The indications were in the guide plate to ring beam welds and excavation through to the concrete was required. There was some concern as to the existence of the design fillet welds, therefore, the excavation was extended to confirm their existence. The problem with indications at this location was very similar to that encountered at 187°-30'.
- b. Indications at Azimuth 187°-30' (NCR's 6685, 6702, 6703, 6647):

The first indication (1/2" long X 1/16" wide X 1/16" deep) at this location was reported on NCR 6647. This defect was 17" clockwise from 180°Az and running normal to the face of the wall, i.e., in the excavation area and radial with respect to the SSW. An ESW is centered 15-1/2 inches from 180°Az in the front flange of ring #3 (Figure 3), so again this indication may have been at the edge of the ESW.

NCR 6685 shows that grinding in the area of the indication discussed above exposed linear indications and slag inclusions which extended back into the wall along the top of the ring beam. The indications at 187⁰-30' have resulted in the complete excavation of the bottom plate of ring 4 and the top plate of ring 3 through to the concrete and extending back about 18" to the inside web plates of the beams. A guide plate at this location is set through the bottom plate of ring 4 and the top plate of ring 3 (Figure 3). The indications were in the welds attaching the guide plate to the ring plates (Section BB of Figure 3). During the extensive excavation of the welds to the right of the guide plate, Figure 3 Sections AA and BB, lack of fusion was found just above the backing bar of the lower weld (NCR 6702). NCR 6703 documents a 1" long linear indication also located to the right of the guide plate. NCR 6702 also indicated that grinding occurred to the left of the guide plate. An indication was cleared from this area after grinding into the top corner of ring beam #3 through to concrete. NCR 6647 suggests that the indication was in the guide plate to ring #3 flange weld, not the electroslag weld.

In summary, most of the defects at 187⁰-30' were associated with the guide plate welds and consisted of slag and linear indications (about 1" long) throughout the welds. The requirement to grind 2" beyond the end of each indication lead quickly to major repairs for a few scattered defects.

c. Porosity slag and linear indications at Az 300-315⁰:

Again, there is a guide plate at this location with a geometry similar to that shown in Figure 3. Defects (slag, porosity and linear indications) were observed in the guide plate to ring beam welds. Linear indications were observed within the girth weld excavation, oriented in a circumferential direction. It is thought that the linear indications may have been areas where the excavation reached back to the root of the ring and web/flange weld.

The repair was deferred by isolating the SSW girth weld from the unexcavated region by use of backing material. Base material was built up to the SSW girth weld joint configuration using the SMAW process. A final magnetic particle examination was performed for acceptance.

Completion of the defect removal was performed by removing the ring 4 skin plate and concrete above the isolated area (PED 215-CS-A347) and excavating from above the ring 4 bottom ring beam web. When the inclusions have been repaired, material removed for access through ring 4 will be replaced. Inspections will be performed as required by AWS D1.1.

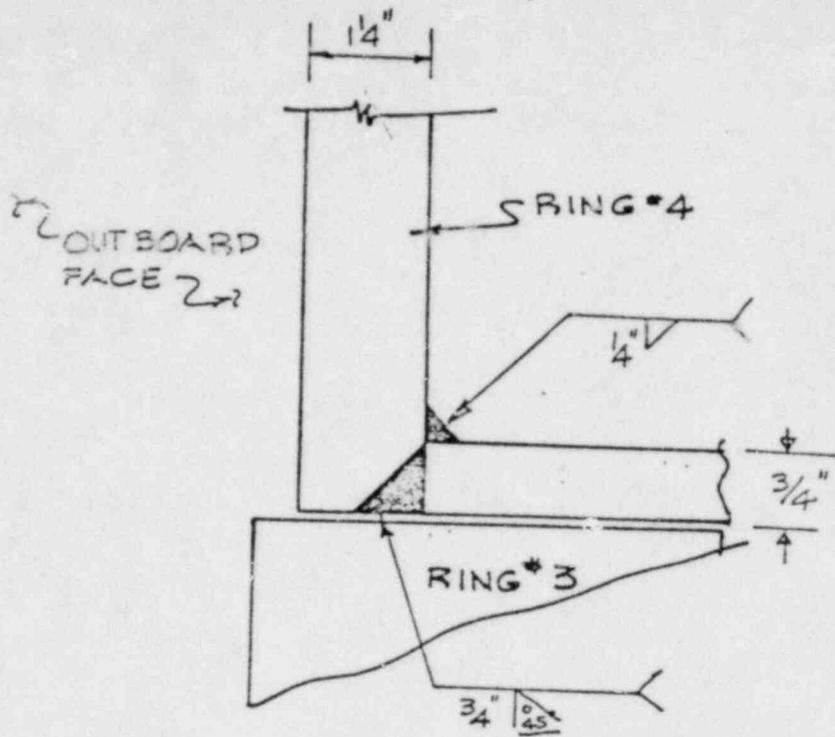
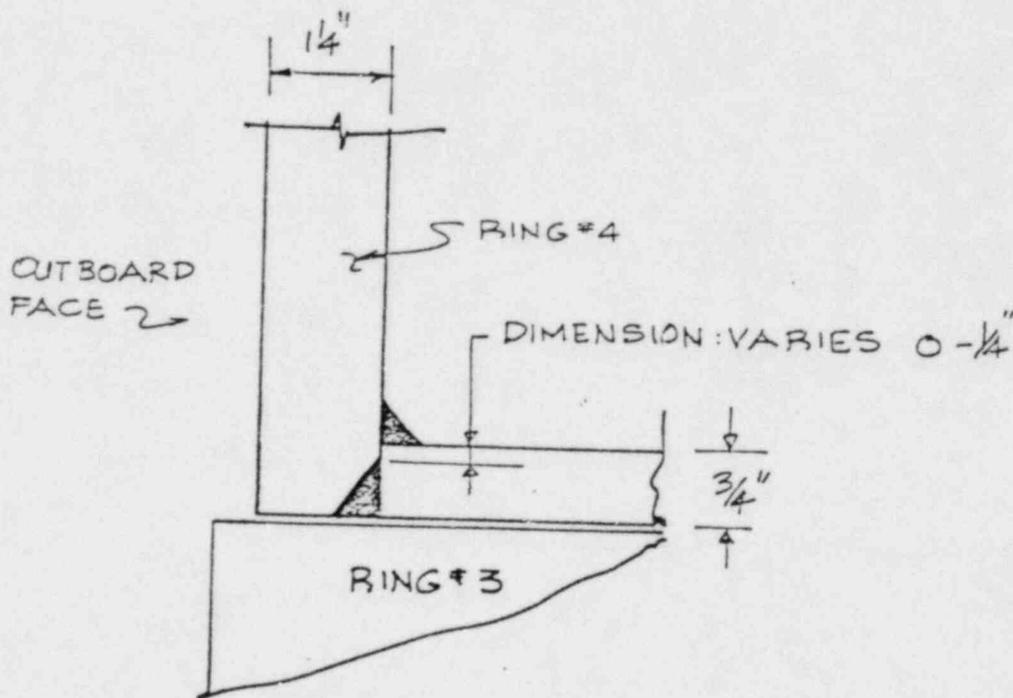
FIGURE 4 LACK OF PENETRATION AT AZ 90-105, 0-15, AND 180-195°

During preparation of the weld joint for the SSW girth weld, it was discovered that the ring 4 bottom beam flange to web weld was partial penetration, not full penetration as required by design. NCR 6643 was issued against this deficiency.

Design of the ring beam as shown on Burns and Roe drawing S782 requires the use of a 3/4" single bevel groove weld to join the 1 1/4" flange to the web of the ring 4 bottom beam. This joint is reflected on fabrication drawing W66, Section A-A, with an additional 1/4" fillet weld inside the beam as a nonstructural, fabrication convenience weld.

Partial penetration in the flange-to-web plate weld, ring 4 (Figure 4) was observed at three locations (90-105°, 0-15°, 180-195°). The MT indication resulted from lack of penetration at the root of the weld. Excavation of the girth weld revealed lack of fusion defects at the root of the weld joining the front flange plate of ring 4 to the web plate (Figure 4). The extent of the lack of penetration was estimated to be from 0"-1/4", based on the relationship between the profile of the excavation and the thickness of the web plate.

Linear indications in the girth weld excavation area were also noted at one location (300-315° Az). These defects may have resulted from the interface/lack of fusion observed elsewhere at the weld between the flange and web plate of ring 4, as discussed above.

B AS BUILT CONDITION AT AZ. 90-105°, 0-15°, AND 180-195°.

In order to meet the design requirement for a full penetration weld, PED 215-W-A079 was issued to remove material from the ring beam flange to provide full exposure of the edge of the ring beam web. As a base metal repair, the contractor was directed to replace the removed material using the shielded metal arc welding process, restoring the geometry to that required for the SSW girth weld. Upon completion of the repair, the area was inspected by magnetic particle. The balance of the full penetration weld was then completed using the flux cored arc welding process.
