ANALYSIS AND EVALUATION OF THE
DECEMBER 21, 1981
IN WHICH THE CONTROL ROD WITHDRAWAL LIMITS
WERE EXCEEDED

PREPARED BY THE INVESTIGATING COMMITTEE CONSISTING OF:

SEQUOYAH NUCLEAR PLANT

Report Description

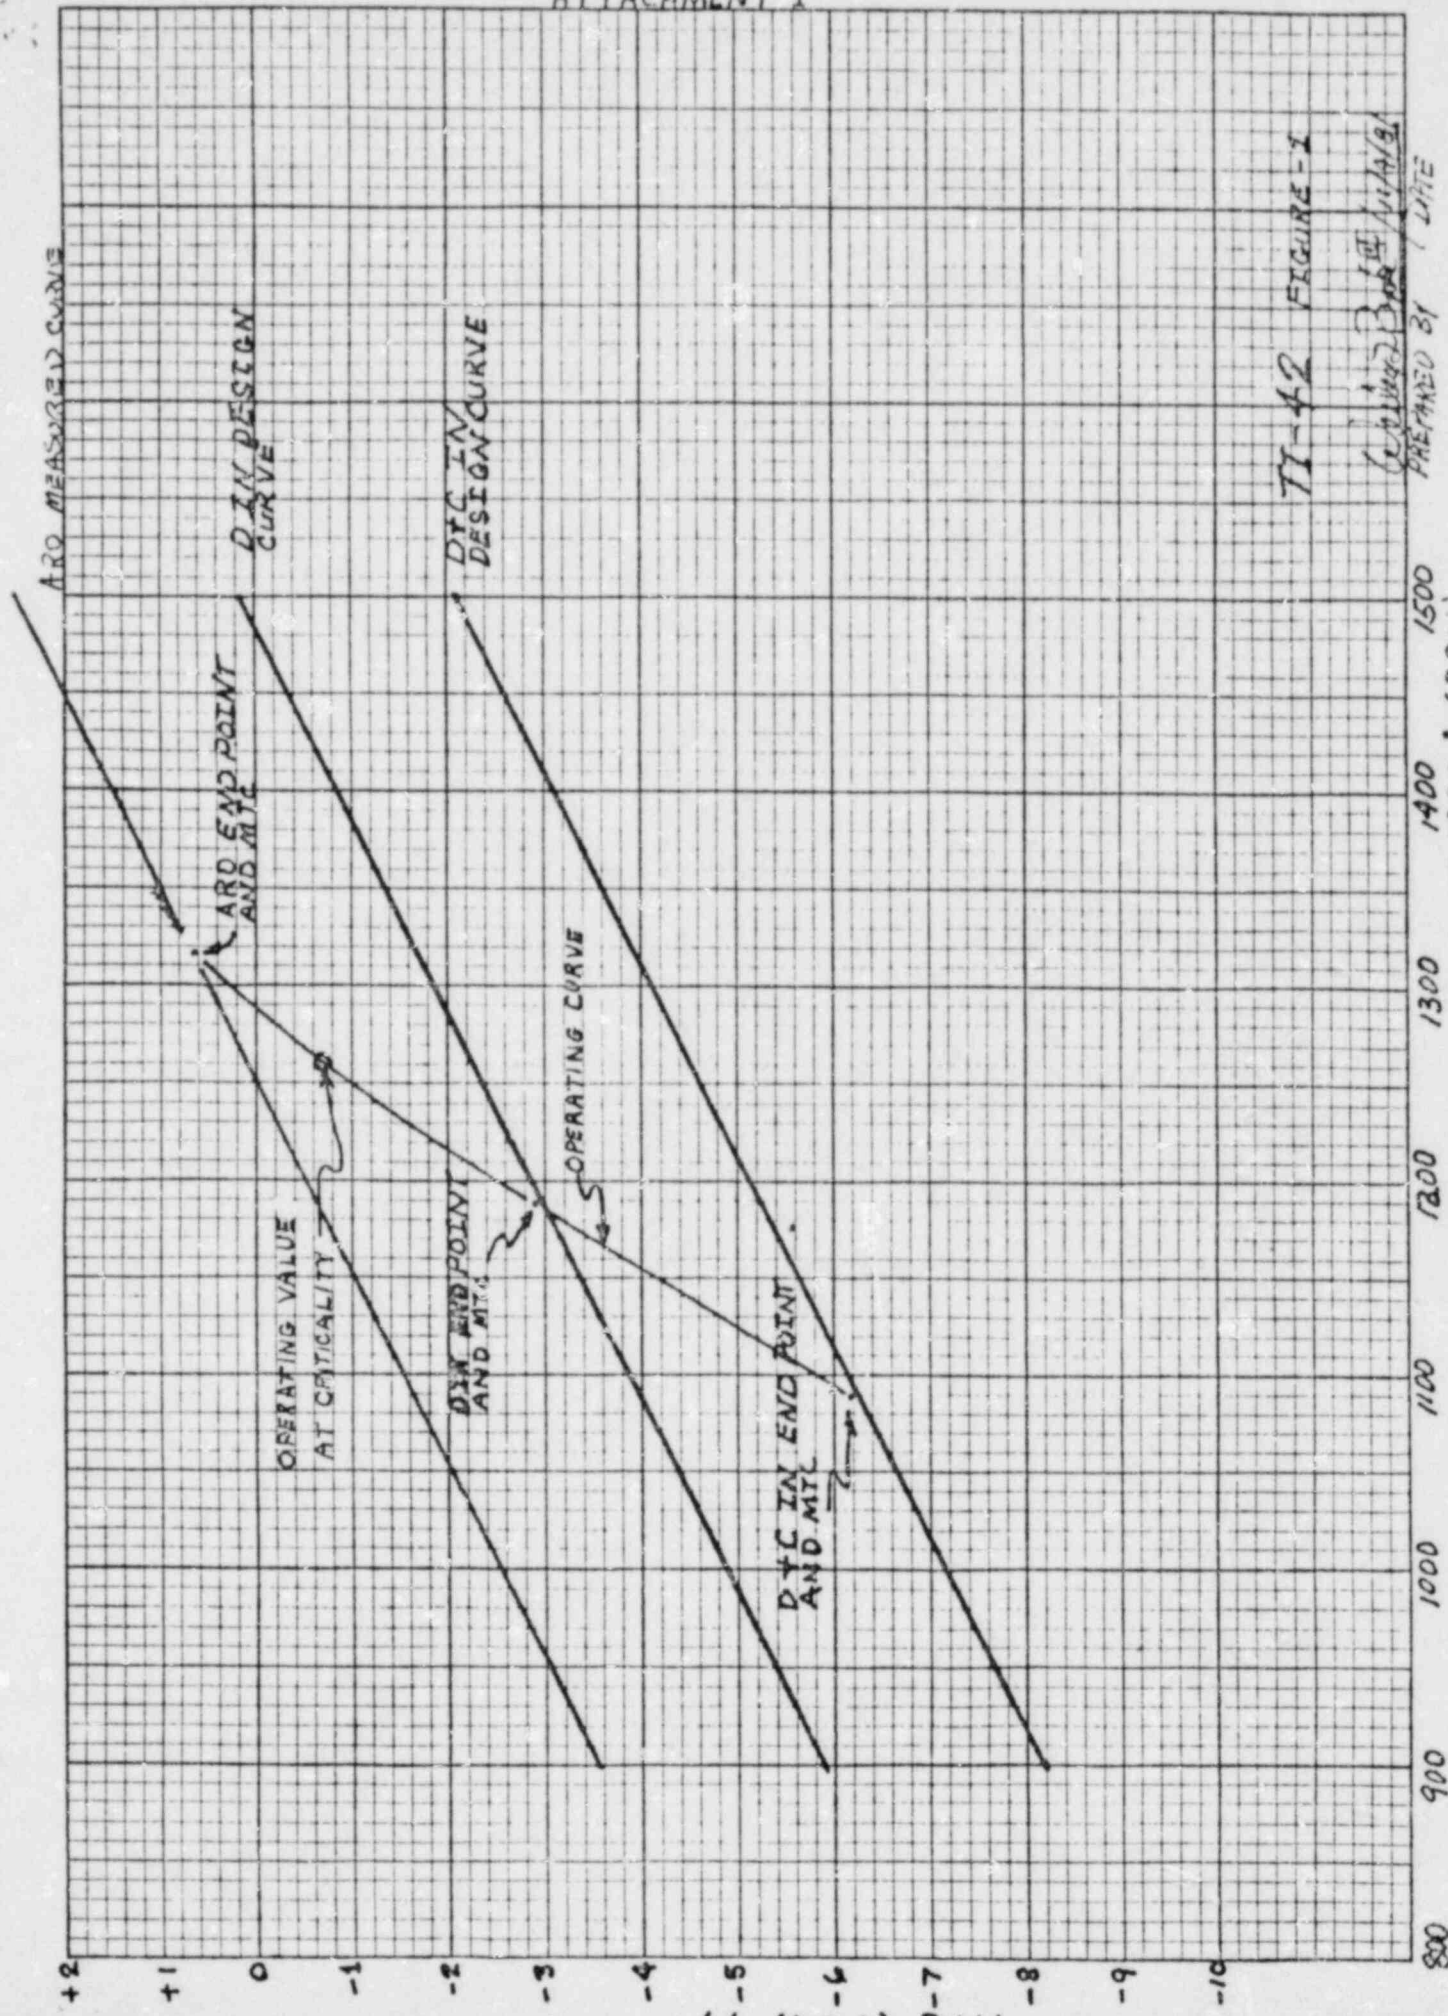
TI-42 FIGURE-1

The control rod withdrawal limit curves submitted in Special Report 81-8 and in use at the plant are based on measured MTC values and are adjusted by 1.0 pcm per degree F for conservatism. The attached graph shows the design and measured MTC and verifies that the moderator temperature coefficient never exceeded a negative value.

The labeled design curve showing the control rod banks D and C configurations were taken from our Technical Instruction (TI) 42, Figure 1 (reference Westinghouse WCAP 9516). The all rods out (ARO) curve was constructed from design data and ARO measured data. An operating curve at any boron concentration at which criticality occurs has been drawn by connecting three known points. At the time of criticality on 12/21/81, the boron concentration was measured to be 1262 ppm. This point corresponds to a moderator temperature coefficient value on the curve of approximately -0.7 pcm per degree F. This point is labeled "Operating Value At Criticality".

- II. Based on the interviews with operating personnel and the fact that an operator discovered the situation and took appropriate corrective action, it is concluded that no additional training is required on rod withdrawal limits.
- III. Based on subsequent calculations it is concluded that the reactor was not operated with a positive moderator temperature coefficient.
