SUBJECT: CONTROL ROOM DESIGN REVIEW/AUDIT REPORT, PALO VERDE  
UNIT 1

HUMAN FACTORS ENGINEERING  
CONTROL ROOM DESIGN REVIEW/AUDIT REPORT

PALO VERDE NUCLEAR GENERATING STATION  
ARIZONA PUBLIC SERVICE COMPANY

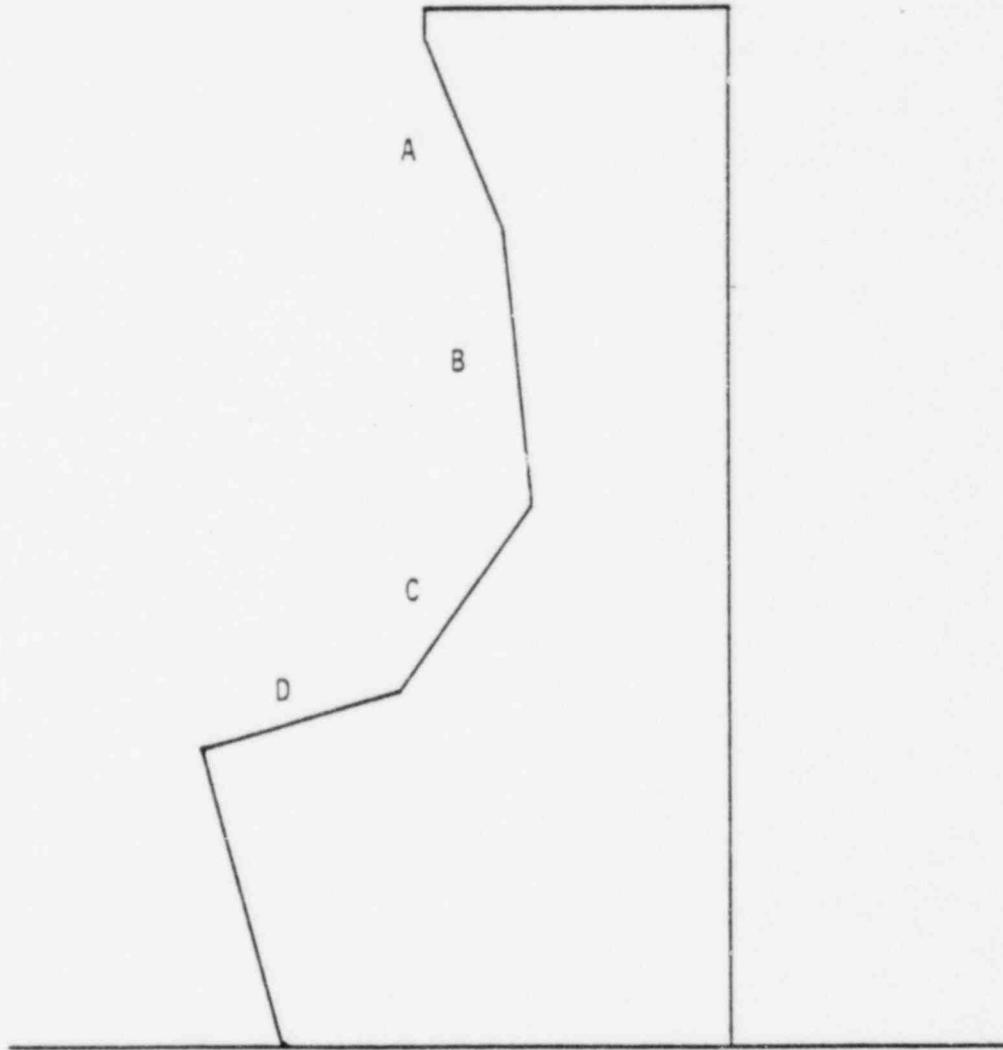
FIG. 1. Identification of control board surfaces.

<u>PRIORITY RATING</u>	<u>FINDING</u>
3	1* The control room bookshelves are inadequate. (056C)
2	2* Glare is a problem for most displays on all of the panels. It is worst on the "C" surfaces, depending on viewing angle. (See Fig. 1 on page 3 for the meaning of "A", "B", "C, and "D" surfaces.) (049C) (064C) (100B) (101B) (103C)
1	3* Glare on CMC switch surfaces hinders "light-on" determination. This is more apparent on the "C" surfaces. A matte surface might not be as effective a solution as brighter lights. Example: (Panel B02) a.) ESF SWGRA/EQPT Room switch (098C)
31	4* The concrete control room floor is not carpeted, which will lead to earlier fatigue during long periods of standing by the operators. (068B)
