DUKE POWER COMPANY

Reference: Oconee Nuclear Station
Docket Number 50-269
RO-269/81-11, Supplement 3

Thermal Shield Lower Restraint Repair Task Information

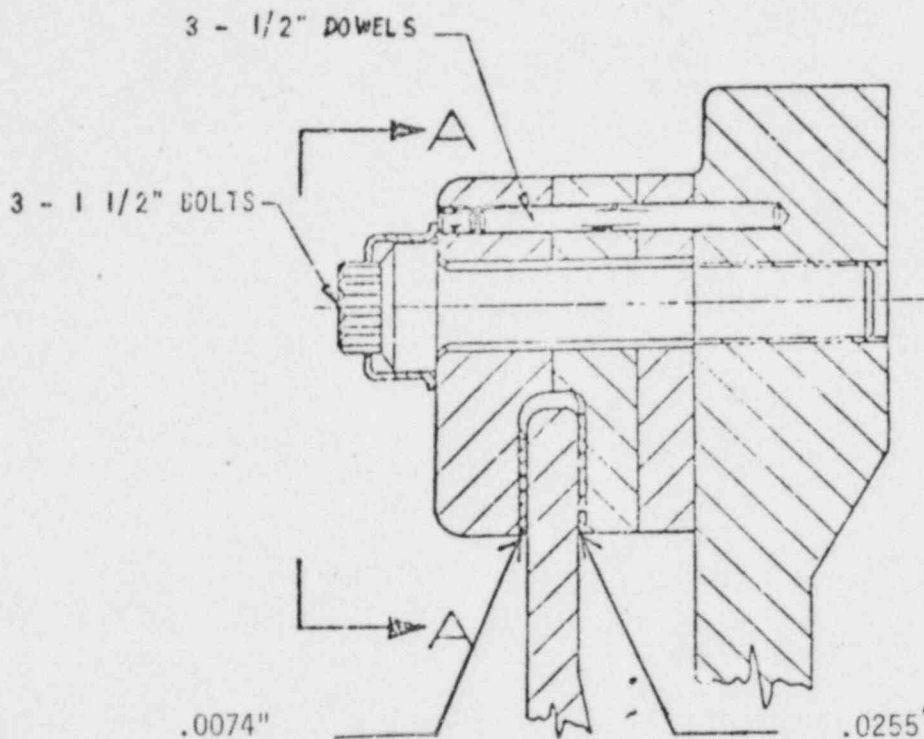
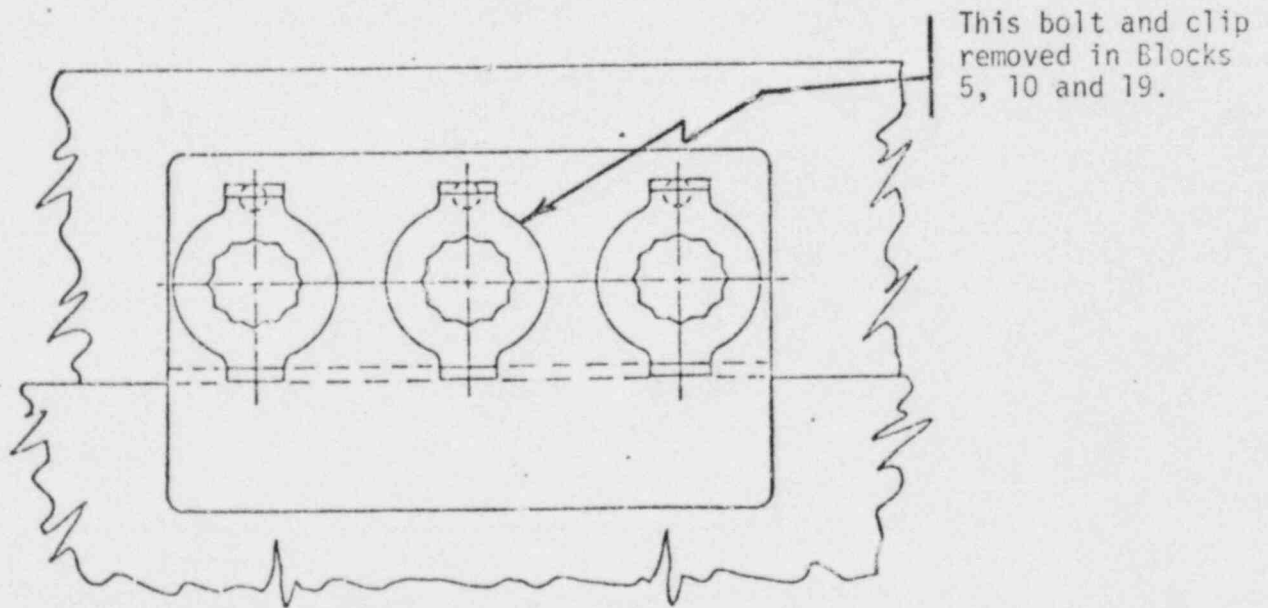
Figure 1 Thermal Shield Upper Support

In summary, the above evaluation confirmed that the upper end of the thermal shield can be left as is (see Figure 1) even though inspections indicate loss of the original interference fit condition.

.0074"
Average clearance (original).
Various clearances up to
.160" prior to reseating the
thermal shield on the lower
grid.

.0255"
Average interference (original).
(No later measurement)

This bolt and clip
removed in Blocks
5, 10 and 19.

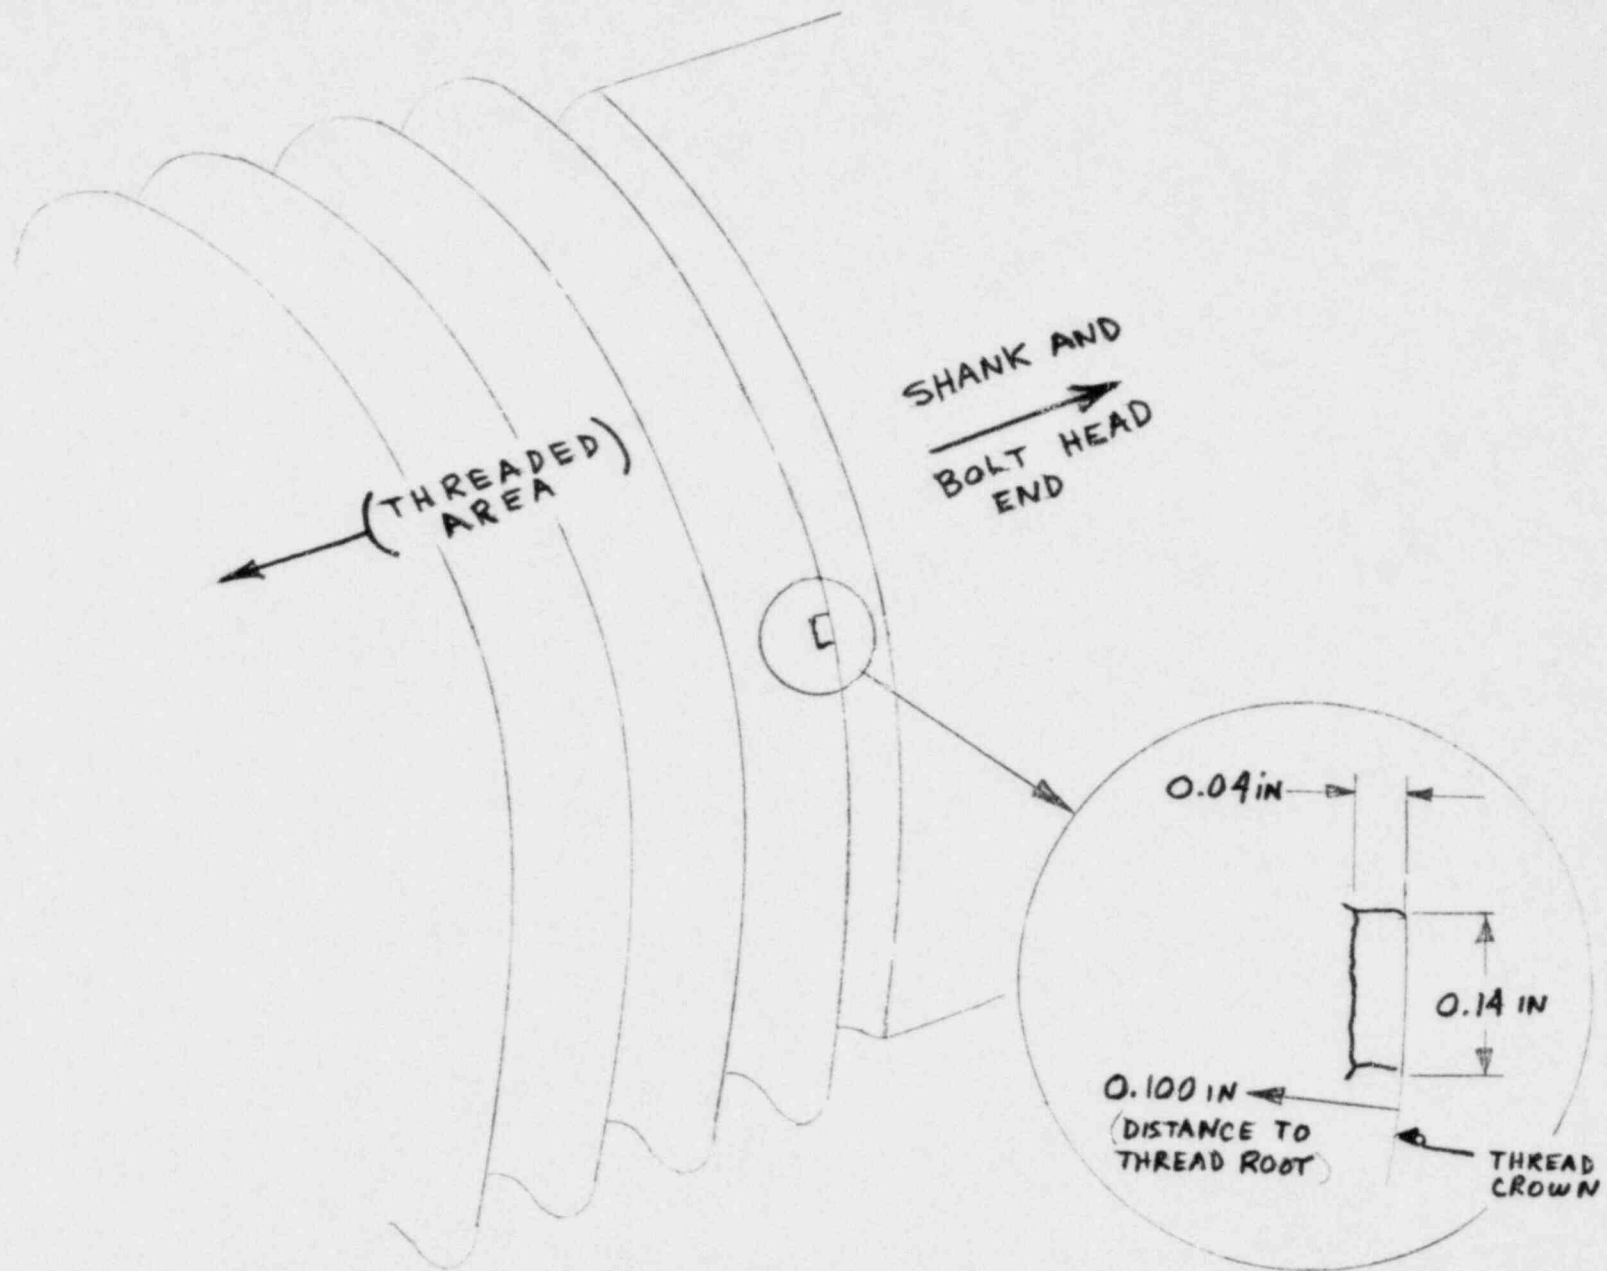
FIG. 2

UPPER RESTRAINT BOLT - SMALL INTERGRANULAR
CRACK LOCATED IN TOP PORTION OF THREAD.
