SAFETY EVALUATION REPORT FOR THE DRYWELL EVENT

BOSTON EDISON COMPANY

JANUARY 1982

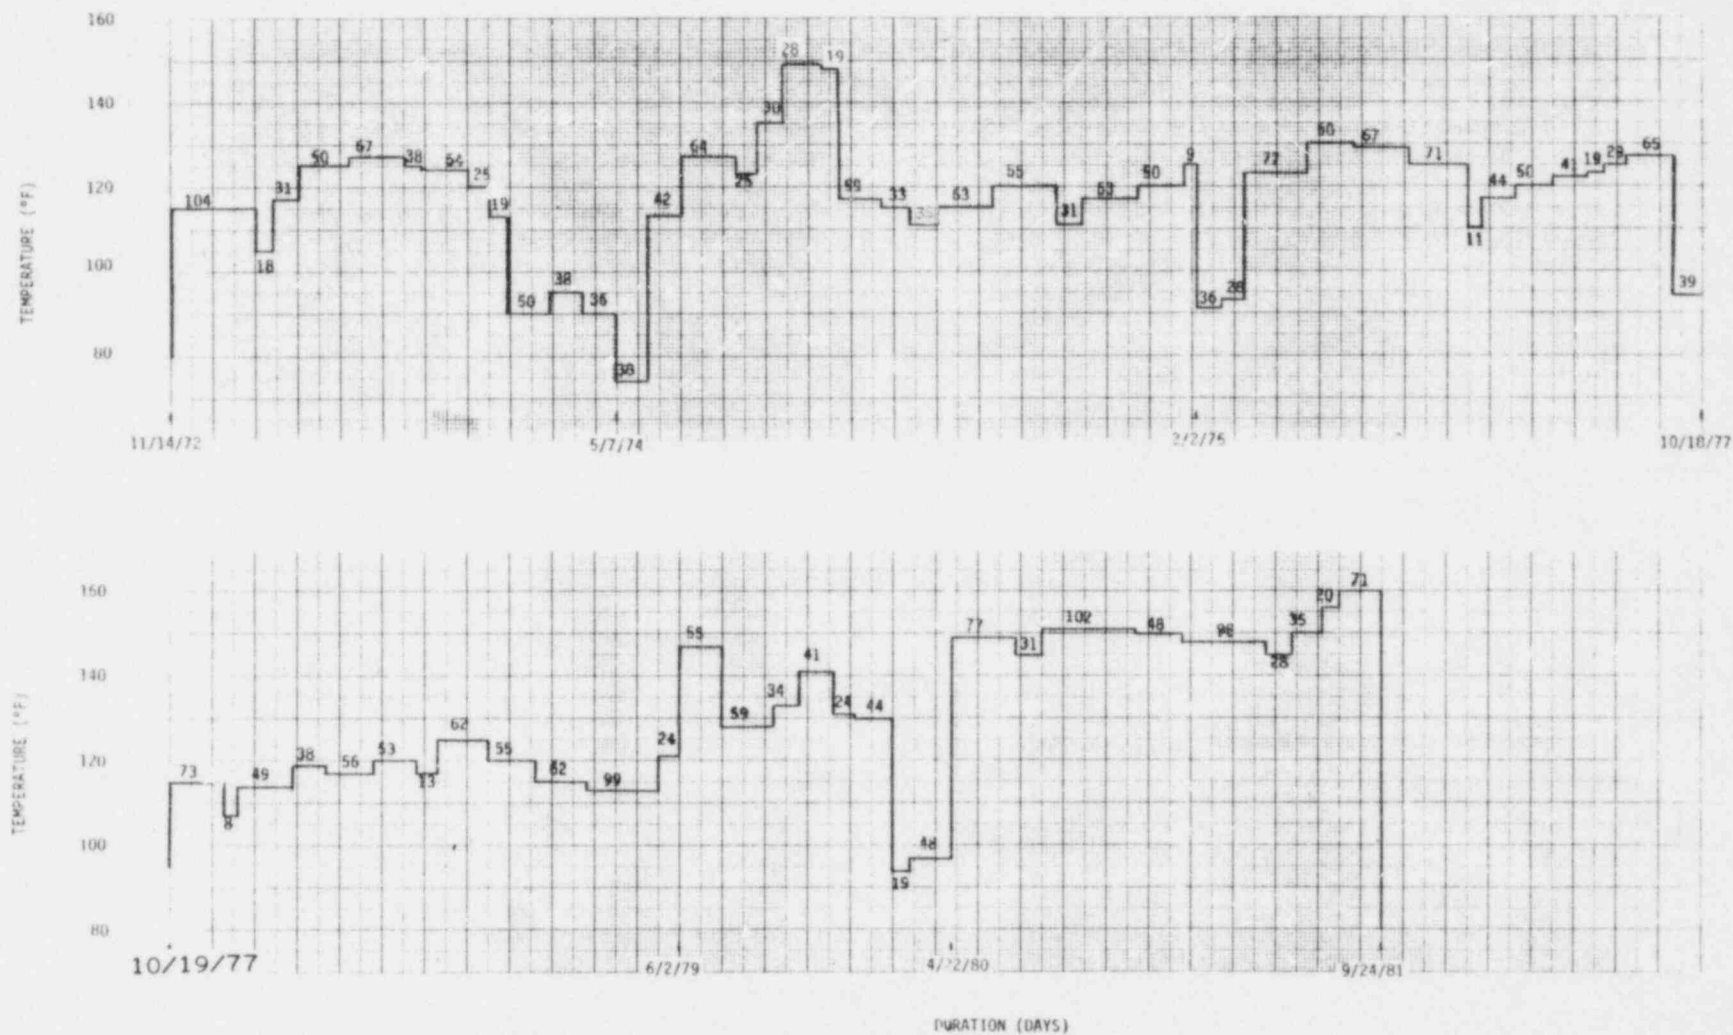
FIGURE I-1
 PILGRIM NUCLEAR POWER STATION, UNIT 1
 TEMPERATURE PROFILE (36' ELEVATION)

A time-temperature profile at the 38 foot elevation was developed for the history of the plant, based upon readings from TE-9044. This profile is presented in Figure I-1 as a series of plateaus where the plateau value is the maximum record temperature for the particular interval. The numbers above the plateaus indicate the respective interval durations. The plateau approach was selected because it simplifies the subsequent degradation analyses while ensuring that any error injected through this approximation method is conservative.

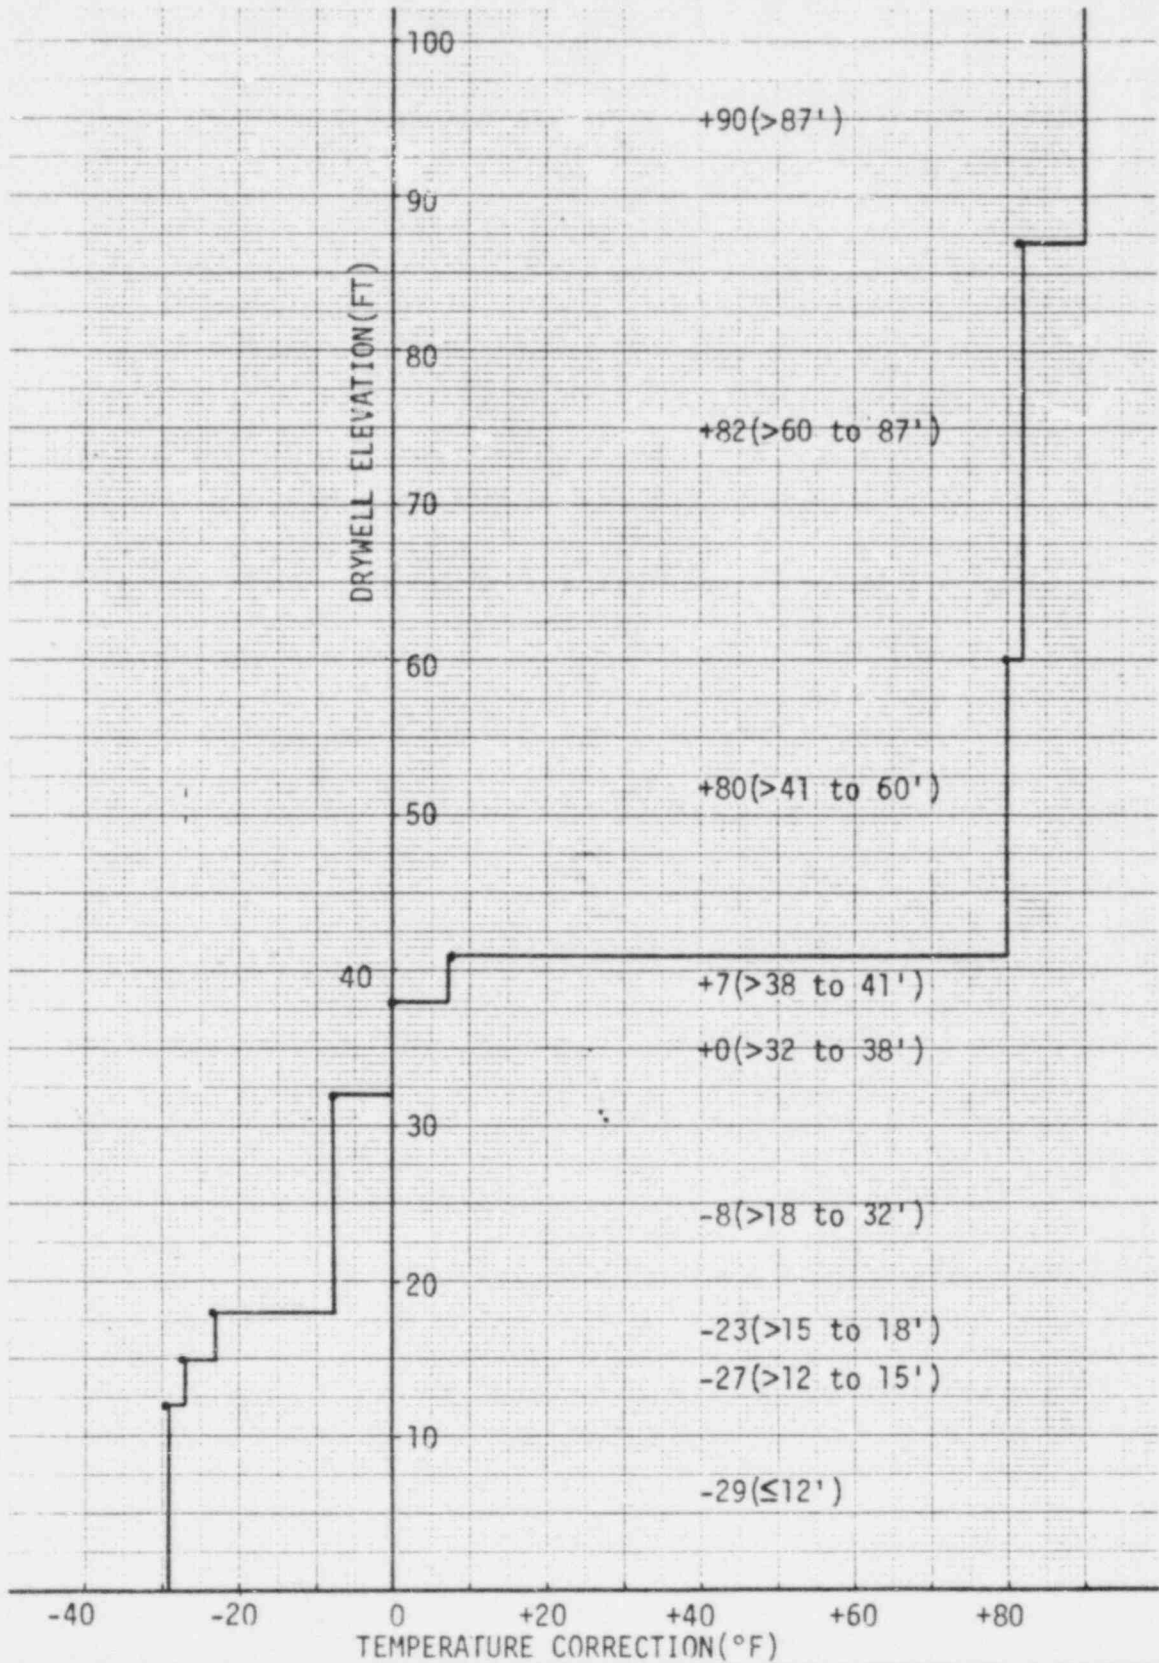
FIGURE I-2

Drywell temperatures for other elevations were estimated by determining the worst-case temperature difference with respect to 38 foot readings for the ten 5050-series elements listed above. "Worst-case" for elevations above 38 was the largest observed difference; below 38 feet, the smallest difference was used.

The resulting temperature differentials as shown in Figure I-2 were applied to the "plateaued" history of temperature at 38 feet to obtain a conservative estimate of temperature at other elevations for the entire operating history of the plant.
