**NORTHEAST UTILITIES**

Docket No. 50-336  
B10445

MILLSTONE NUCLEAR POWER STATION, UNIT NO. 2  
STEAM GENERATOR OVERVIEW

Attachment 1

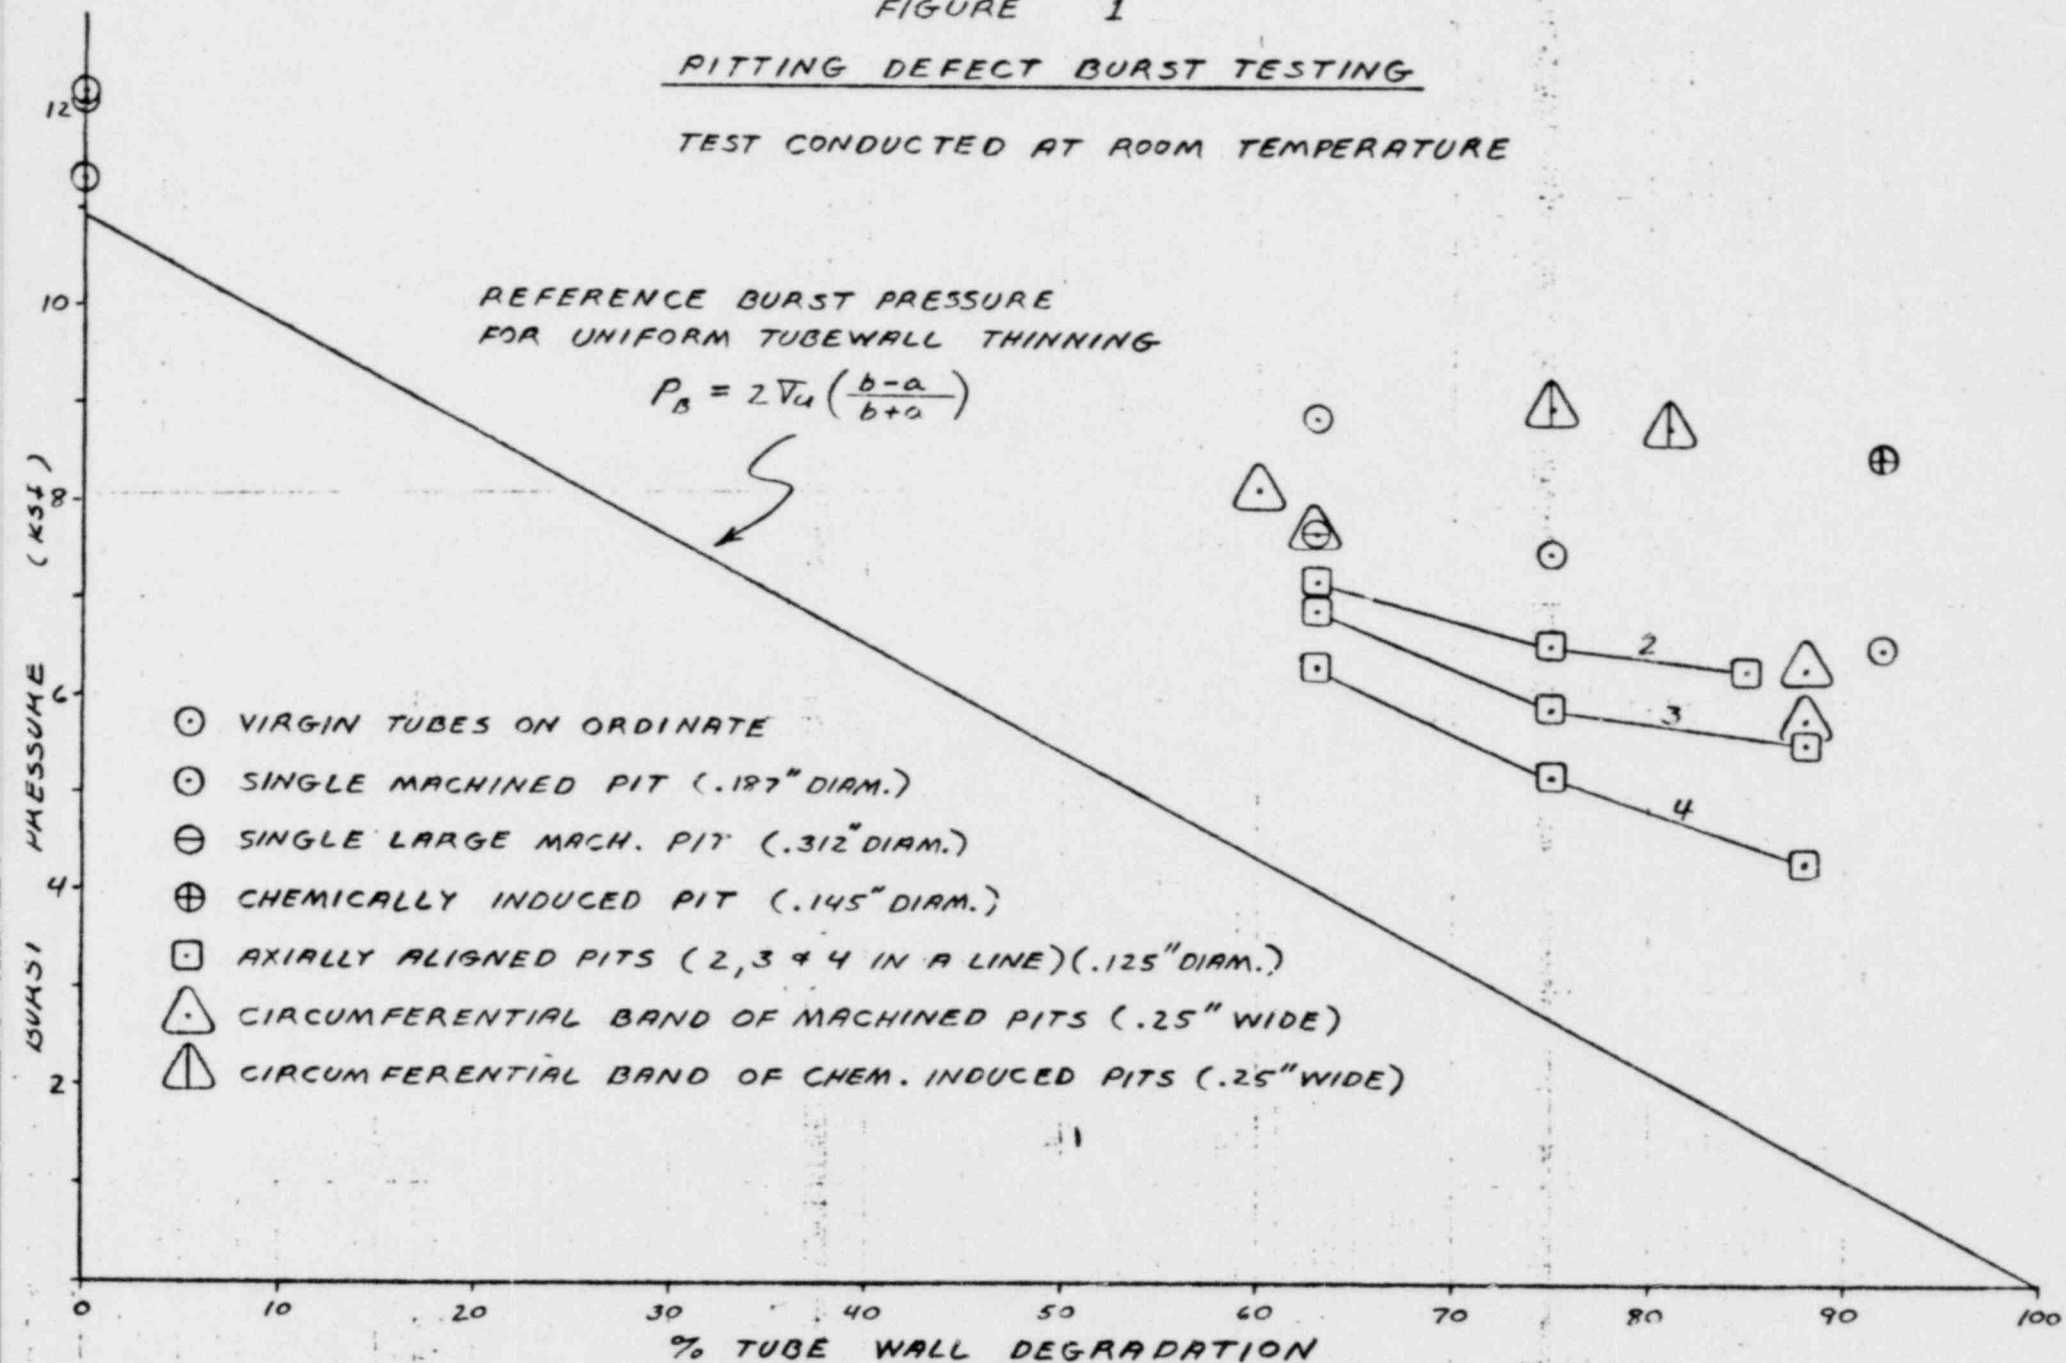
FIGURE 1

The results of the burst tests demonstrate the conservatism inherent in the analytical approach used to justify the proposed tube plugging limit. The burst tests demonstrate additional operational margin beyond that identified by the conservative analytical results. Burst testing was performed on a tube sample removed during the current refueling outage. The pressure required to induce failure of the tube sample was in excess of 9,000 psi providing further evidence of the integrity of the steam generator tubes at Millstone Unit No. 2.

PITTING DEFECT BURST TESTING

TEST CONDUCTED AT ROOM TEMPERATURE

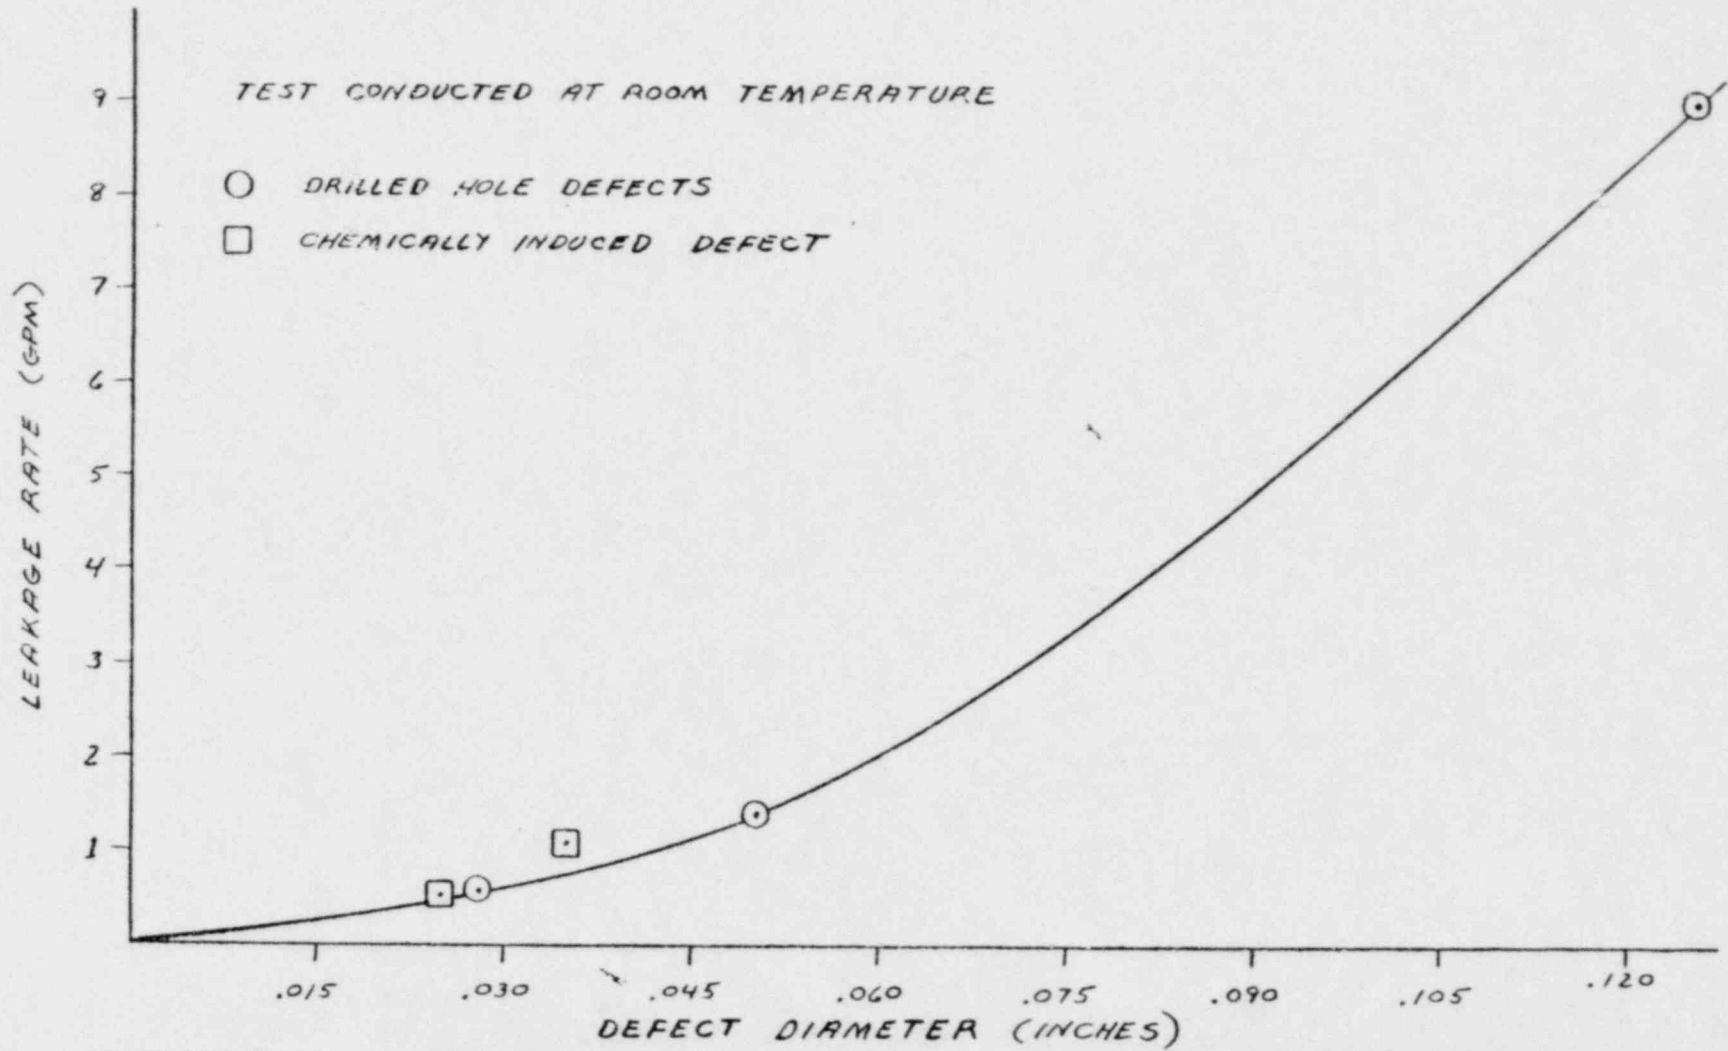
FIGURE 7-1  
THROUGH WALL PIT LEAK RATES

Leak rate tests performed on tubes after experiencing failure pressures demonstrate that potential leak rates in failed tubes remain below Technical Specification allowables. This information is provided in Attachment 2.

In addition, the Attachment 2 information illustrates the leak rates which one would expect for different through-wall pit diameters. This data demonstrates that leakage from large diameter pits (approximately 1/8 inch) at system operating pressures can be adequately handled by plant makeup systems if required. It is noted that the largest diameter pit identified at Millstone Unit No. 2 was approximately 60 mils. The expected leak rate from a pit this size is about 2 gpm. The leak rate tests also demonstrate leak stability. This is expected since the steam generator tube material, Inconel 600, is very resistant to flow induced erosion.
