SNUPPS

Standardized Nuclear Unit  
Power Plant System

March 16, 1982

SLNRC 82-016 FILE: 0671.1.2  
SUBJ: NUREG-0737, Item I.D.1

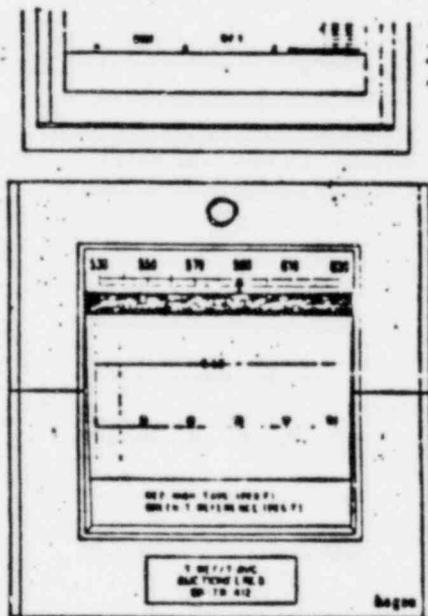
Finding 16 (3<sup>1</sup>) The label for the T REF/T AVG AUCTIONEERED trend recorder is located at the bottom of the recorder, rather than above as is the plant convention.

Response The location of the label is such that there is no question at all as to which device it refers to. There is inadequate room to locate the label above the recorder. See sketch

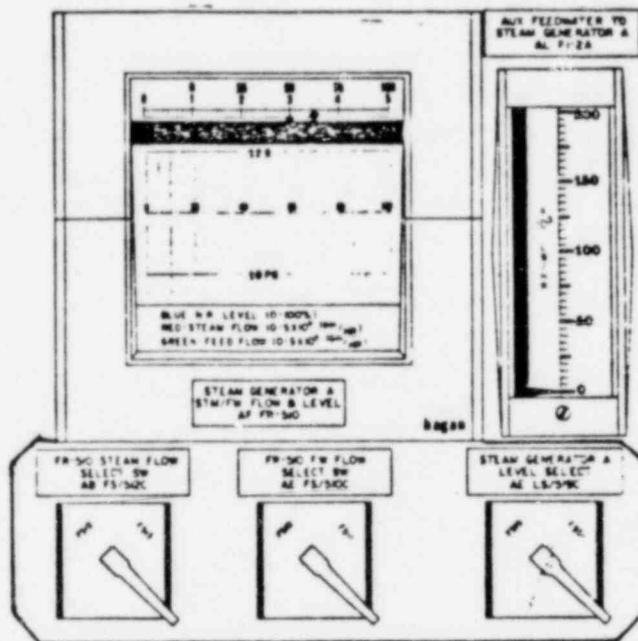
Finding 4  
(3<sup>1</sup>) The STM GEN A through D LVL SEL SW controls are not located directly below their associated trend recorders. These switches may be inadvertently associated with the AUX FEEDWATER display that they are located directly beneath.

Response Demarcation lines will be added to clearly group these three switches (see sketch).
