BOSTON EDISON

Pilgrim Nuclear Power Station
Rocky Hill Road
Plymouth, Massachusetts 02360

December 26, 1989
BECo Ltr. 89-181

Subject: NRC Inspection Report 50-293/89-10

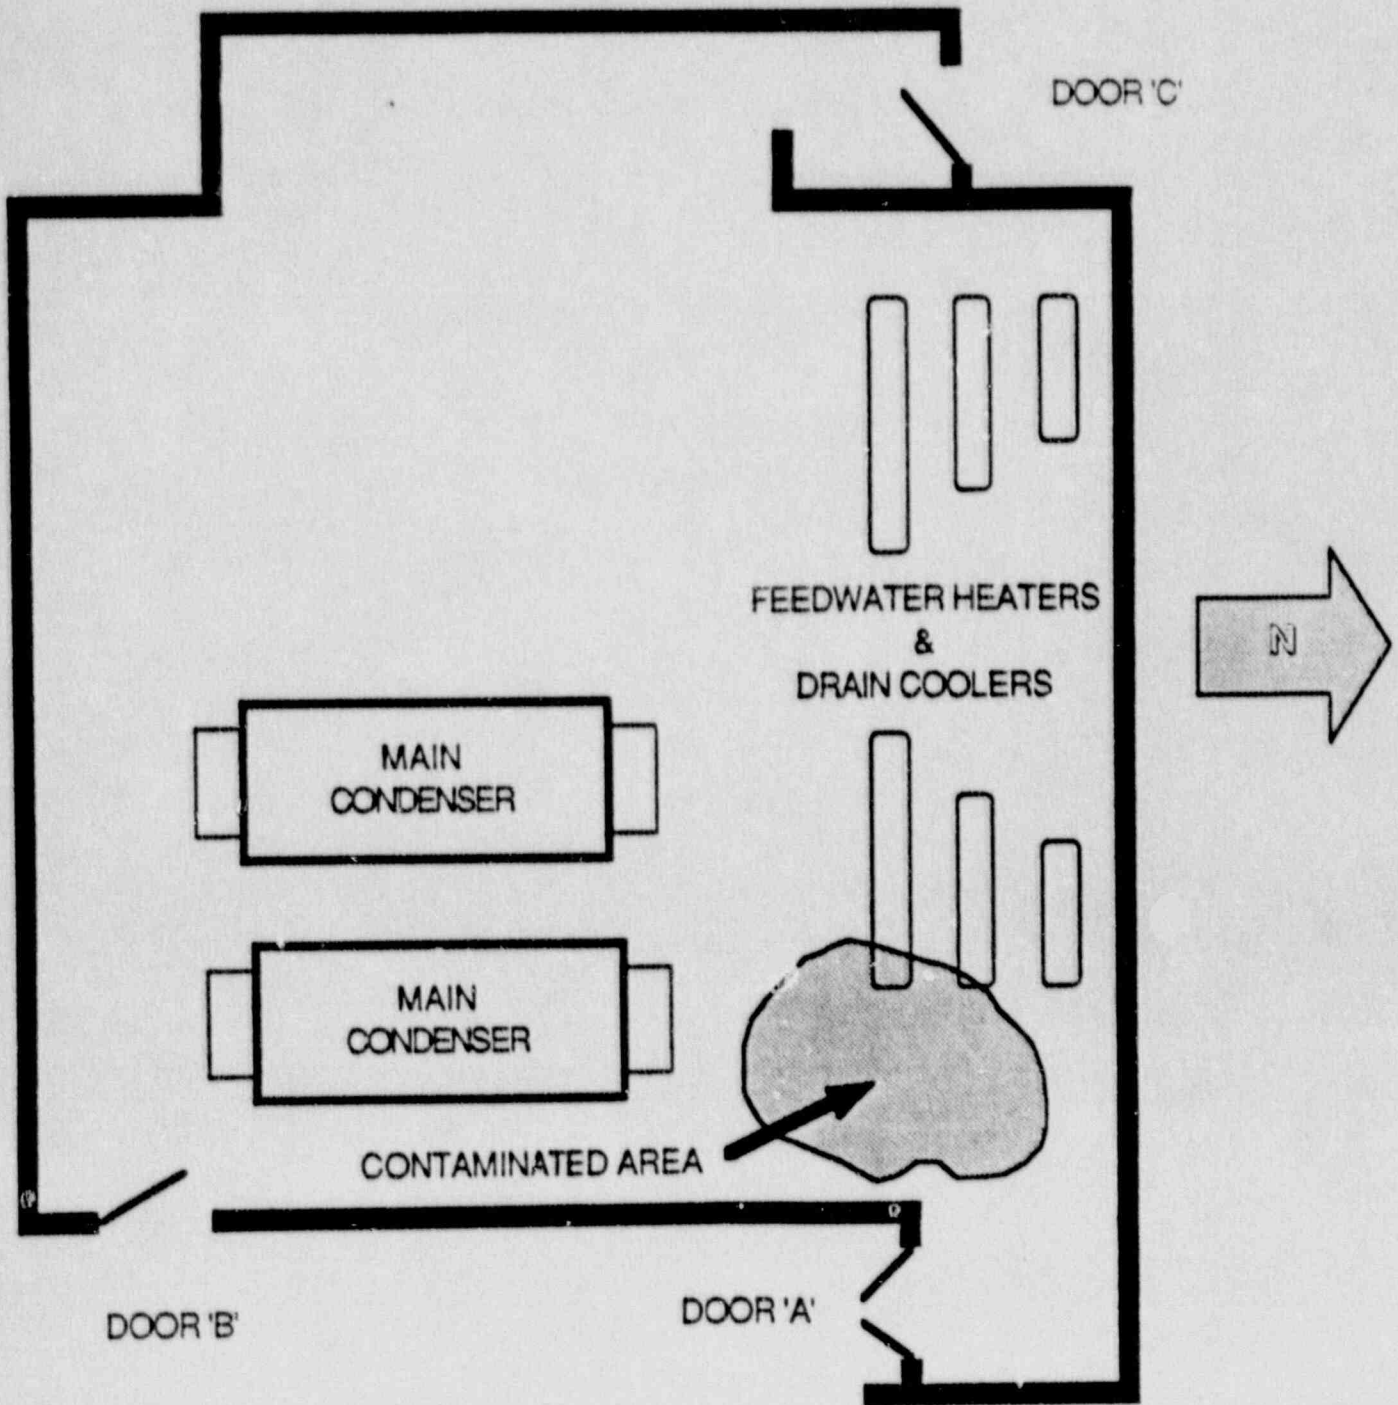
FIGURE 1

On September 14, 1989, multiple Condenser Bay (CB) entries occurred for Instrument and Control (I&C) work and to define and post a contaminated area. Access to the CB was being controlled through door 'A' (see Figure I, Pg. 7). When the I&C work was completed at approximately 1120 hours, the I&C Technicians were directed by the Radiological Protection Technician (RPT) #1 to exit via door 'B' to prevent crossing a contaminated area. The contaminated area was created when a floor drain backed up after the I&C Technicians had entered the CB. Upon exiting door 'B', the I&C Technicians did not check that the door was locked and secured. After the I&C Technicians left, RPT #1 checked the door by pulling the door from inside the CB. The door did not open. It was later determined that although the door latching mechanism was locked, the latch did not extend into the doorjamb.

At 1235 hours, the two NPAs who were to provide outside support went to door 'B' expecting to meet the RPT #2 and the third NPA. When the two NPAs arrived at door 'B', the RPT #2 was not present. They assumed the RPT was already in the CB and they should enter. One NPA then pushed on door 'B' with his shoulder and it opened. The two NPAs then entered the CB looking for RPT #2.

The functioning of the door also contributed to the event. The door was sticking against the doorjamb and would not self close. The door could be opened/closed without using excessive force, but did require greater than normal force (a strong push/pull). RPT #1 has a small thin build, making it plausible that the door would have appeared secured when pulled. However, because LHRA doors are designed to open from inside an area, it would not be possible to determine if a door was locked from inside the area.

CONDENSER BAY ACCESS DOOR LOCATIONS

- GET was revised on September 22, 1989 to present and emphasize the requirements for entry to HRAs.
- Maintenance Request No. 89-33-236 has been initiated to repair door 'B' to the CB.
