PRAIRIE ISLAND NUCLEAR GENERATING PLANT
Docket Nos. 50-282 License Nos. DPR-42
50-306 DPR-60

Automatic Start of a Safeguards Cooling Water Pump
Caused by Inadequate Procedures

LICENSEE EVENT REPORT (LER)

TITLE (4)
Automatic Start of a Safeguards Cooling Water Pump Caused by Inadequate Procedures

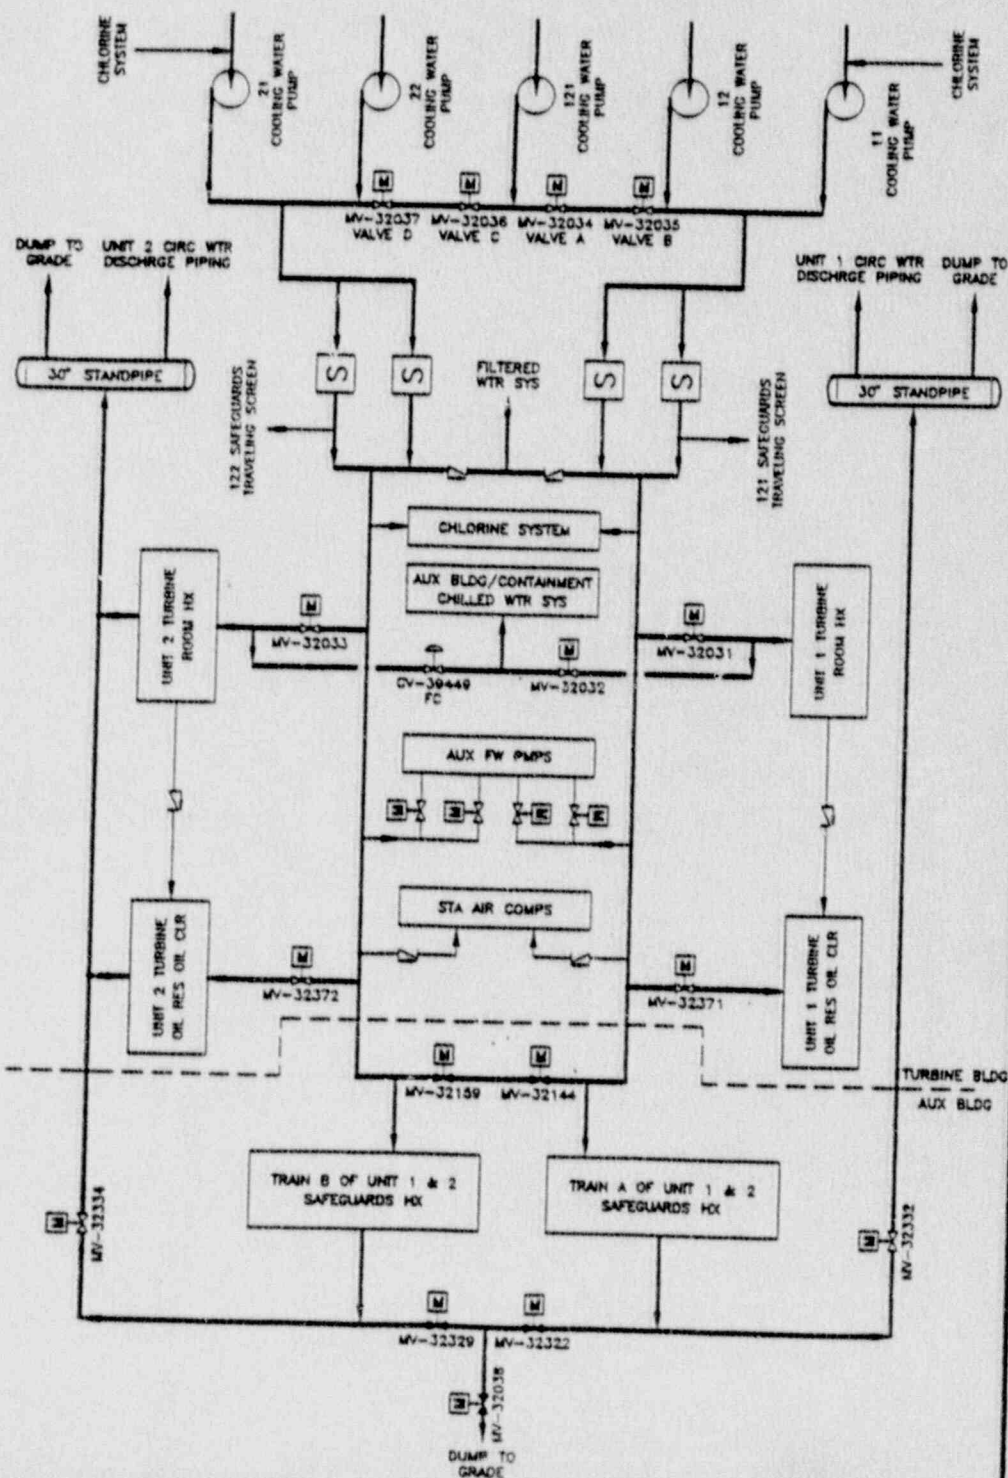
COOLING WATER SYSTEM

Though observation of those two parameters (header pressure and engine speed) indicated that No. 21 Motor-Driven Cooling Water Pump had assumed some cooling water load, in fact the pump was air bound and was not pumping. Therefore, when the speed of No. 22 Diesel-Driven Cooling Water Pump was reduced, header pressure dropped to the start setpoint of the other diesel-driven cooling water pump.

The cause of the loss of prime of No. 21 Motor-Driven Cooling Water Pump was pump wear, allowing excessive air in-leakage while it was idle.

Procedures have been revised to improve guidance for detecting loss of prime.

The start setpoint for No. 121 Motor-Driven Cooling Water Pump, a non-safeguards backup pump, has been raised slightly to be sure it will start automatically before the diesel-driven cooling water pumps.

No. 21 Motor-Driven Cooling Water Pump will be replaced shortly after its replacement pump, which was ordered in 1989, is received.
