U.S. NUCLEAR REGULATORY COMMISSION

Reports No. 50-282/90004(DRP); 50-306/90004(DRP)

Facility Name: Prairie Island Nuclear Generating Plant

Inspection on February 28 through April 9, 1990 (Reports No. 50-282/90004(DRP); 50-306/90004(DRP))

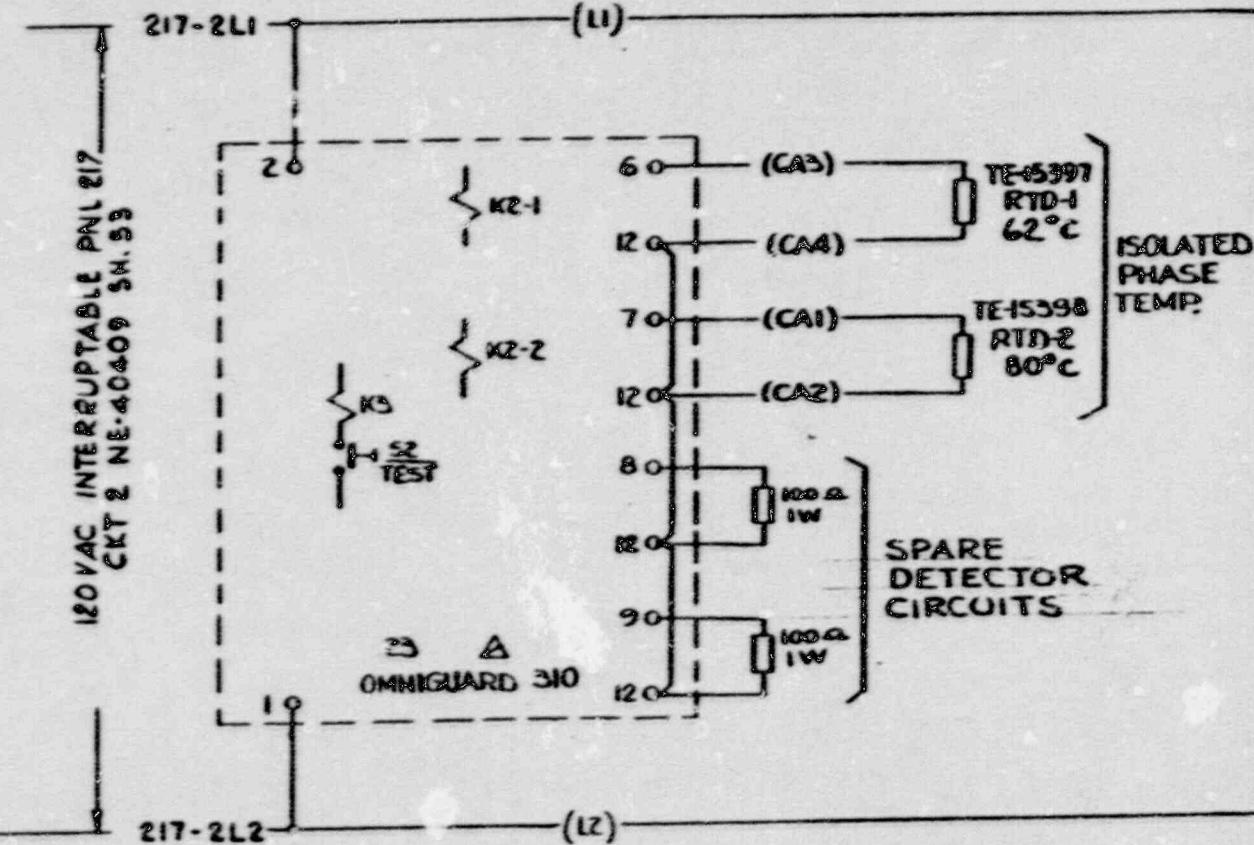
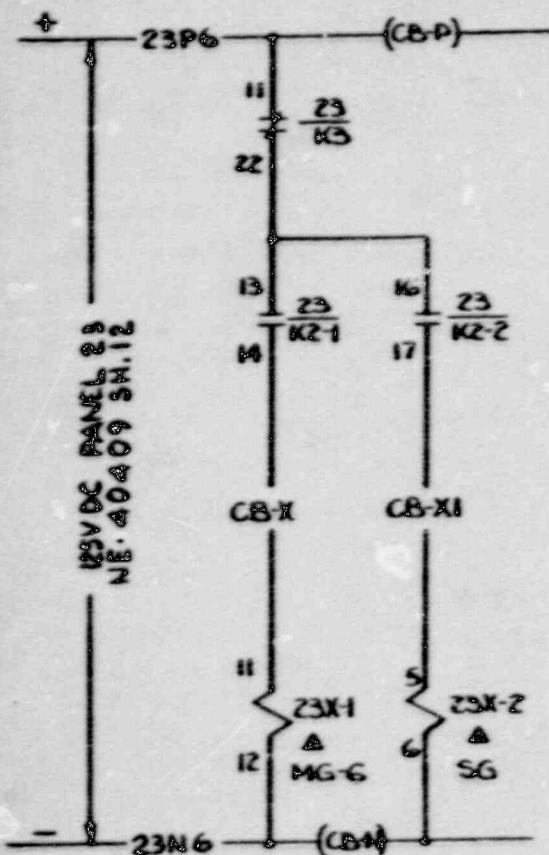
## 2 GENERATOR BUS DUCT COOLER BLOWER CONTROL

The cause of the turbine trip at 100% power was a generator lockout signal generated at the generator bus duct cooling control panel. The lockout signal was generated when an operations instructor depressed the panel test push button. Depressing the test push button energizes the K3 relay (the attached schematic diagram). When the K3 relay is energized, a "b" (normally closed) contact (K3-23) in the "generator lockout power supply" should open, thereby preventing the generator lockout relay (23X-2) from being energized. Additionally, during actuation of the test circuitry an "a" (normally open) contact on K3 closes which provides power to the K2-1 and K2-2 relays. When relays K2-1 and K2-2 are energized, "a" contacts K2-1 (23) and K2-2 (23) close, and would energize relays 23X-2 and 23X-1,

if contact K3-23 were closed. Energization of relay 23X-2 would cause a generator lockout (setpoint 85 degrees C sensed in the bus duct). Energization of relay 23X-1 would cause the autostart of a second bus duct cooling fan to occur (setpoint 60 degrees C sensed in the bus duct).

When the test button was depressed all functions occurred as designed except the K2-23 "b" contact remained closed. Once K2-2 was energized (by K3), the K2-2 (23) contact closed and energized the 23X-2 relay, causing the generator lockout.

The root cause of this equipment failure appears to be age. The equipment was installed during initial plant construction. In response, the licensee has electrically disarmed the test push button on Unit 2. The Unit 1 test button is SECURE CARD tagged against usage. The test push button performs no valuable function other than illumination of test lights which indicate the K2-1 and K2-2 relays are energized. The setpoints for the 23X-1 (second) bus duct cooler fan autostart and the 23X-2 (generator lockout) which are based on bus duct temperature, receive calibration during every refueling outage.
