LIMERICK GENERATING STATION

SUBJECT: Limerick Generating Station, Unit 1  
Reply to a Notice of Violation  
NRC Inspection Report NO. 50-352/90-07 and 50-353/90-06

Reply to a Notice of Violation

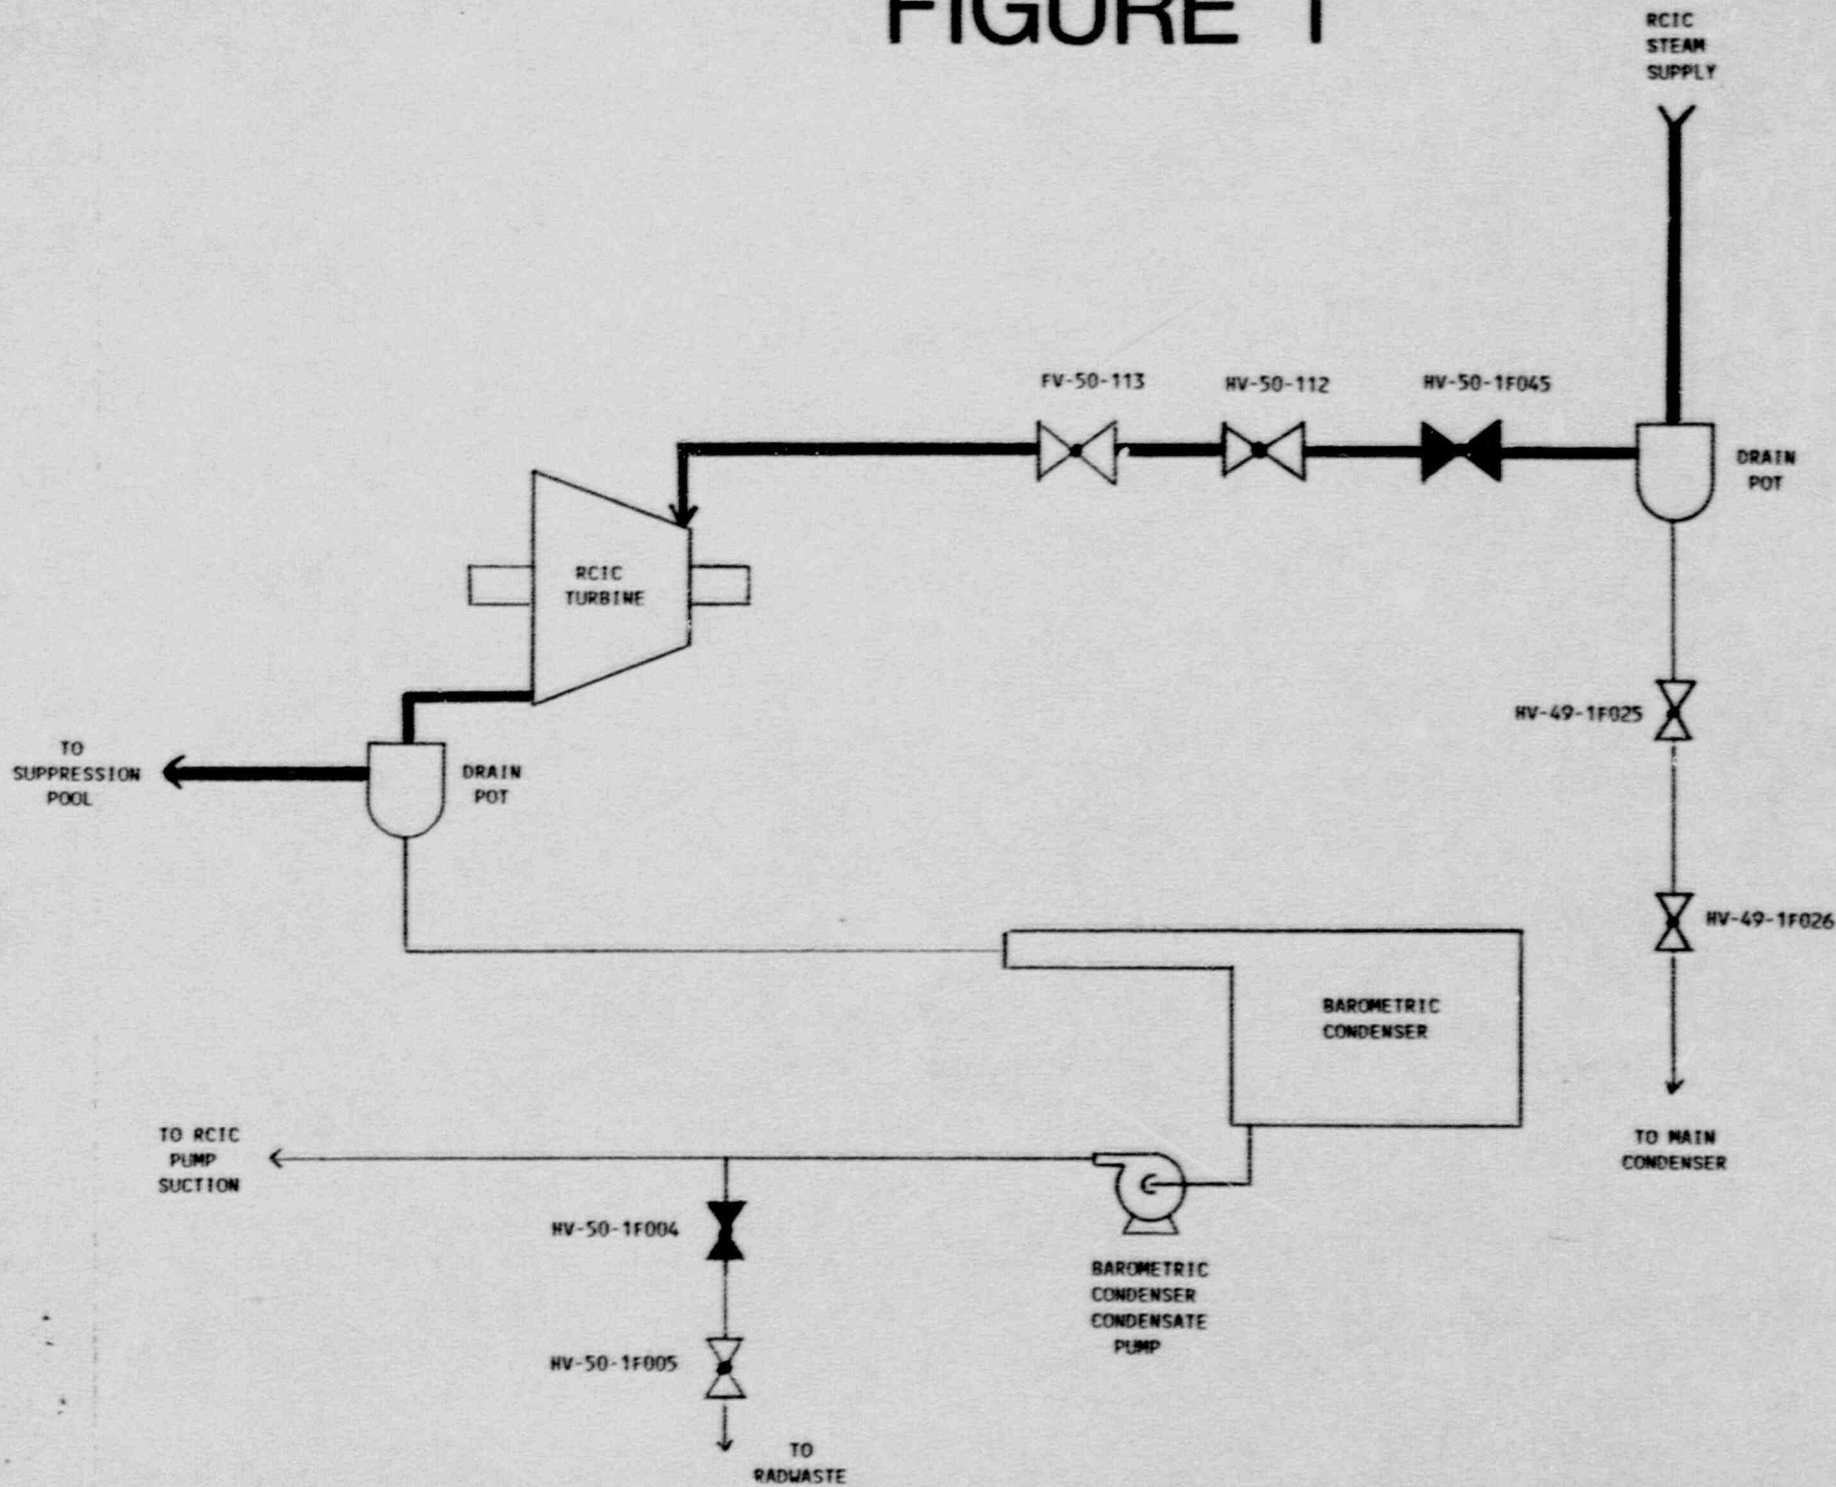
# FIGURE 1

On February 28, 1990, HV-50-1F005 failed closed (see figure 1) when the operating solenoid failed. The discovery of the valve failure prompted an investigation into the event. This valve is not essential for the operation of the RCIC system, therefore, the RCIC system remained operable. Subsequently, on March 1, 1990, HV-49-1F025 failed via the same mechanism as the HV-50-1F005 failure. With HV-49-1F025 failed closed, there was a possibility of condensation collecting in the steam supply line to the RCIC turbine. With condensation in this line, there is a possibility that the RCIC turbine would not properly respond to an initiation signal. For this reason the RCIC system was declared inoperable.

On March 6 and 7, 1990, a short outage was initiated on the RCIC system. During this outage, the RCIC system was again declared inoperable. The outage was used to replace HV-49-1F025 and HV-50-1F005 with the correct ASCO D/C solenoid valve. Also, the temporary plant alteration that maintained HV-49-1F025 in the open position was removed. At the completion of this work the RCIC system was declared operable.
