U. S. NUCLEAR REGULATORY COMMISSION

Report No.: 50-461/90005(DRS)

Facility Name: Clinton Power Station

Areas Inspected: Special, announced team inspection of a licensee identified reportable event of inadequate design flow through components using the Shutdown Service Water (SX) System for cooling water, and actions associated with Generic Letter (GL) 89-13, "Service Water System Problems Affecting Safety-Related Equipment".

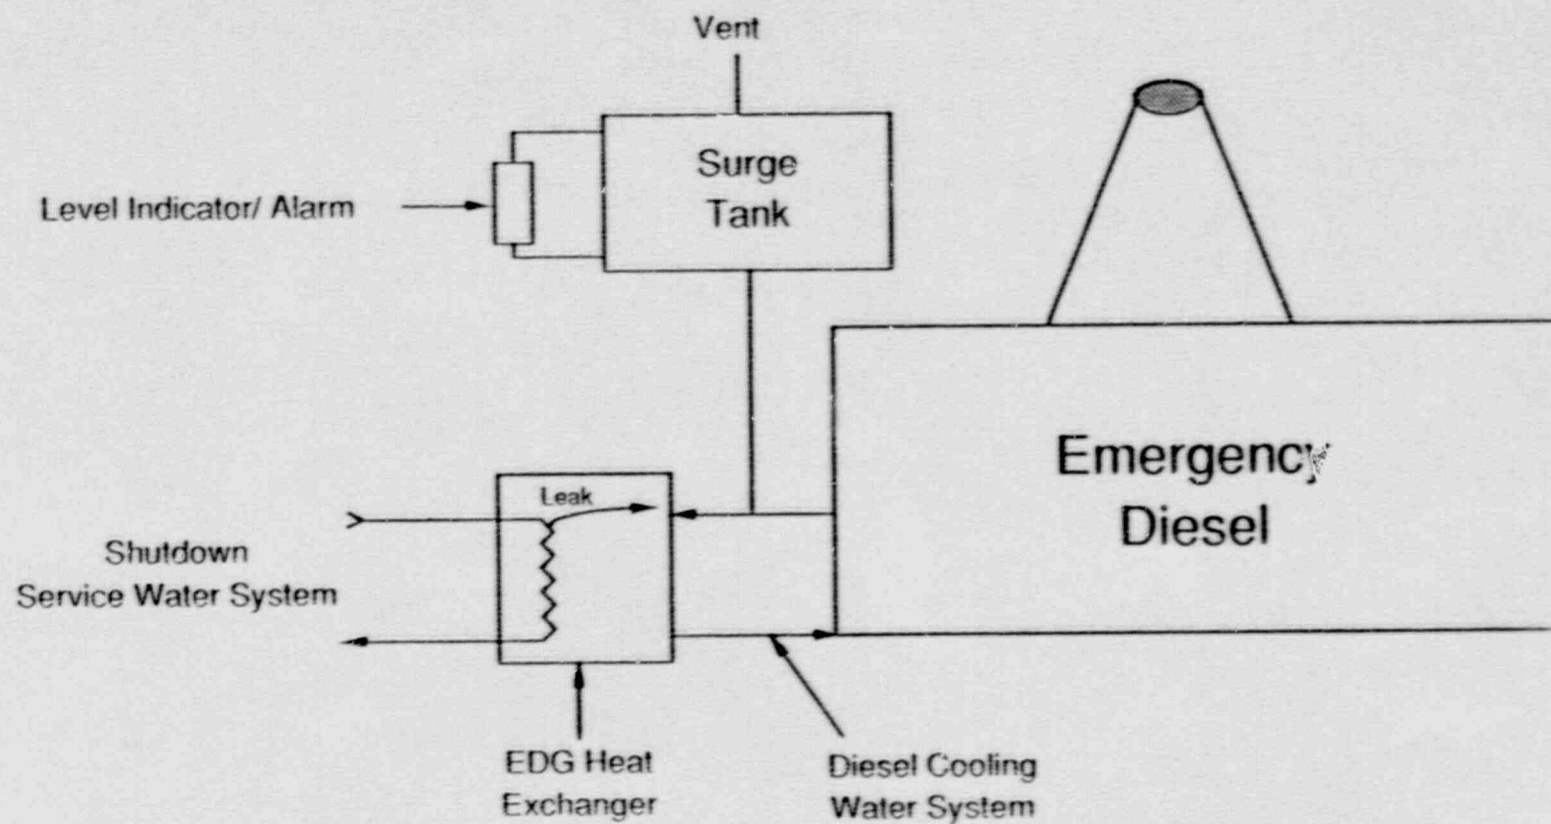
FIGURE 1. Emergency Diesel - SX System Interface

In late December 1989, after approximately three years of commercial operation, a Division I emergency diesel expansion tank high level was observed. The high level was caused by apparent in-leakage from the SX system (having a line pressure of approximately 100 psig) to the emergency diesel generator (EDG) engine closed cooling water system (slightly above atmospheric pressure), reference Enclosure 2. The Division I EDG was declared inoperable and, during the subsequent Limiting Condition for Operation (LCO) of 72 hours, the licensee examined the suspect HX and found through wall pitting in one tube of the dual HX units. The defective tube was replaced with a new tube of like material (90/10 Cu/Ni), the HX was tested, and the EDG was returned to service.

Approximately one week later, a similar tube failure occurred. The HX was repaired, eddy current tested and approximately half of the tubes were cleaned, within a 72 hour LCO. A third failure took place on January 15, 1990, at which time the licensee completely retubed and hydrostatically tested both Division I EDG HX units. A consultant associated with the Electric Power Research Institute (EPRI) was called in to examine the degraded HXs and identified the degradation mechanism as local Microbiologically Induced Corrosion (MIC) accelerated by the thermal and stagnation environment present in the EDG HX tubes.

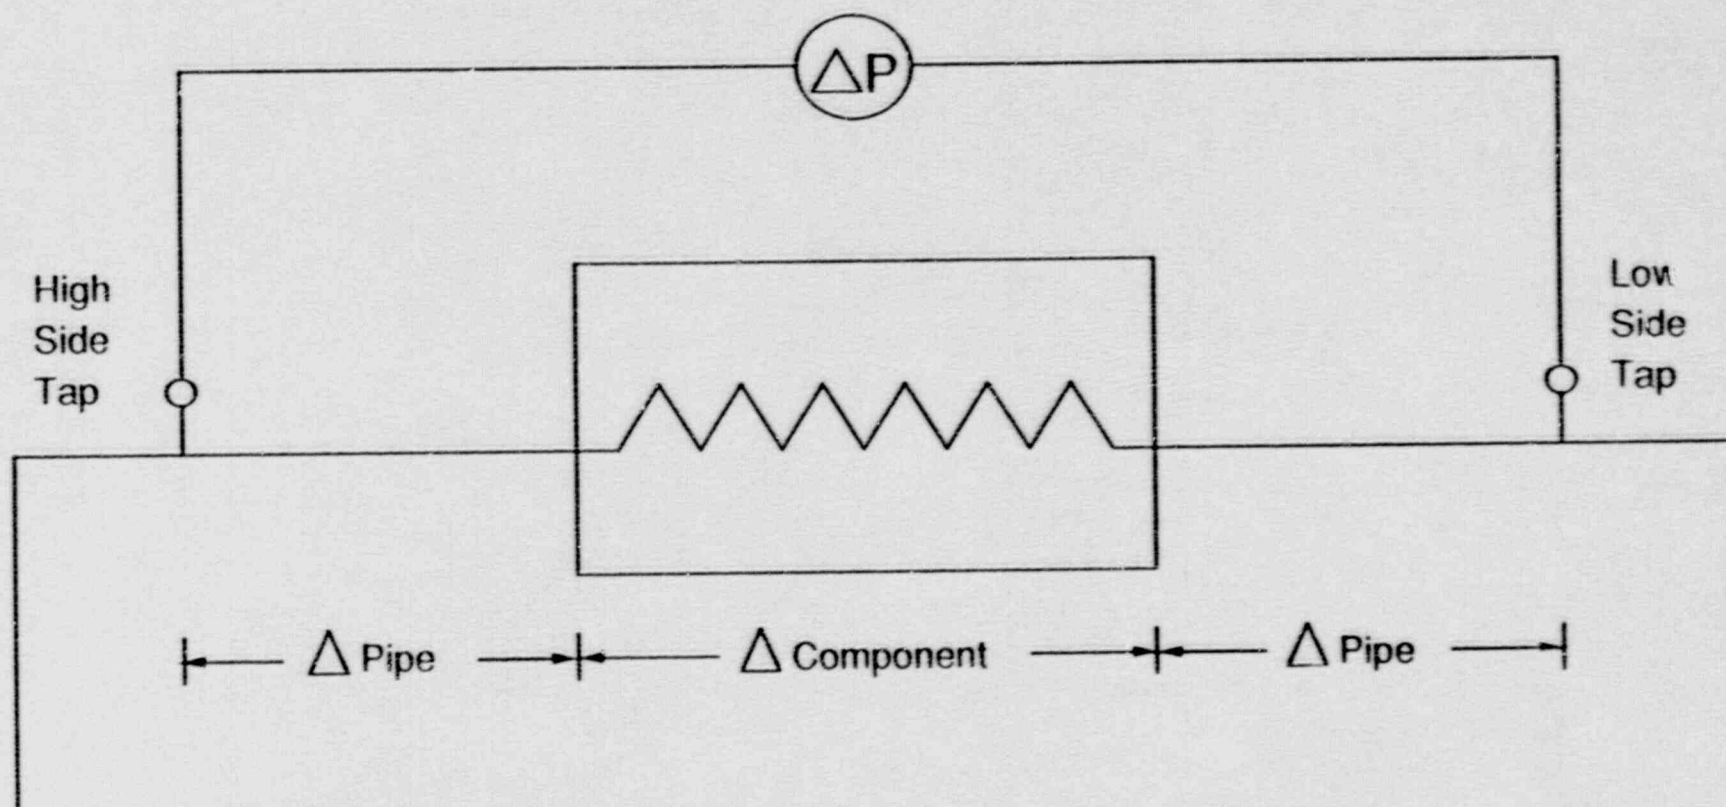
FIGURE 4. Component Differential Pressure Drops

It was noted during the review that the acceptable flow rate values supplied by engineering made no additional allowances for any pressure drops between the taps for differential pressure measuring devices and the cooling coils. The vendor supplied pressure drop data was accountable only for the pressure drop across the coil. The actual locations of the instrumentation used during the preoperational tests could not be established, but assumptions were made of the possible pressure tap locations and additional line losses should have been accounted for. (Reference: Enclosure 4)

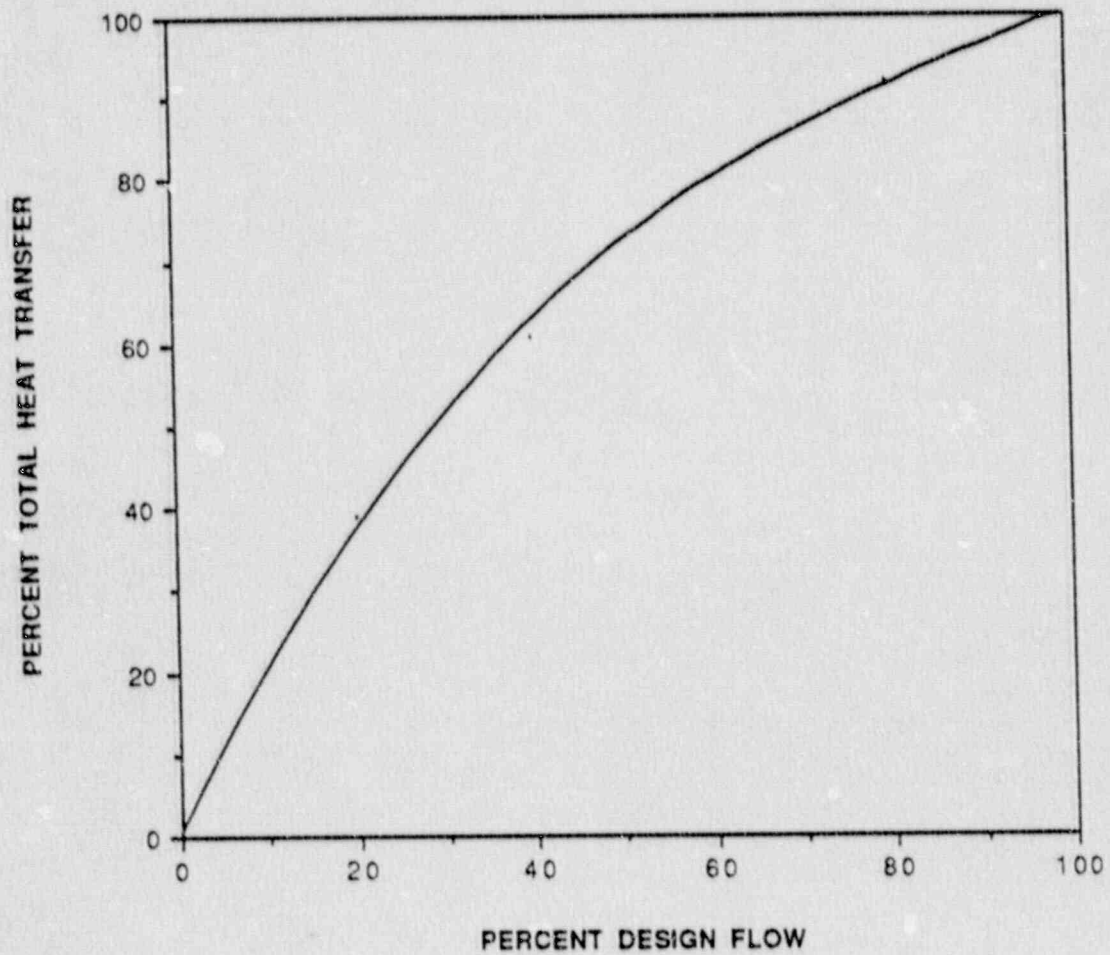
FIGURE 3. Chilled Water Terminal Flow versus Heat Transfer

It should be noted that the flow through the HX is not a direct measure of the calculated heat removal capacity of the component. The basic relationship for water to air heat exchangers is shown in Enclosure 5. This enclosure indicates that, at least in a generic case, a reduction to only 20% of the design liquid flow for the HX results in the component still being able to remove approximately 40% of its design heat load. A second observation that should be made is the difference between the heat exchanger design heat removal capacity (design heat load), which is the manufacturer's performance guarantee for rate flows and temperatures, and the maximum heat rejection rate required during a loss of coolant accident (LOCA) or other potential core damage sequence (required emergency load). The required emergency load is the value (Btu/hr) required by Technical Specifications to avoid exceeding the ambient temperature limitations of equipment in the proximity of the HX, and is considerably lower than the HX design load. This difference in capacity allows for variations such as lower than design flow rates, fouling of heat transfer surfaces, and the like, while still providing protection to the local equipment.
