PRAIRIE ISLAND NUCLEAR GENERATING PLANT  
Docket Nos. 50-282 License Nos. DPR-42  
50-306 DPR-60

Response to Notice of Violation  
Inspection Reports No. 50-282/90004(DRP) and 50-306/90004(DRP)

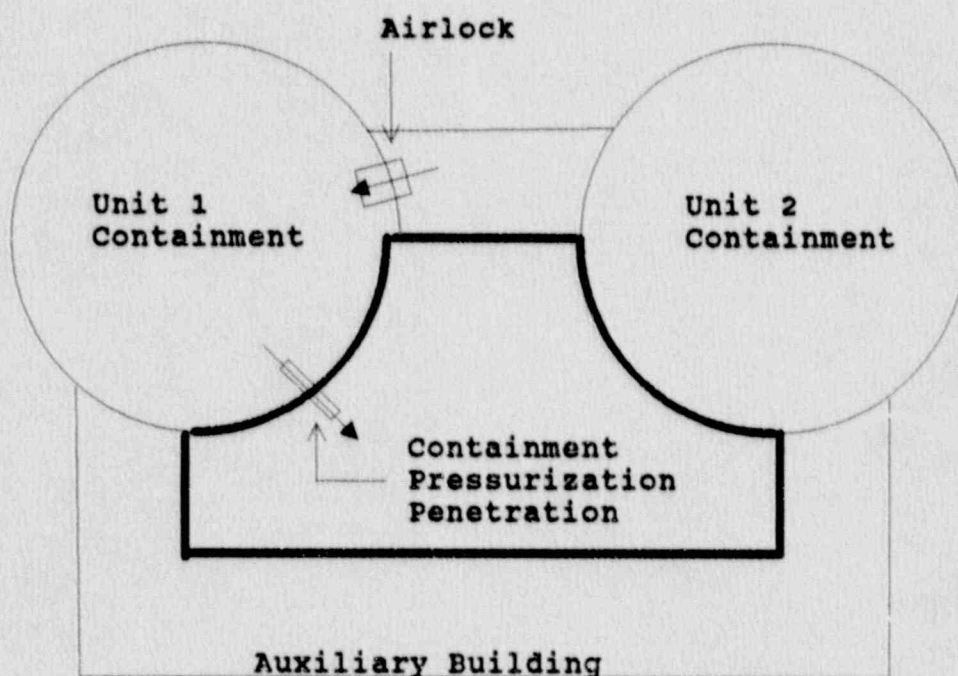
Figure

The Auxiliary Building Special Ventilation Zone is common to both Unit 1 and Unit 2. The function of the system is to maintain a negative pressure within the Auxiliary Building Special Ventilation Zone under accident conditions. Openings in the Auxiliary Building Special Ventilation Zone boundary if left open and if larger than 10 square feet could defeat the function of the Auxiliary Building Special Ventilation Zone. The potential flow path of air associated with this violation would have been 1) through the Unit 1 airlock into the Unit 1 containment 2) through the containment pressurization penetration into the Auxiliary Building Special Ventilation Zone. Since the cross sectional area of this penetration (0.5 square feet) is less than 10 square feet, the function of the Auxiliary Building Special Ventilation Zone would not have been defeated. However, there was no administrative control for these two breaches of the Auxiliary Building Special Ventilation Zone boundary.

Leakage Path Created By the Removal  
of the Unit 1 Containment Pressurization  
Flange
