SEMINAR ON THE USE OF UNUSUAL EVENT REPORTS
FOR IMPROVING NUCLEAR POWER PLANT SAFETY

Lessons Learned from Unusual Event Analysis
to Improve Measures to Cope with Steam
Generator Tube Ruptures

Dr. K. Kotthoff

PART I: Nuclear Vessel Head Penetration Cracking in France

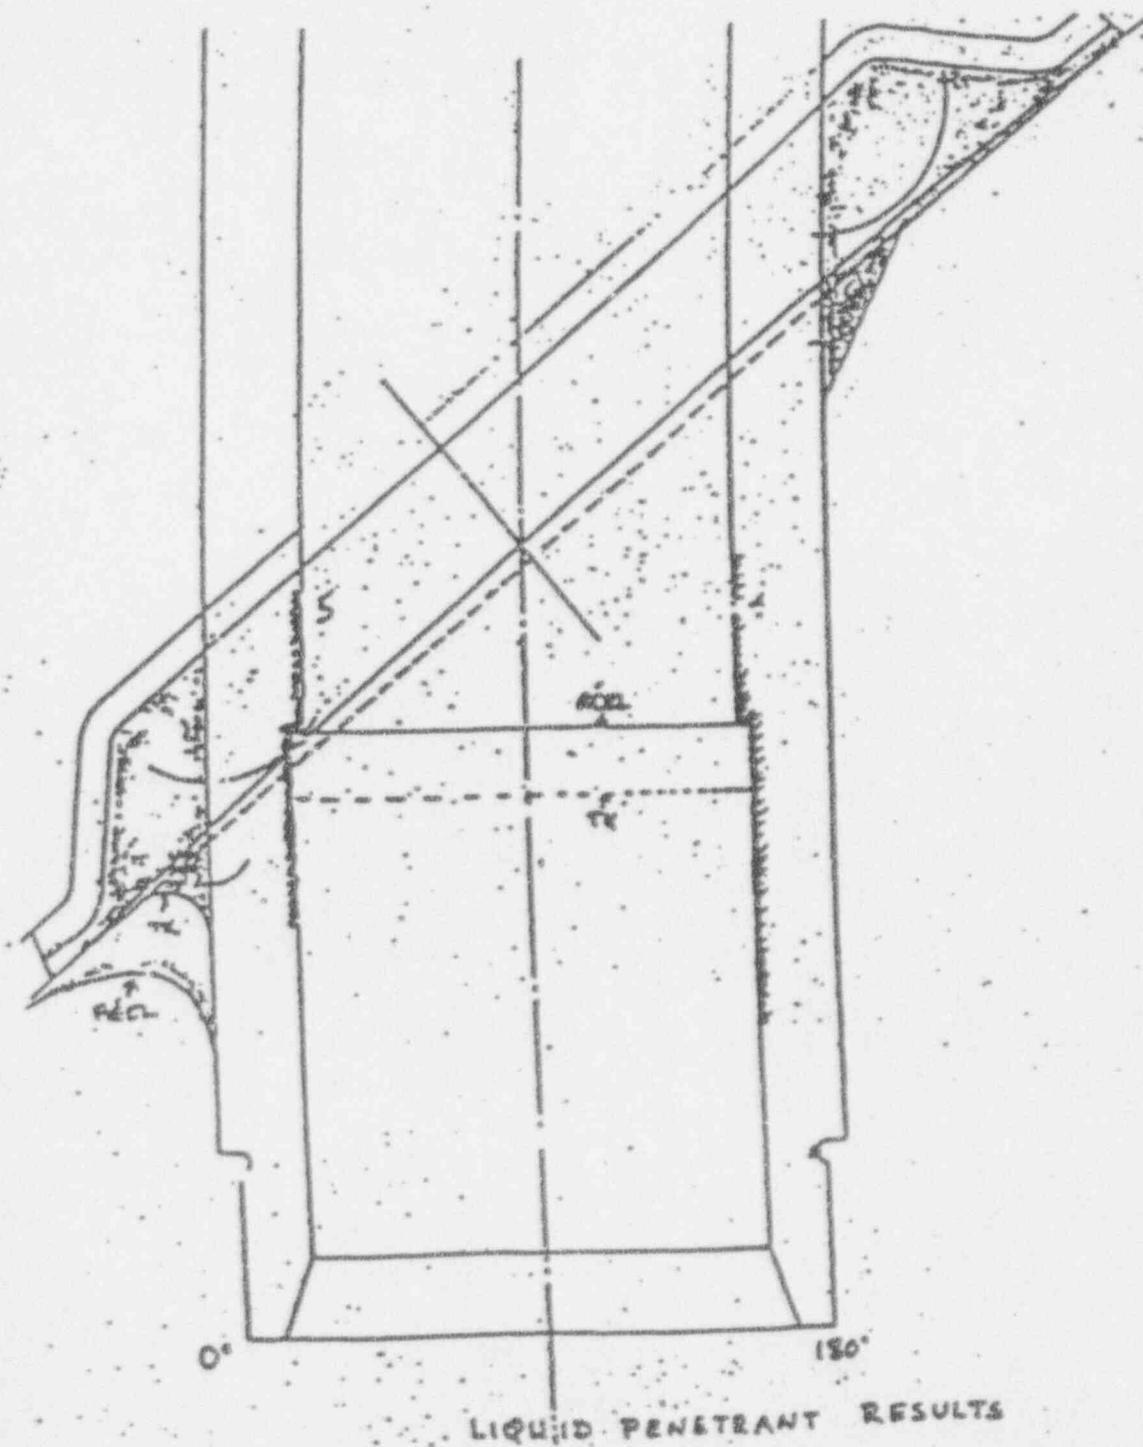
Figure II.2: Findings of VHPC at Bugey-3sm

According to Framatome, after shutdown of the primary pumps at 166 bars, the acoustic sensors produced an increasing noise indicating a pressure increase.¹² A leak of about 1 litre per hour was identified on one (n°54 on the periphery of the vessel head) of the 65 Inconel-600 vessel head penetrations. The CRDM and thermocouple conduits enter the core through these penetrations. The Fessenheim and Bugey reactors were the first 900 MW reactors of the so called CPO (Contrat de Programme - 0) series of French reactors.

By the middle of October 1991 investigations had revealed 11 longitudinal cracks of 15 to 73 mm length occurring in two groups on the inner wall of the incriminated VHP of the Bugey-3 reactor. Four external checks indicated penetrating cracks of which only two were thought to have caused the leak. In addition the tube itself had become somewhat oval.

By early November 1992, the VHP which caused the leak at the Bugey-3 reactor had been replaced. The extraction was qualified by EDF technical staff as "very delicate", because they shrink fitting had been employed and the process had to be reversed to extract the tubes. Also 59 of the 65 VHPs have thermal sleeves which had to be extracted before the penetration itself could be removed. Four VHPs have been repaired at Bugey-4 and one at Paluel-4. EDF has also asked Framatome to replace Inconel-600 penetrations with Inconel-690 ones in the vessel heads under construction for Chooz-B1 and -B2 "and to bear all the responsibility, including financial".³⁶
