Duke Power Company
McGuire Nuclear Station
12700 Hagers Ferry Road
Huntersville, NC 28078-8985

Subject: McGuire Nuclear Station Unit 1
Docket No. 50-369
Licensee Event Report 369/90-15

TITLE (4) **Technical Specification 3.0.3 Was Entered For Inoperable Power Range Nuclear Instrumentation During Power Escalation Because Of A Management Deficiency**

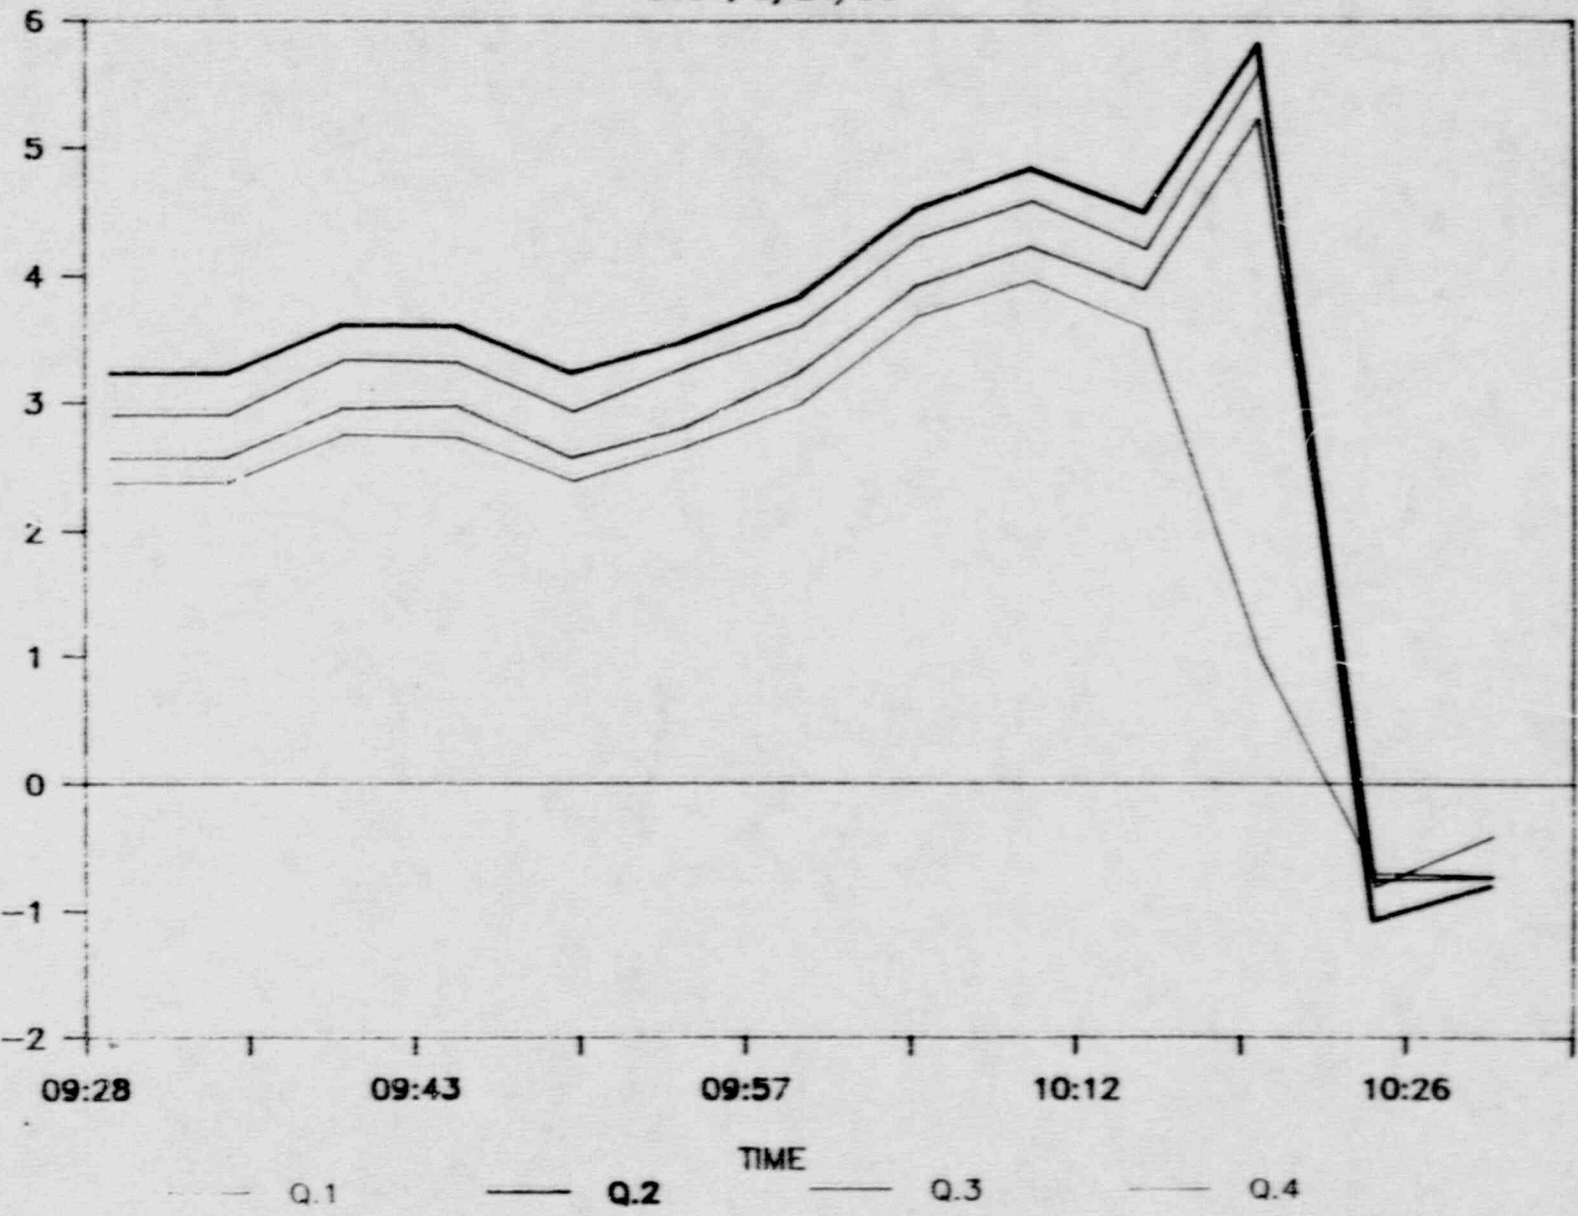
U.1 POWER MISMATCH

Operations personnel were continuing to monitor power mismatch while IAE calibrated the PRNIs. Operations personnel stated that when the power mismatch reached approximately +4.7 percent, the load increase was secured. Once the load increase was secured, steam pressure increased and the power mismatch exceeded the +5 percent limit. Power mismatch was greater than 5 percent for less than 10 minutes (reference page 7 of 7). Operations personnel stated they added boric acid to compensate for the steam pressure increase. They also stated the rods could have been inserted to compensate for the steam pressure increase. Either of these means is acceptable.

U1C7, 5/24/90
