LIMERICK GENERATING STATION

SUBJECT: Licensee Event Report
Limerick Generating Station - Units 1 and 2

Reference:	Docket Nos. 50-352 and 50-353
Report Number:	1-90-013
Revision Number:	00
Event Date:	June 11, 1990
Report Date:	July 12, 1990
Facility:	Limerick Generating Station P.O. Box A, Sanatoga, PA 19464

LICENSEE EVENT REPORT (LER)

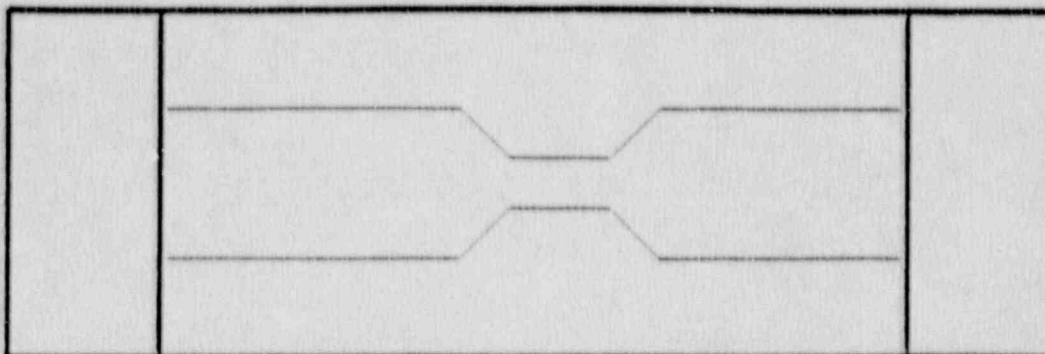
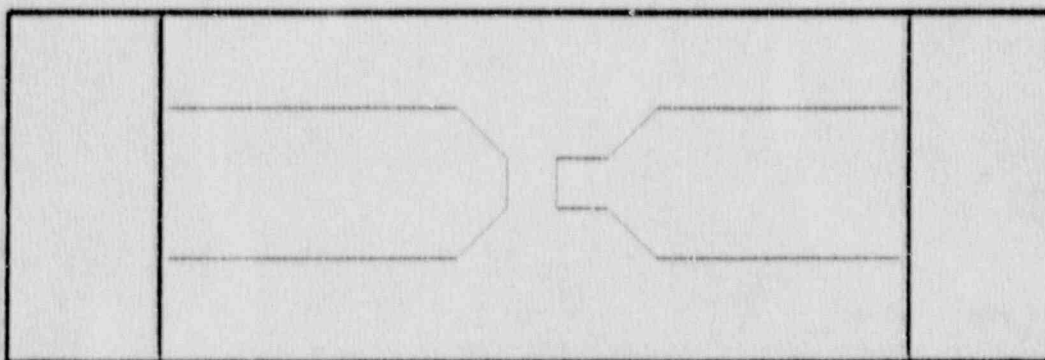
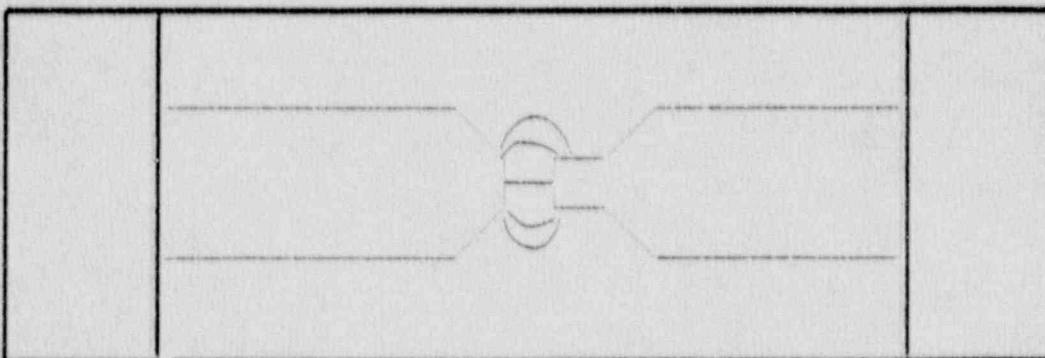
FIGURE 1

As shown in Figure 1, a fuse restrike condition is such that a current overload condition exists causing a fuse to blow; however, the air gap resistance created is insufficient to isolate current flow. An arc is produced and allows continued overload current flow in the DC circuit. This fault condition can then propagate to the upstream fuse (see Figure 2), causing it to blow and result in a loss of DC power to all loads in the associated division of DC power. The Fire Protection Evaluation Report (FPER) states that at least one

INTACT FUSE

BLOWN FUSE

RE-STRIKE

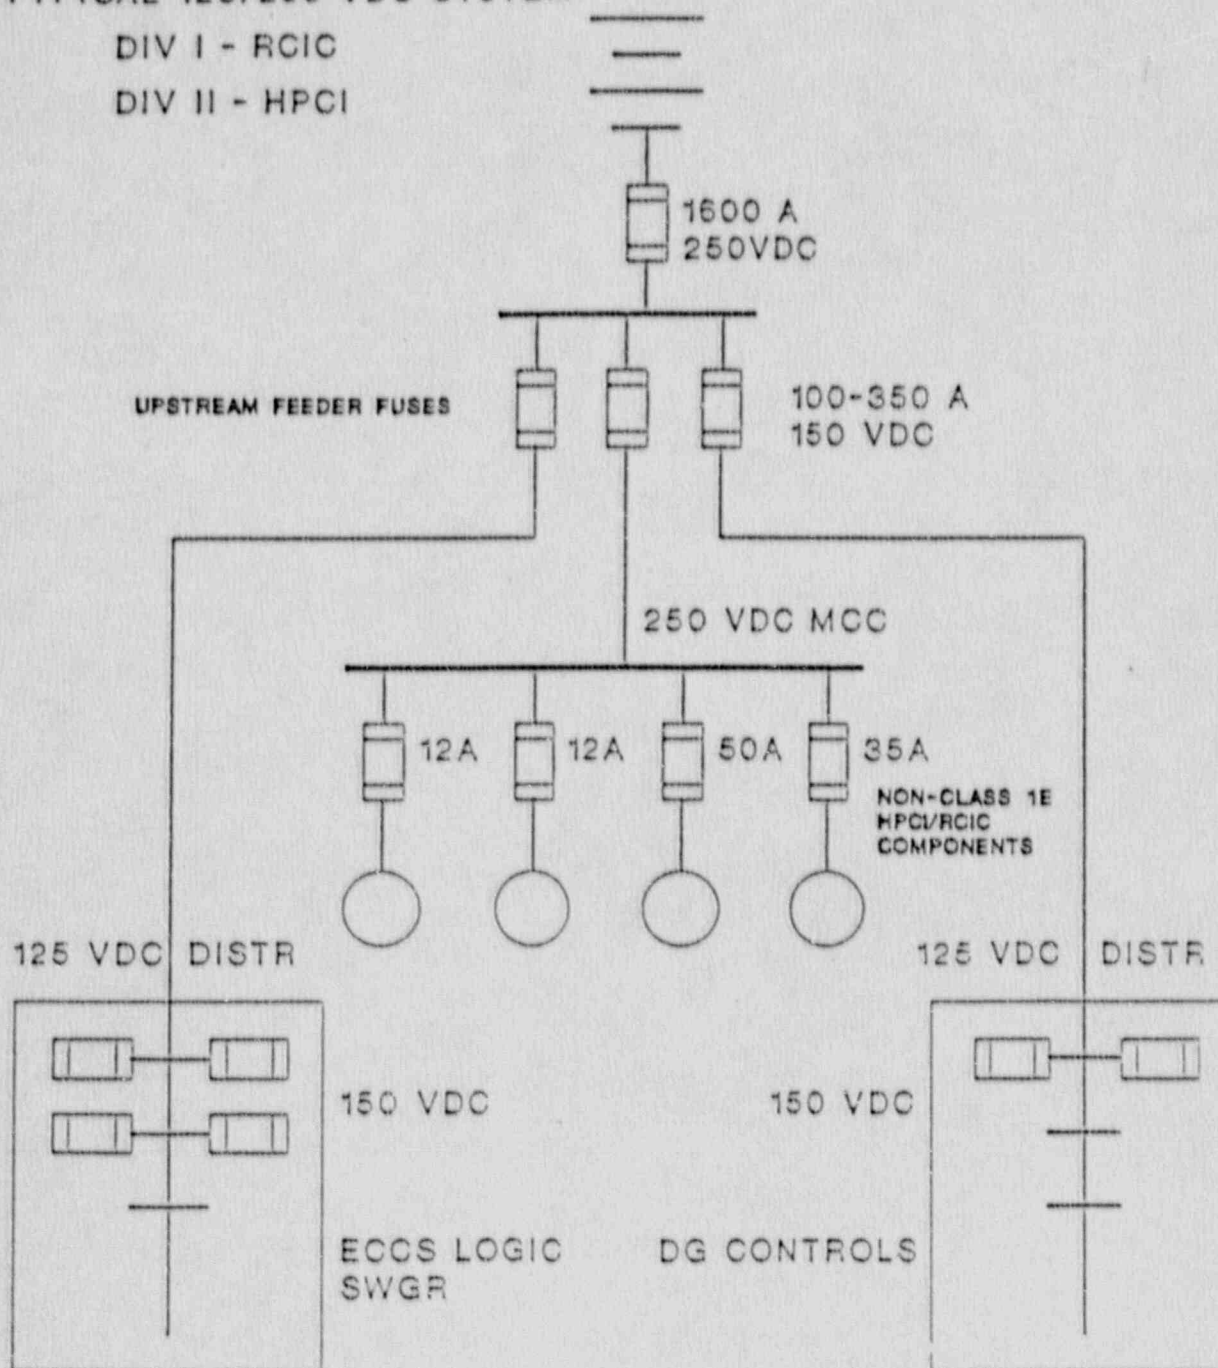
FIGURE 2

TYPICAL 125/250 VDC SYSTEM

DIV I - RCIC

DIV II - HPCI
