14-DAY REPORT OF A "REPORTABLE EVENT"  
CONCERNING AN INADVERTENT MODIFICATION OF THE  
UNIVERSITY OF VIRGINIA REACTOR CONSOLE

Robert U. Mulder, Director  
U.Va. Reactor Facility

May 12, 1993

14-DAY REPORT OF A "REPORTABLE EVENT"  
CONCERNING AN INADVERTENT MODIFICATION OF THE UVAR CONSOLE

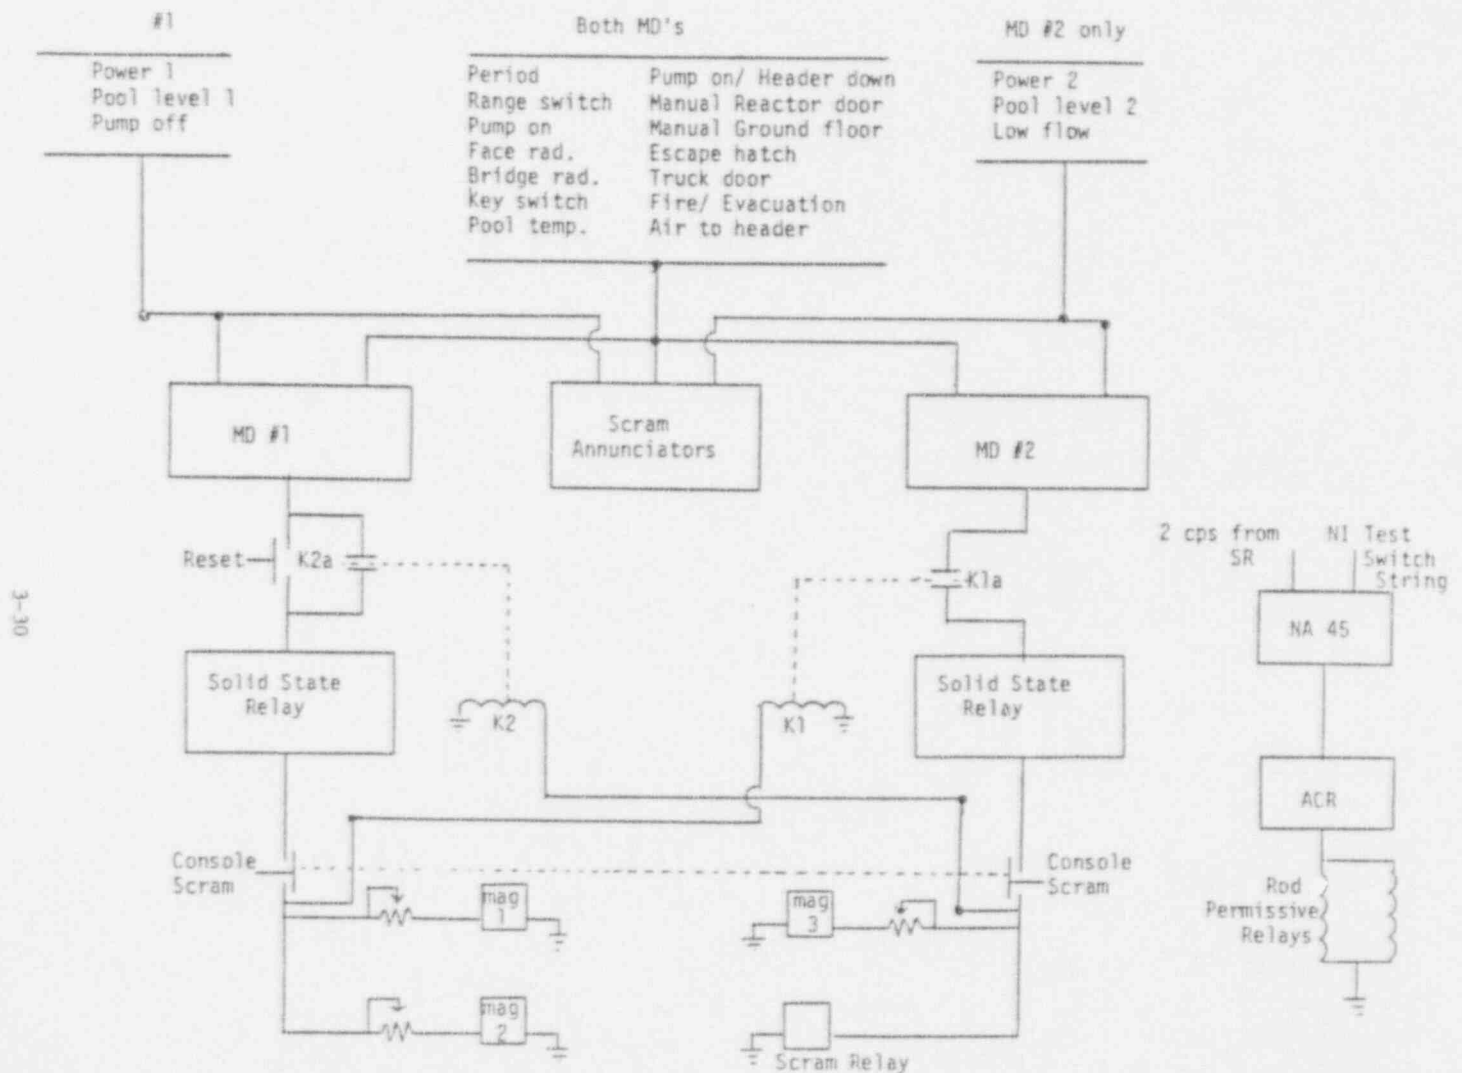
Figure 3.15 Scram Logic Drawer

One side of the circuitry controls the shutdown functions of two of the control rods and the second side controls the third rod. The fourth rod, a regulating rod, is not scrammable. Each side of the circuitry contains a component called a solid-state relay (SSR) and a mixer/driver (MD) module. The SSR plug-in modules are identical units. As regards the MDs, in Figure 3.15 they are shown as single blocks with identifiers MD#1 and MD#2. These SSR and MD modules have been in use since the early 1970's and outwardly appear identical, with the exception for identifying serial numbers on the labels. In the accompanying text on page 3-31 of the Handbook, both the MD modules are described as "being essentially 28 input OR gates." There is no mention of any difference between them. (Please refer to Appendix B for a discussion of the Mixer Driver Characteristics).

The SRO with electronic background and familiarity with the console interior noted in the logbook that he could isolate the side down which the signal causing the spurious trip had come, by holding the reset button in and observing which rods had magnet current. It occurred him that by a simple exchange of the SSR modules he might trace from which SSR module the spurious signal could be coming from.

With the reactor shutdown, the SSRs were switched. The SRO waited for a time with the console instrumentation on and the reactor shutdown, and observed that the spurious scram signals were still coming on the original side of the system. The SRO then recorded in the logbook that he had eliminated the SSR modules as a source of the spurious scram signals.

The MD modules were identified as the next potential source of the spurious signal. These MDs were also interchanged in the belief that they, like the SSRs, were identical. With the reactor still shutdown, the MD modules in the interchanged position and the console turned on, the SRO waited for another spurious scram signal to occur. When after about 30 minutes no further spurious shutdown signals were received, the SRO discussed the possibility of restarting the reactor with the Reactor Administrator. There being no discernable cause for the original scram (no scram annunciators had lit), a reactor restart was authorized by the Reactor Administrator without a recheck of the automatic trips.

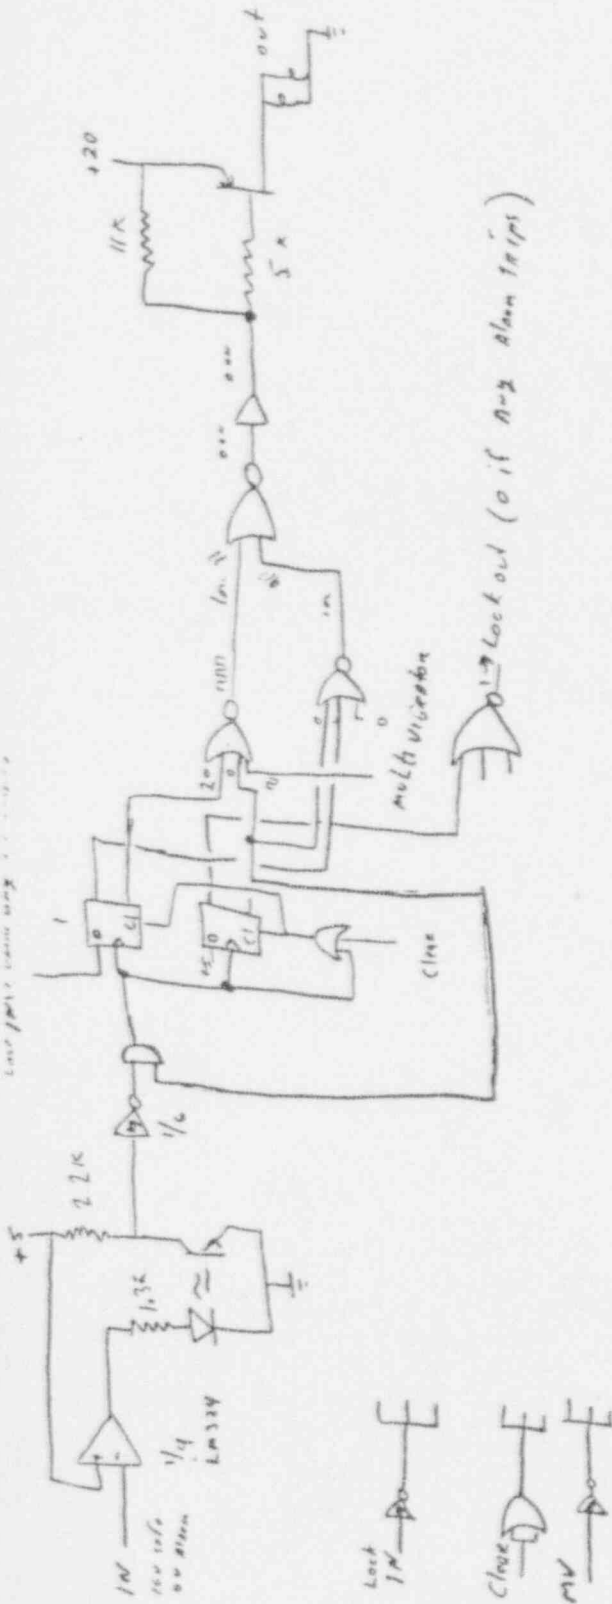
input impedance of  
 MIXER DRIVER  $\approx 1.1K \Omega$   
 Valley comparison  $\approx 1.79 \Omega$   
 Isolation resistors =  $50K \Omega$
