**PERRY NUCLEAR POWER PLANT**

Perry Nuclear Power Plant  
Docket No. 50-440  
Response to Confirmatory Action Letter

This letter is submitted as the second partial response to Confirmatory Action Letter (CAL) RIII-93-07, dated April 16, 1993, which detailed actions requested by the NRC regarding the performance of ECCS Suction Strainers at the Perry Plant.

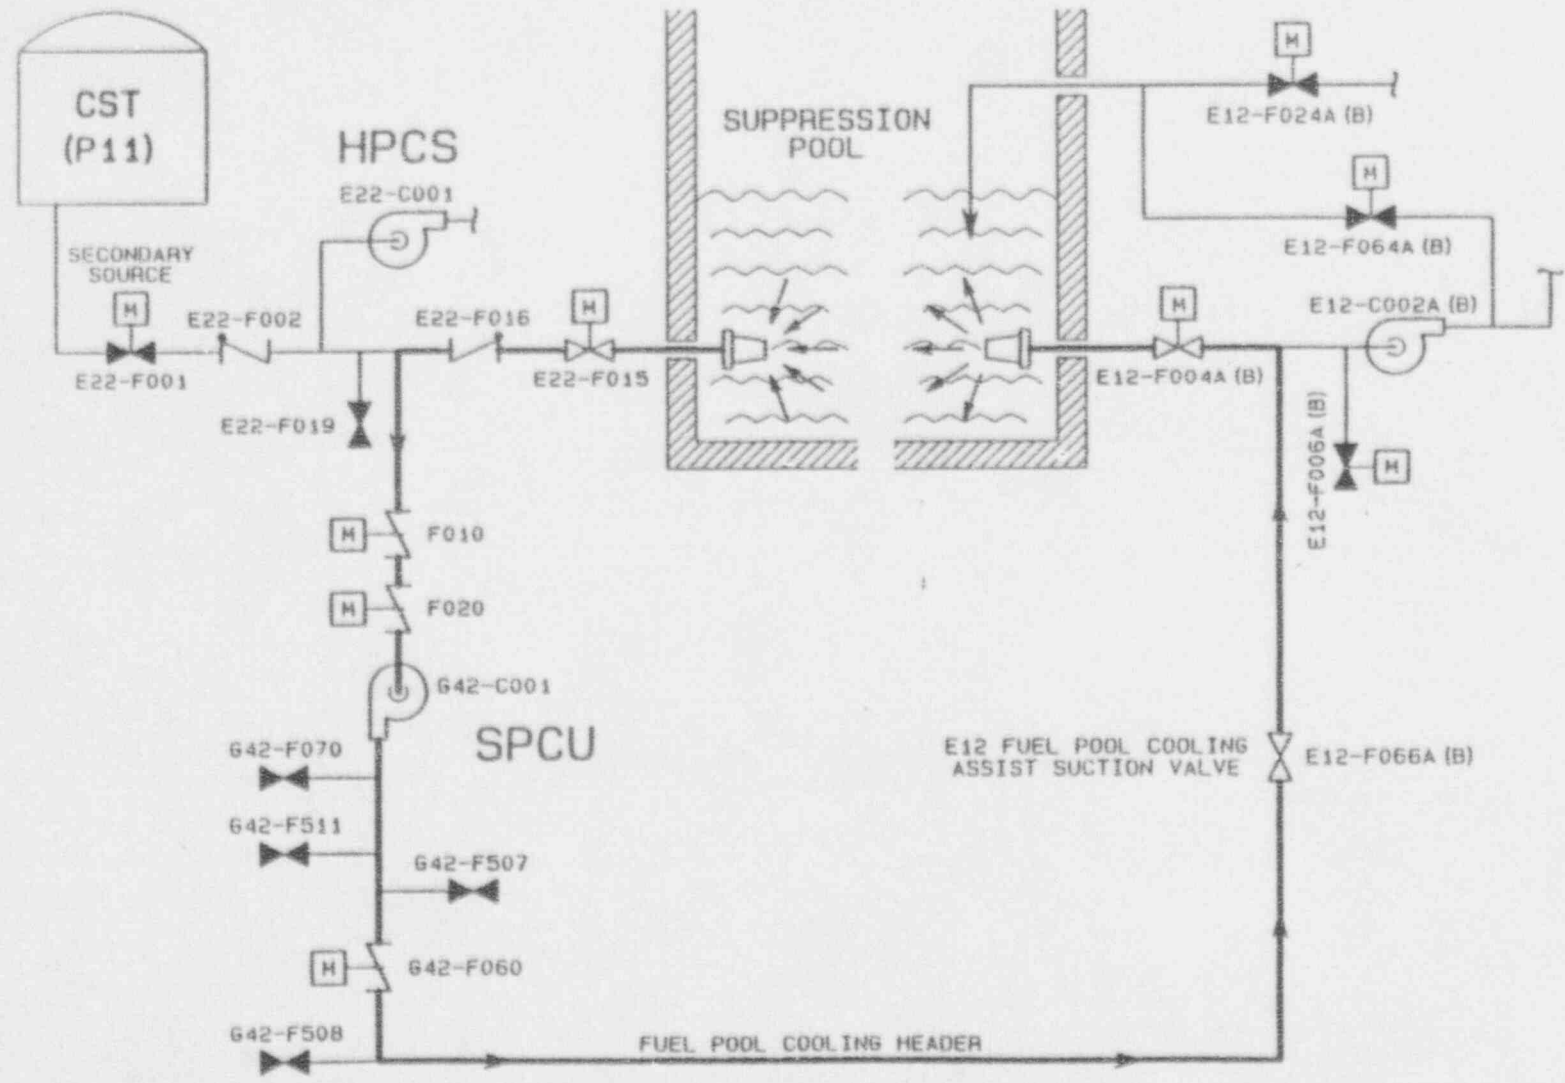
BACK FLUSH OF RHR "A" (B) STRAINER

4. Question: Please provide a one-line diagram of a suction path for backflushing RHR suppression pool suction strainers.  
Response: See Figure below.
