LICENSEE EVENT REPORT (LER)

Facility Name (1) SAN ONOFRE NUCLEAR GENERATING STATION, UNIT 2										Docket Number (2) 0 5 0 0 0 3 6 1				Page (3) 1 of 0 5													
Title (4) INCONCLUSIVE CHECK VALVE TESTING METHODOLOGY - VOLUNTARY REPORT																											
EVENT DATE (5)			LER NUMBER (6)				REPORT DATE (7)			OTHER FACILITIES INVOLVED (8)																	
Month	Day	Year	Year	///	Sequential Number	///	Revision Number	Month	Day	Year	Facility Names				Docket Number(s)												
1	2	09	9	2	9	2	-	0	1	3	-	0	0	0	6	0	9	9	3	SONGS, Unit 3				0 5 0 0 0 3 6 2			
OPERATING MODE (9) 1			THIS REPORT IS SUBMITTED PURSUANT TO THE REQUIREMENTS OF 10CFR (Check one or more of the following) (11)																								
POWER LEVEL (10) 1 0 0 //////////////////// //////////////////// //////////////////// ////////////////////			20.402(b)				20.405(c)				50.73(a)(2)(iv)				73.71(b)

SAN ONOFRE NUCLEAR GENERATION STATION UNIT 2	DOCKET NUMBER 05002761	LER NUMBER 92-013-00	PAGE 2 of 5
---	---------------------------	-------------------------	----------------

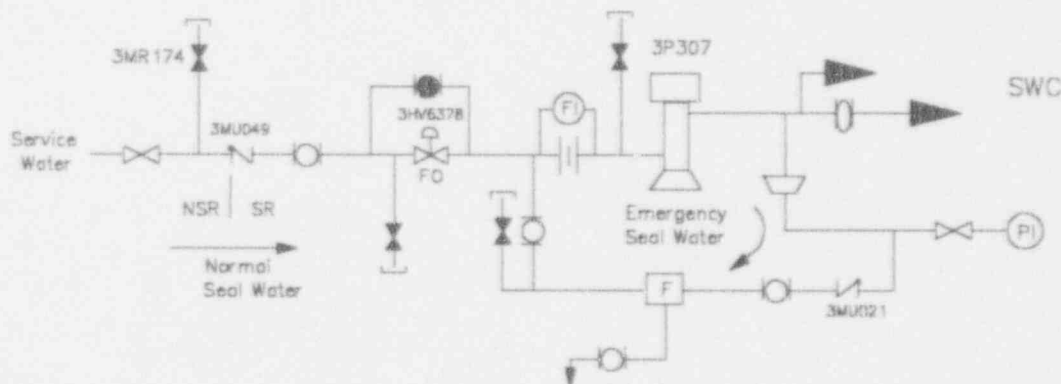
Figure 1: SWC Pump Seal Water Supply

The SWC pump seals [SEAL] and bearings are normally cooled and lubricated by the service water system [KG] (domestic water). In the event that the service water system becomes inoperable due to maintenance or in the unlikely event of a design basis earthquake (DBE), the SWC system is equipped with emergency recirculation water lines to cool and lubricate the pump seals and bearings (refer to Figure 1).

During Unit 2 SWC pump service water supply design modification work (piping and vent valve replacement), it was noted that several vent valves were blocked with debris. In this condition, it was questionable as to whether previous testing had adequately determined that the normal service water seal supply check valves were capable of reverse flow seating during a postulated DBE event requiring emergency seal water recirculation flow. Therefore, on December 7, 1992, the applicable check valve test procedure was modified to require verification of flow out the vent valves first, prior to isolating normal service water and checking for check valve closure.

Subsequent to the Unit 2 vent valve blockage discovery, this condition was also confirmed to have existed at Unit 3. An example was the vent valve blockage (debris) discovered in 3MR174 (the upstream vent valve for 3MU049). Upon removing the vent valve 3MR174 blockage, subsequent testing on December 9, 1992, indicated that 3MU049 would not seat.

The procedure for testing check valves did not specifically require verification that the upstream vent valve (e.g., 3MR174), which is opened when verifying check valve leak tightness (refer to Figure 1), would pass flow. Instead, the instructions were to open the vent valve with upstream normal service water isolated and verify that seal water flow to the SWC pump was still greater than or equal to the manufacturers recommended minimum flow. With a blocked vent valve there was no positive indication that the normal seal water system supply check valve had seated on reverse flow as required to verify valve operability.

The vent valve flow blockage was attributed to a build-up of sediment (from untreated domestic water) and corrosion products from upstream nonsafety-related thick wall carbon steel service water (domestic water) piping.

- a. The applicable check valve procedure was modified to require verification of flow out the vent valves prior to isolating normal service water and checking for proper check valve closure.
- b. The normal service water SWC pump seal supply just down-stream of the seal supply isolation valve up to and including the associated seal water supply vent valve has been modified for all Unit 2 SWC pumps to minimize corrosion product buildup. The associated piping and vent valves have been replaced with stainless steel components, and Y-strainers have been added.

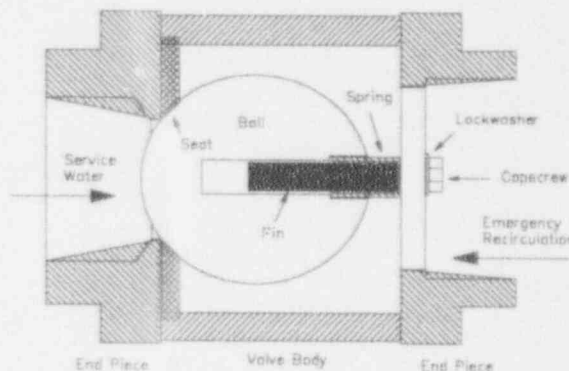
Figure 2: Seal Water Supply Check Valve

Check valve 3MU049 was not able to seat on reverse flow due to a similar corrosion product buildup in low flow areas within the valve body (refer to Figure 2). Upon flow reversal during emergency recirculation flow path testing, the debris became trapped between the ball and seat preventing closure.
