Long
Island
Power
Authority

Licensee Event Report 93-001
Shoreham Nuclear Power Station - Unit 1
Docket No. 50-322

TITLE (4) Movement of Heavy Load on Refuel Floor Which Was Outside Design Basis of the Plant

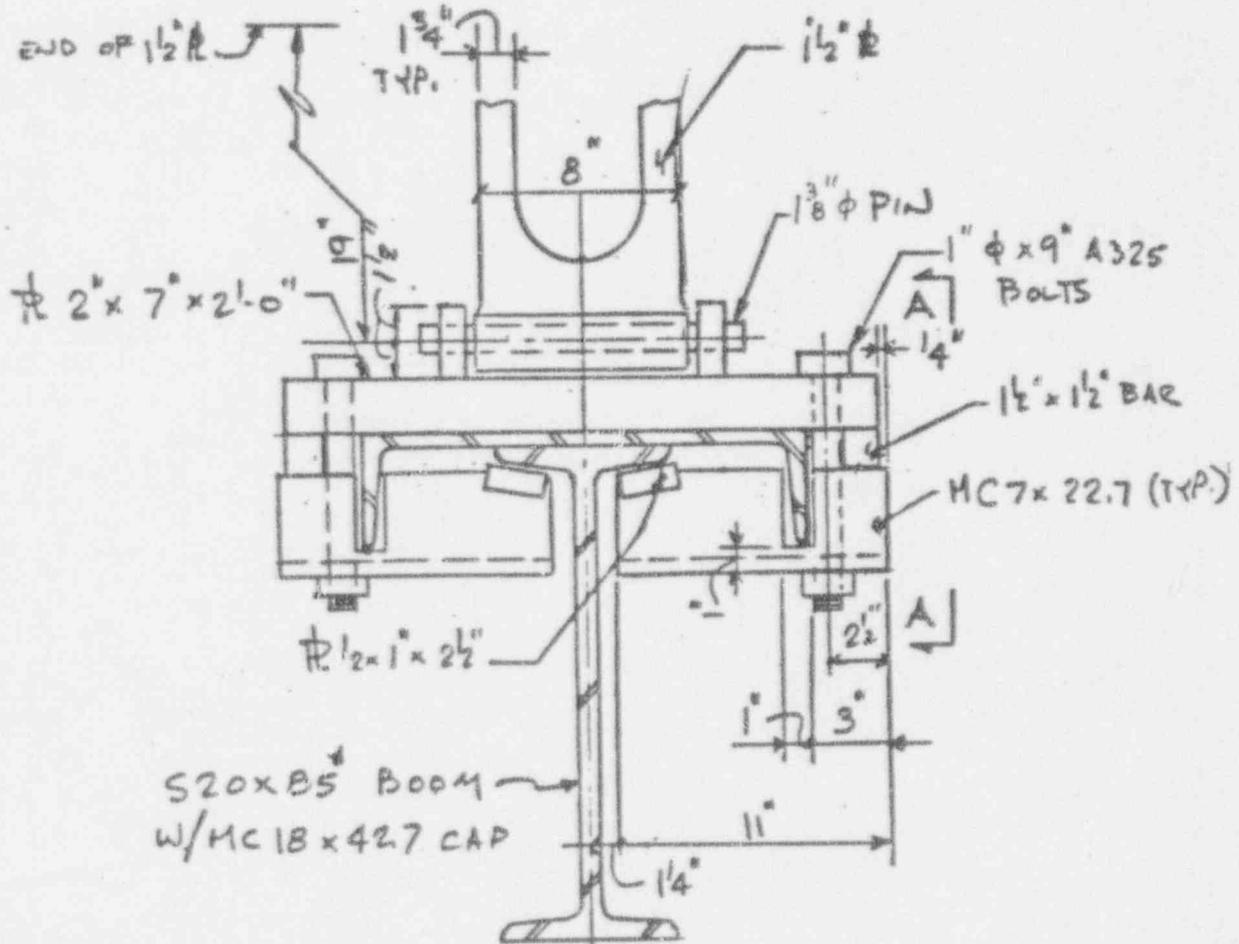
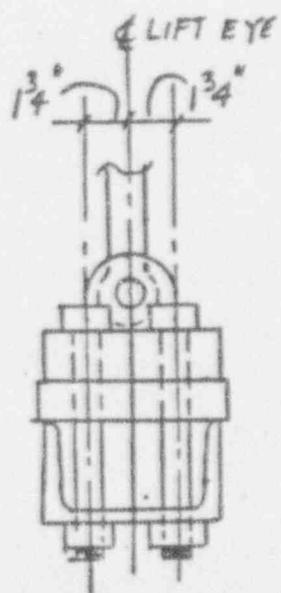
SKETCH #1
LIFTING EYE ASSEMBLY
DETAILS

It was concluded that the principle cause for the failure was inadequacies associated with the design of the lifting eye assembly. The assembly's extreme sensitivity to fabrication tolerances and a lack of detailed installation instructions contributed to the assembly being unforgiving to installation alignment. This could have allowed the lifting eye assembly to be misaligned, relative to the upper boom flange centerline, when it was moved from its balanced lift location at the start of the job. Misalignment or excess tolerances could cause the end of the MC-7 channel to come in contact with the underside of the upper boom flange which would ultimately fail the channel. (One of the MC-7 channels was found to be permanently deformed.) This scenario is illustrated in sketch #2.

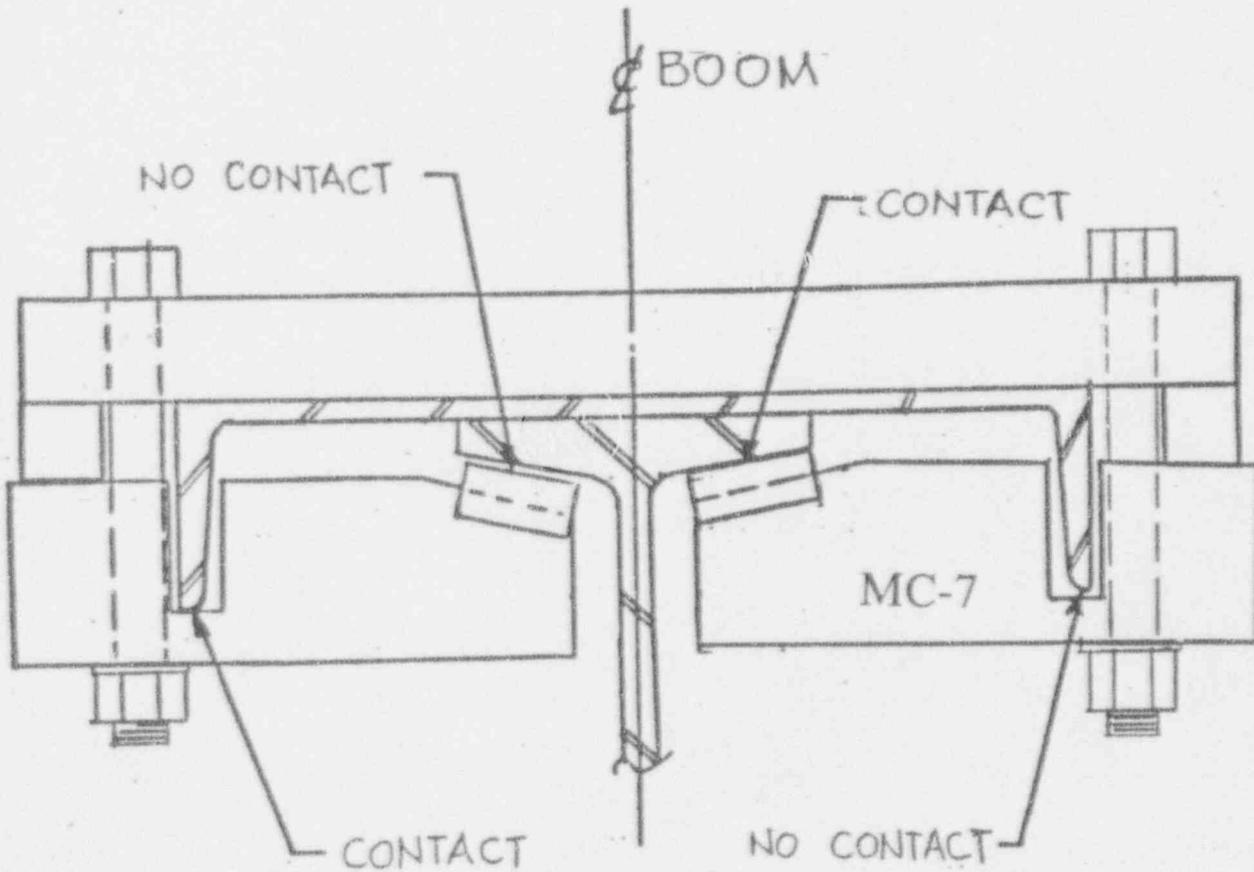
SKETCH #2

MISALIGNMENT OF
LIFTING EYE ASSEMBLY
