Monticello Nuclear Generating Plant  
Docket No. 50-263  
Renewed Facility Operating License No. DPR-22

10 CFR 50.55a Request: Request RR-016 Associated with the Fifth Ten-Year Inservice Inspection (ISI) Interval

**MONTICELLO NUCLEAR GENERATING PLANT  
PROPOSED ALTERNATIVE IN ACCORDANCE WITH 10 CFR 50.55a(z)(2)  
REQUEST RR-016 ASSOCIATED WITH THE FIFTH TEN-YEAR  
INSERVICE INSPECTION (ISI) INTERVAL**

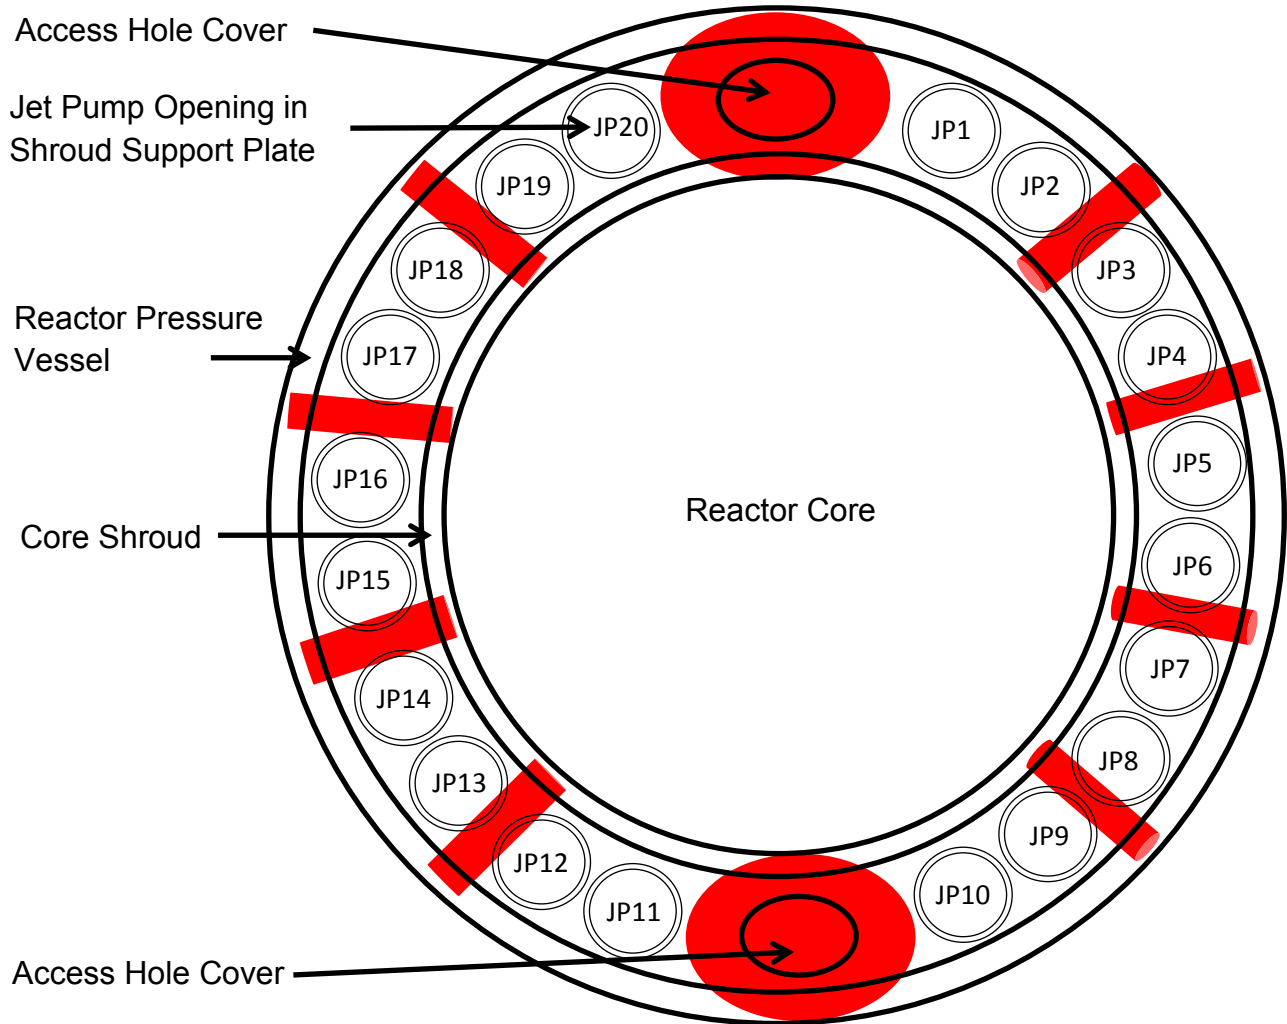
Attachment D – Monticello Shroud Support Plate Underside Illustration  
(Shroud Support Legs Not Illustrated)

When the inspections were performed on the underside of H8 and H9 welds in the lower plenum, the common areas within a jet pump pair were accessible for inspection. Those areas on either side of the access hole covers and the areas between the jet pump pairs could not be inspected due to the rigidity of the equipment and the limited maneuverability as it passes through the jet pump and the opening in the shroud support plate (see Attachments D and E).

Areas in red are inaccessible for inspection due to the rigid nature of the inspection equipment and limited maneuverability within the jet pumps.

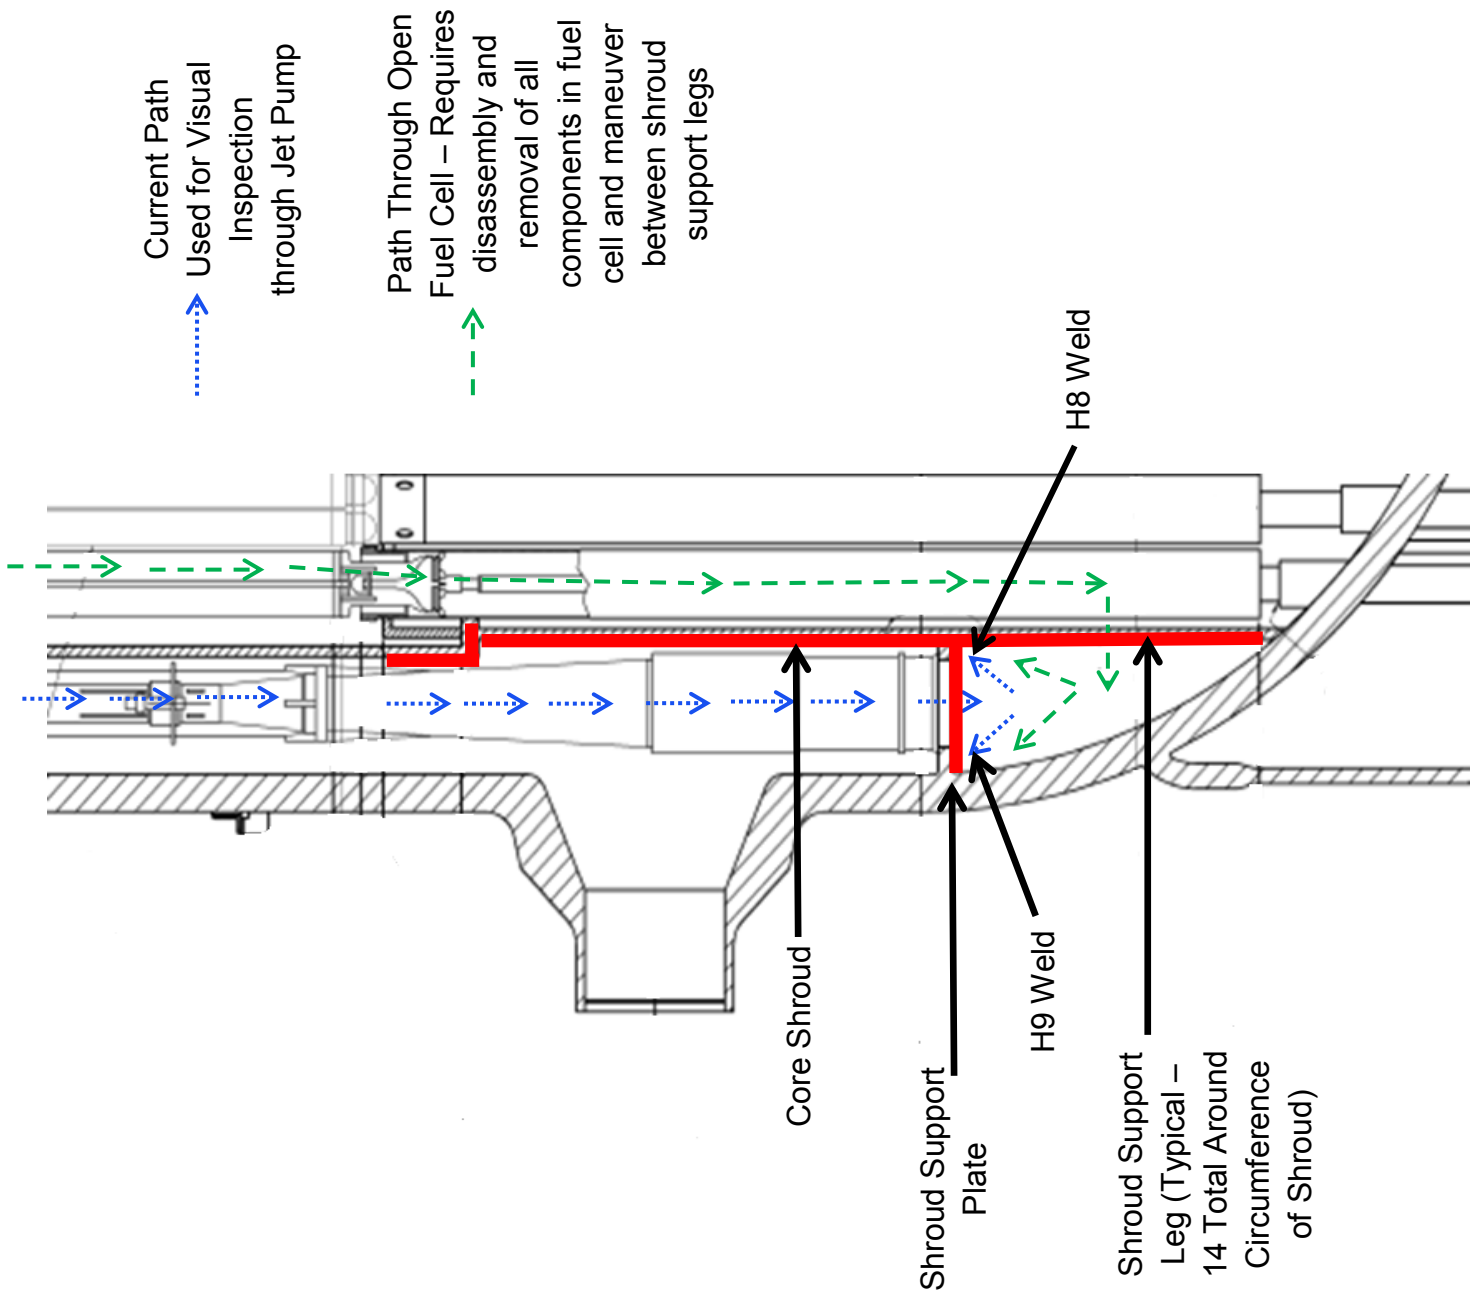
Attachment E – Tooling Insertion Paths

NSPM has successfully inspected MNGP shroud support components in the region below the shroud support plate, on a limited basis, by inserting camera heads and auxiliary lighting into the jet pump inlets, and down through the jet pump to the vessel lower plenum. With this method, which does not require disassembly of jet pump or fuel cell assemblies, the indications on the underside of the H8 and H9 welds were coincidentally discovered during the MNGP 2011 refueling outage while inspecting the H10 weld of the shroud support legs.
