## U.S. NUCLEAR REGULATORY COMMISSION

Report No. 030-16055/93002(DRSS)

Licensee: Advanced Medical Systems, Inc. (AMS) 1020 London Road Cleveland, OH 44110

#### Inspection Summary:

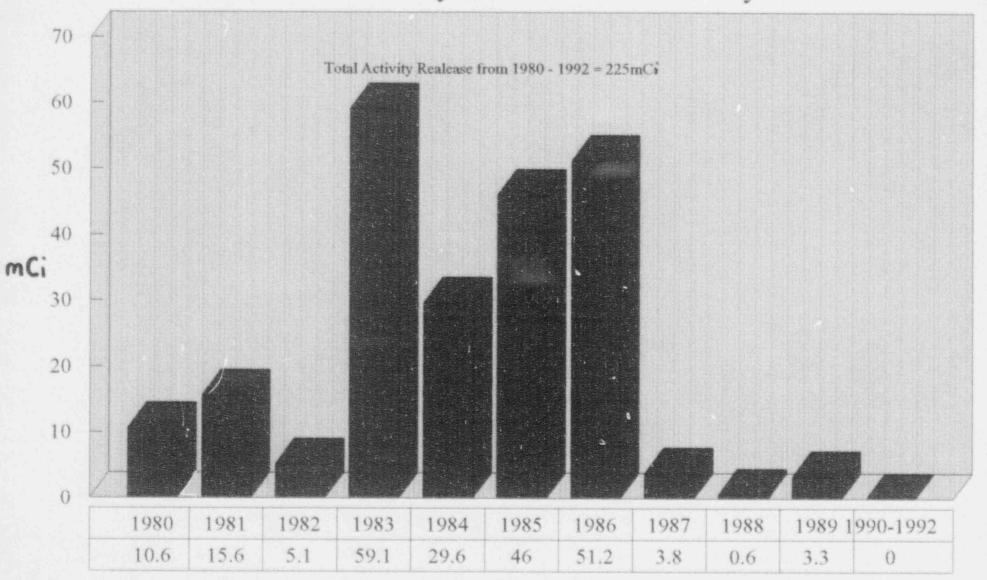
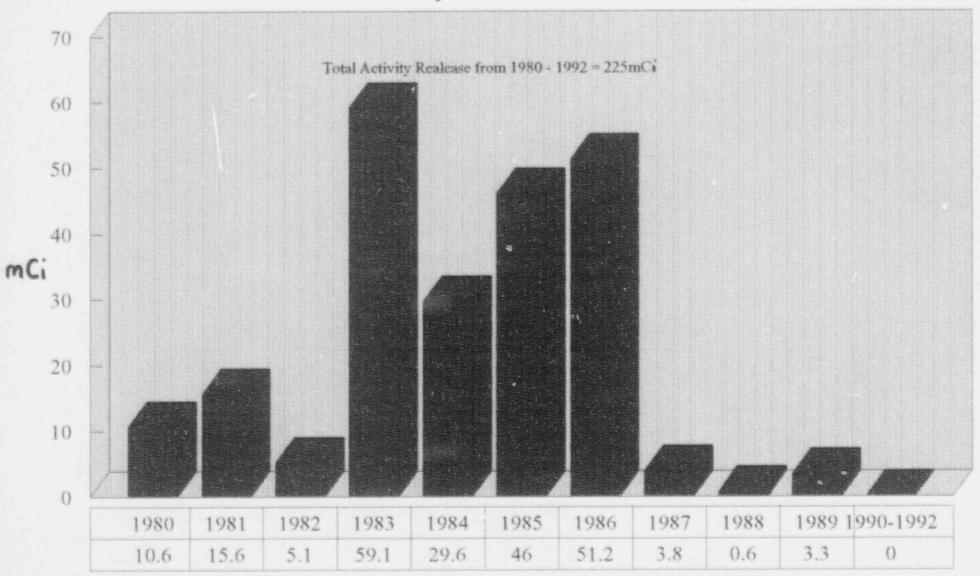
The inspectors reviewed batch tank analysis methods, resultant data and sewer disposal logs maintained by the licensee. Logs were available and reviewed for the period May 1980 to May 1989. Quarterly facility water usage information listed by the licensee for the period June 1981 to date was also reviewed and verified with water billing records, when available. The licensee's records showed that 121 batch tank releases were made to the sanitary sewer system, totaling 225 millicuries (mCi) of cobalt-60, from May 1980 through 1989. Specifically, ten batch tank releases were made to the sanitary sewer system in 1980, 5 in 1981, 4 in 1982, 37 in 1983, 8 each in 1984 and 1985, 20 in 1986, 12 in 1987, 16 in 1988 and one in 1989.

Additionally, records showed that the licensee released 3.2 mCi of cobalt-60 in a volume of about 5300 gallons of liquid to the sewer in May 1989, when a sewer backup flooded the basement of the licensee's facility. There is likely considerable uncertainty regarding the total quantity of licensed material released from the 1989 sewer backup, due to the problems in accurately calculating the volume involved and ensuring a representative sample was obtained for the analysis process. This issue will also be pursued further by the NRC. Records showed the May 1989 release to be the last discharge of liquid radwaste to the sanitary sewer system. Based on the licensee's records, the cumulative quantities of liquid effluent released to the sanitary sewer system in calendar years 1980-1989, satisfied 10 CFR 20.303 annual limits. However, based on the uncertainties and unresolved issues discussed above, the accuracy of the release data is uncertain and continues to be reviewed by the NRC. Annual release data obtained from licensee logs is graphically depicted in Figure I (attached).

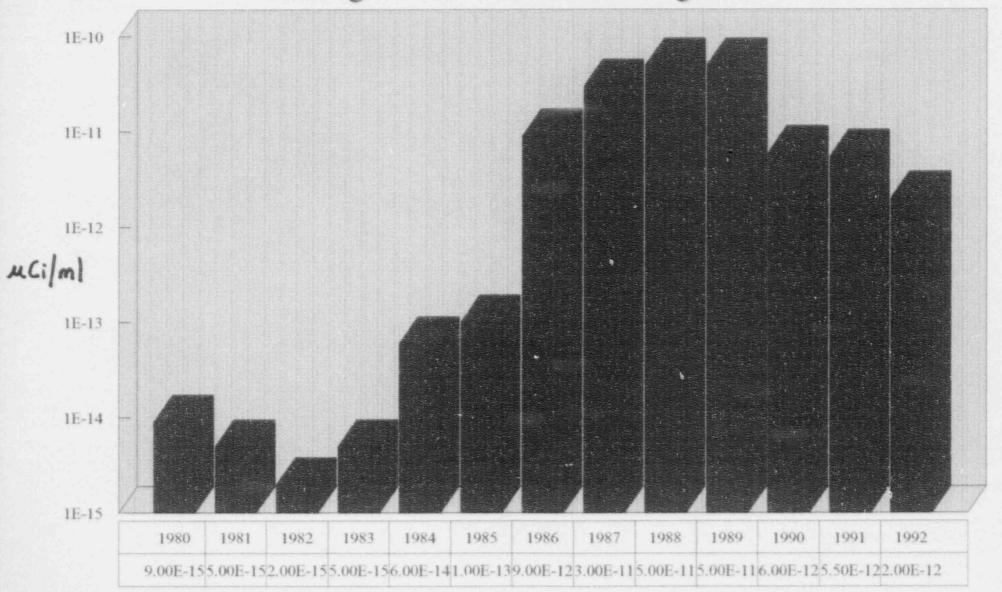
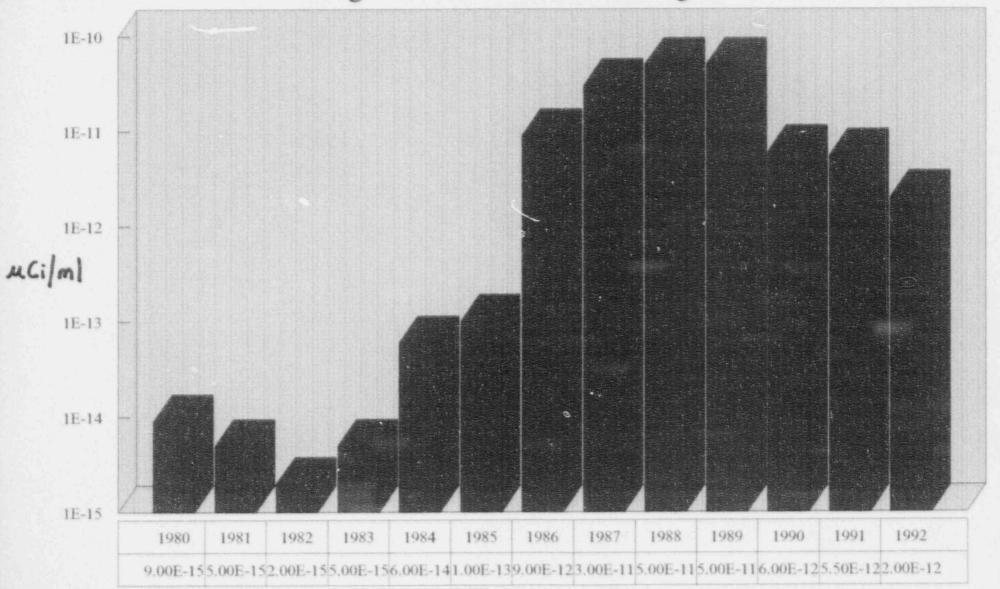
Licensee stack monitoring analysis records indicate that the average annual concentration of effluent released to the environment in calendar years 1980 - 1992 was less than applicable 10 CFR 20.106 limits. As reported in Inspection Report No. 030 -16055/90001(DRSS), short term effluent concentrations would occasionally exceed 20.106 limits; however, when averaged over the calendar year (as permitted in the regulations), discharges were at or less than 18% of applicable limits. Average annual effluent release data obtained from licenser records is graphically depicted in Figure II (attached).
