From: Bob Malley <BMalley@cdtechno.com>
Sent: Tuesday, February 11, 2020 5:07 PM
To: Hoc, HOO X
Cc: Vince Grieb; Kristen Jamison; Jon Anderson; Ken Sigman
Subject: [External_Sender] Part 21 Report - KCR-07
Attachments: KCR07 Part 21 Report 200211 CD Technologies.pdf

Subject: 10CFR Part 21 Evaluation Regarding Container Failure in KCR-07 Batteries

Ref: KCR-07 Container Crack

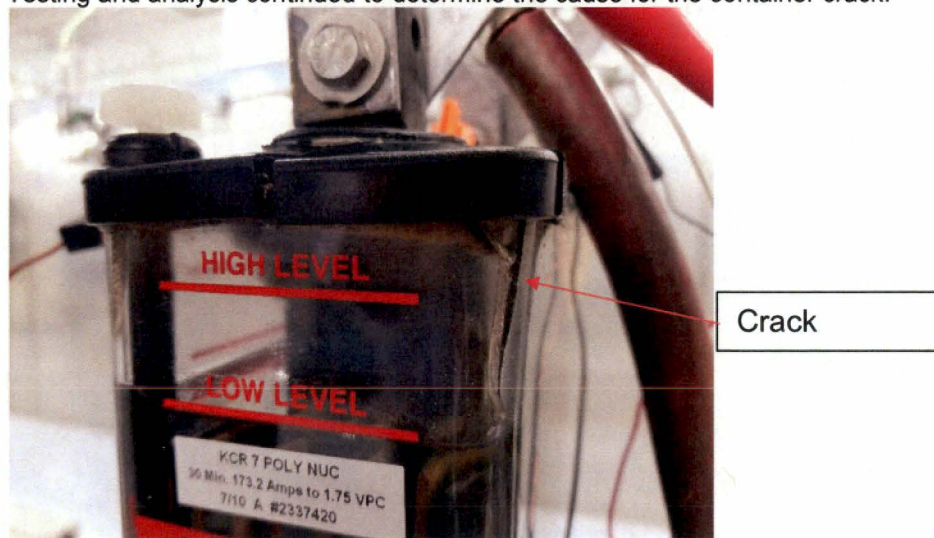
Figure 1

In December 2019, TVA-Browns Ferry notified C&D of a low electrolyte level in a Class1E KCR-07 battery caused by a crack in the upper corner of the container that extended below the low-level line. (Figure 1). The battery was manufactured in July 2010. C&D issued a Return Material Authorization to the customer, and the battery was returned and analyzed. Capacity testing was performed on receipt of the battery, and the battery ran over 100% capacity, despite the reduced electrolyte level. Testing and analysis continued to determine the cause for the container crack.

The cause for the container crack was determined to be direct outward stress placed on the container walls by radial corrosion and expansion of the positive post seals. The corrosion of the post seal is caused by acid infiltration into the post seal. Lead metal exposed to acid and the charging potential of the cell is converted to lead dioxide. This conversion expands the post seal radially, placing stress on adjacent plastic parts.

Recommendations: C&D recommends that operators of KCR-07 batteries perform inspection and replace KCR-07 products exhibiting container or cover cracking. As noted above, corrective actions were completed in 2011 for post seal corrosion, and new products should not exhibit this failure mode.

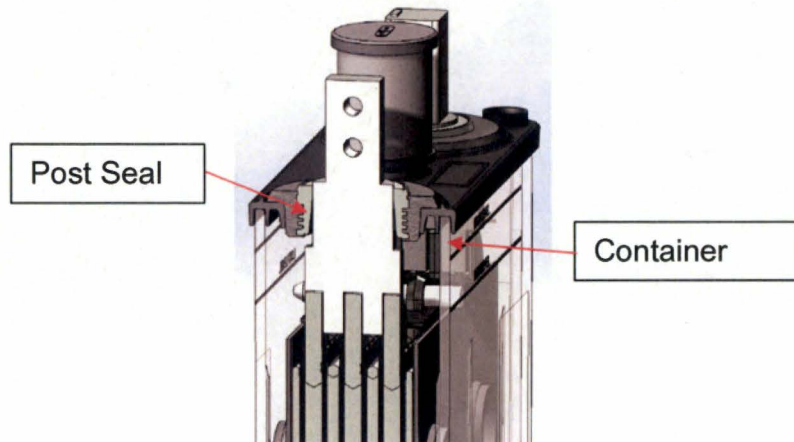
Figure 2

Engineering analysis indicates that the KCR-07 is more susceptible to container cracking due to the proximity of the internal jar wall in relation to the post seal. In the KCR-07 there is minimal space between the post bushing and the inner edge of the container (Figure 2).

There is insufficient space between the terminal seal and the container wall to relieve stress by failure of the cover material, and the stress is transmitted directly to the container wall. This results in the development of cracks in the upper corners of the container that grow down into the container as the post seal continues to expand exerting outward force on the internal container wall.

Corrective Actions: As noted above, C&D implemented corrective actions for the root causes of post seal corrosion and cover cracking in 2011, which were fully implemented by January 2012. Further information on these actions is available on request.
