COMMONWEALTH EDISON COMPANY

QUAD-CITIES STATION

REACTOR WATER CLEAN-UP SYSTEM

TEMPORARY REPAIR OF

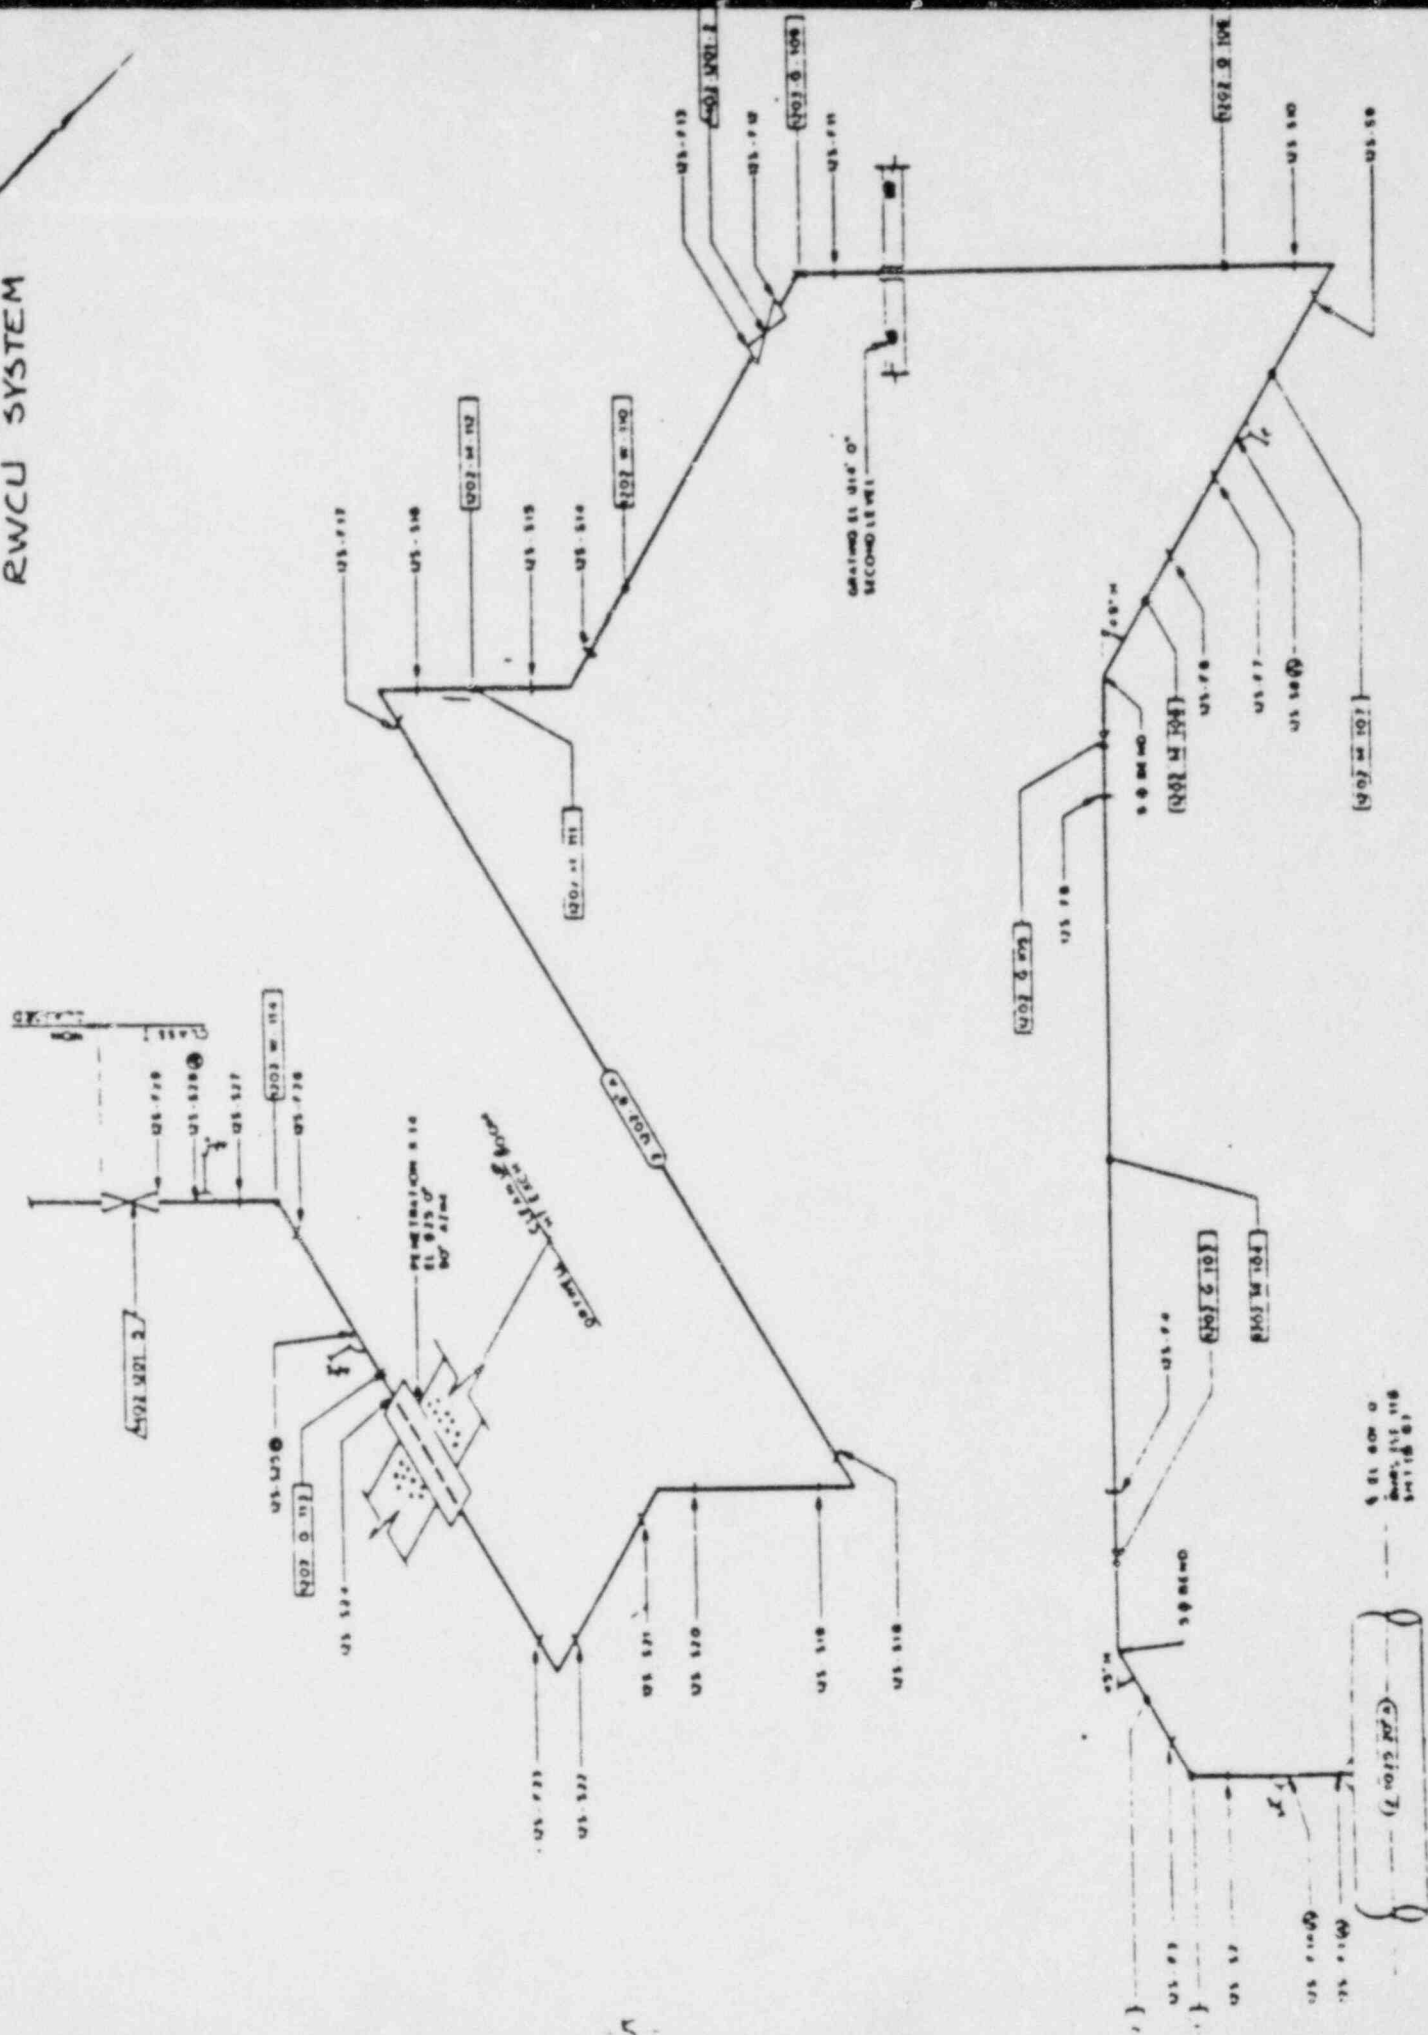
QUAD CITIES UNIT 2  
RWCU SYSTEM

Subsequent to the discovery of a leaking crack on the pipe side of weld joint S-14, a UT inspection program was initiated to examine two adjacent welds, S-15 and S-16 (see isometric drawing on page 5). As a result of discovering linear indication on these two welds, the program was expanded to inspect all butt welds in the RWCU line up to the outboard isolation valve.

1. Eight out of eleven butt welds downstream of the inboard isolation valve (isolable) had UT reflectors indicative of cracks.
2. None of the four welds outside the containment had any unacceptable indications.
3. Four out of ten butt welds upstream from the inboard isolation valve showed UT indications.
4. All axial cracks were found on the elbow side of the welds.
5. All circumferential cracks were found in the Heat Affected Zone (HAZ) of the pipe.

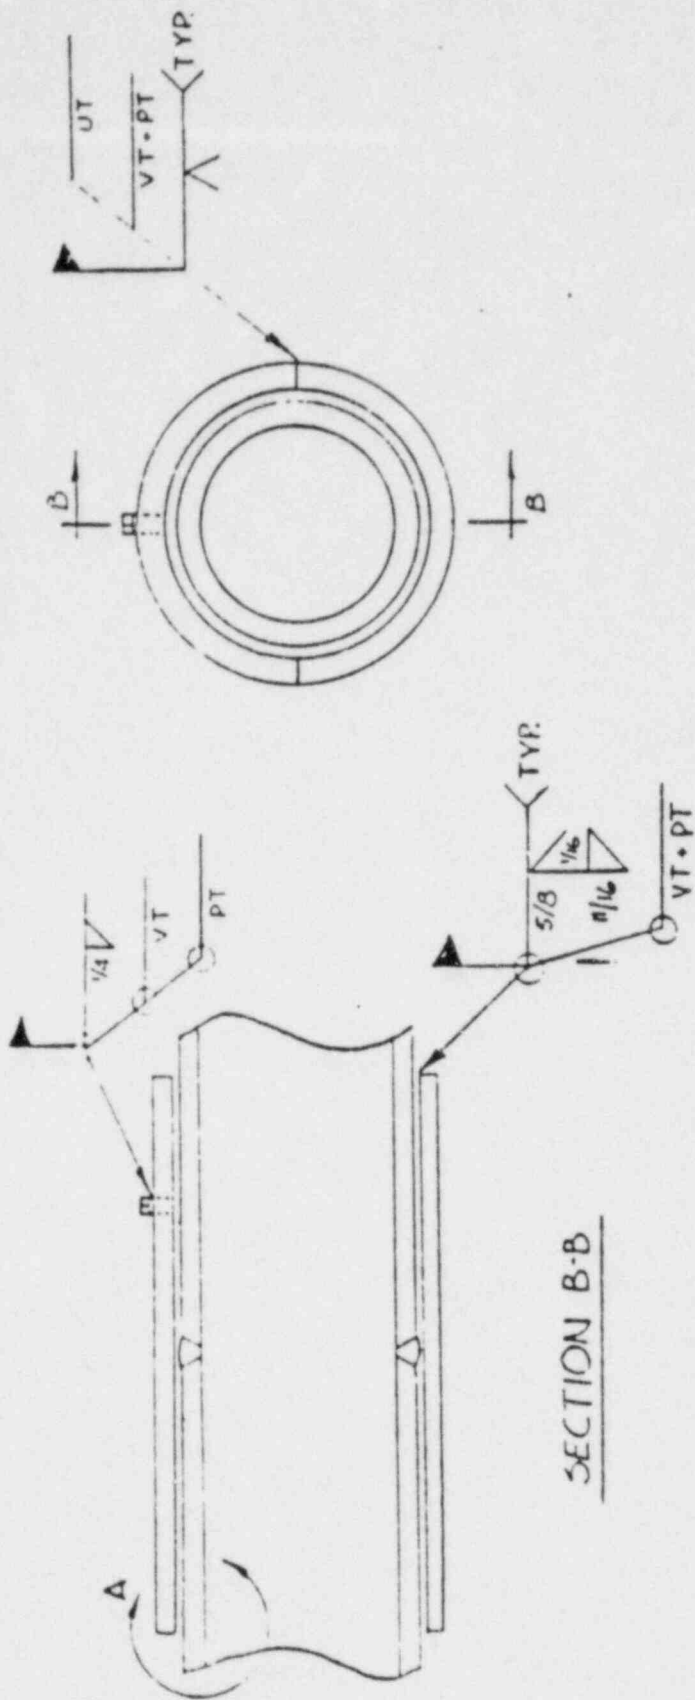
FIGURE 1A

The circumferential flaw repair (Figures 1A, 1B, and 1C) uses a low carbon stainless steel sleeve around the flawed weld extending approximately six inches on either side. The sleeve is machined from wrought material; and is split and welded around the pipe using full penetration welds. The sleeve ends are welded to the pipe using partial penetration welds with

cover fillets. The sleeve allows space for the existing weld crown. An 1/8 inch hole is drilled in the 6 inch pipe through a 1/4 inch threaded hole in the sleeve. This hole provides an unobstructed pathway to the annulus from the inside of the pipe to prevent excessive pressure buildup in the annulus due to a postulated flow path through the pipe crack. A threaded 1/4 inch plug is seal welded into the sleeve. The plug is shown in Figure 1D.

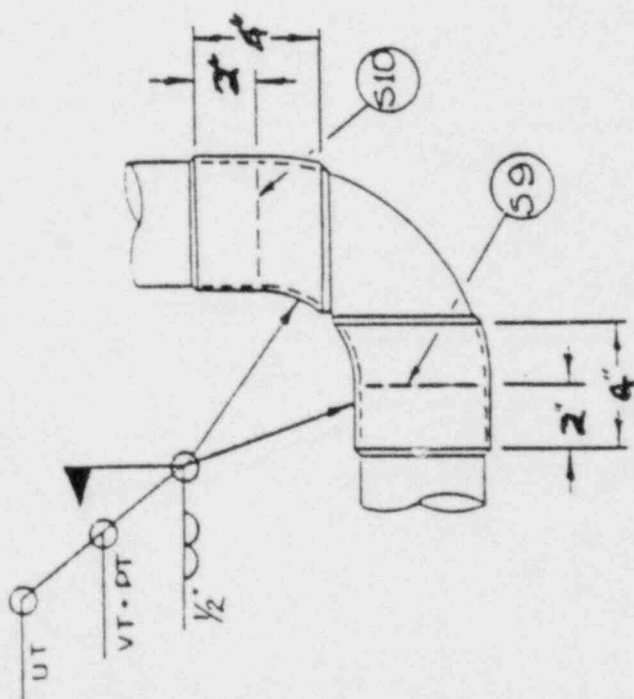
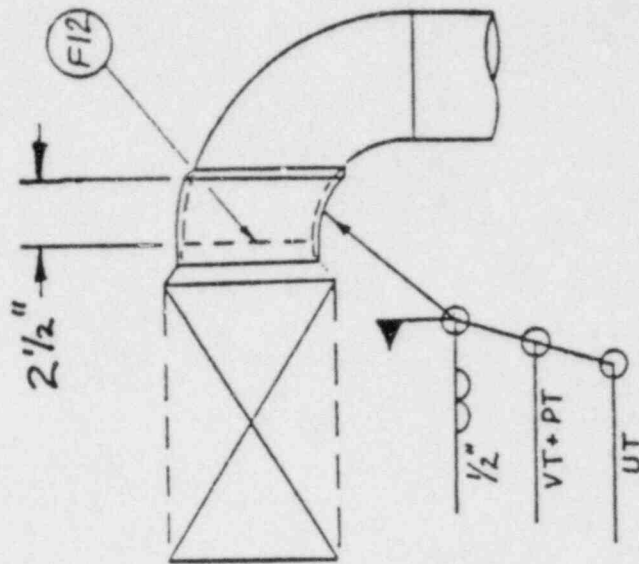
FIGURE 2

The axial flaw repair (Figure 2) establishes a "cast - in place" pipe sleeve from weld metal. In addition to the favorable compressive residual stress pattern, the Type 308L weld metal is resistant to propagation of the IGSCC crack.

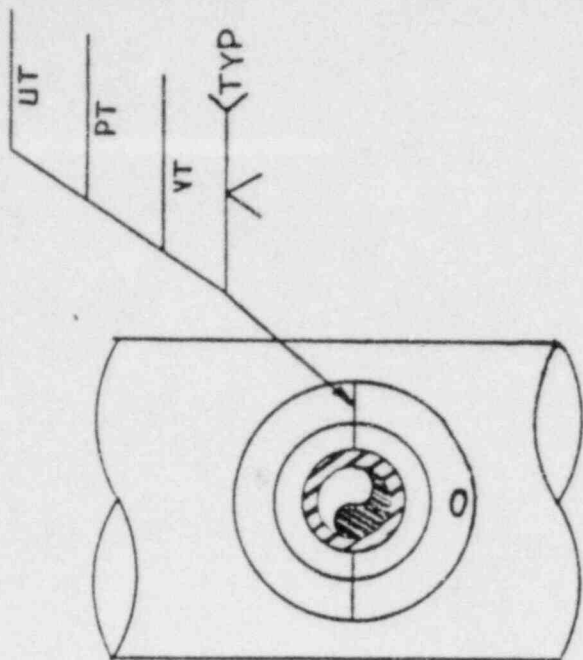
FIGURE 3A

A cone-shaped sleeve is provided around the sock-o-let connecting the two-inch drain line to the six-inch RWCU line. This repair is shown in Figure 3A and 3B. A 1/4 inch threaded hole is provided in the sleeve. It was originally intended to drill an 1/8 inch hole through the 1/4 inch hole into the two inch line, but this was not done due to the extreme likelihood that no crack existed in the first place. A 1/4 inch plug had been machined, and it is located in the QA storage area in the storeroom for future use, if necessary.

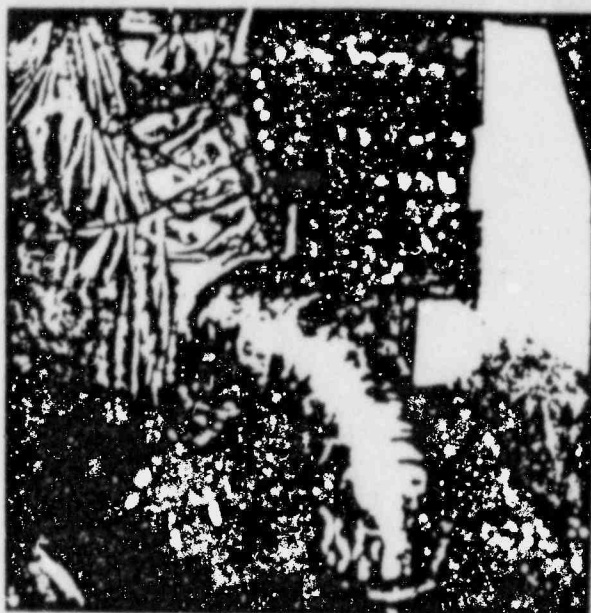
U-2 CLEANUP PIPE REPAIR  
FEB., 1982  
LINE 2-1202-6-A, WELD 125-F12

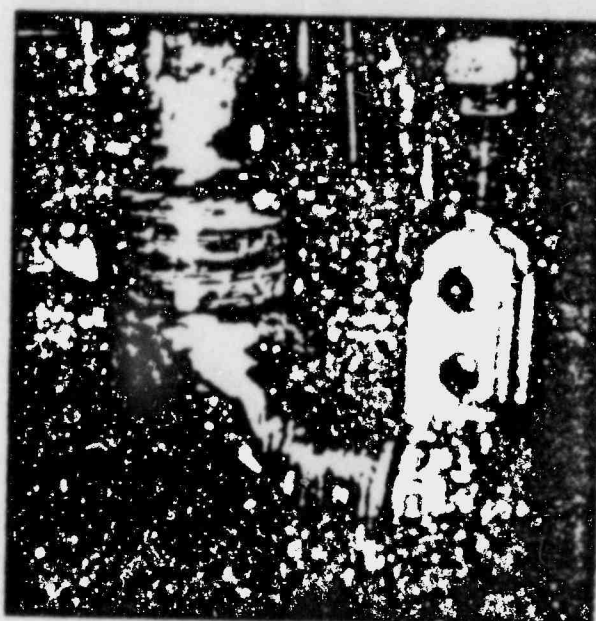
U-2 CLEANUP PIPE REPAIR  
FEB., 1982  
LINE 2-1202-6-A, WELDS 125-39-S10

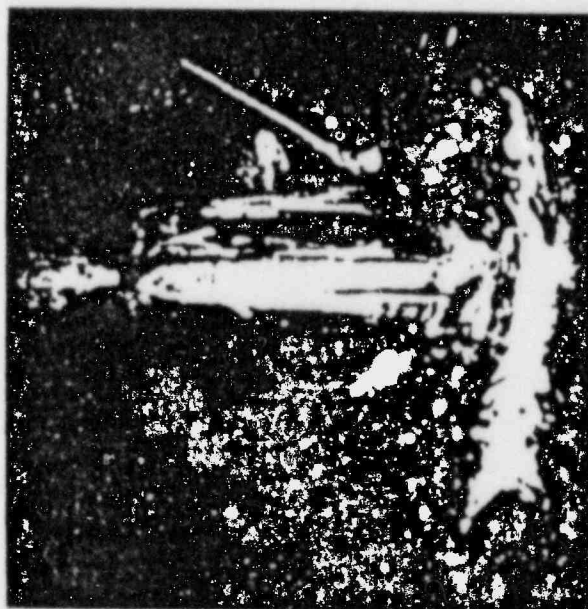
2" LINE 1265  
SPRING OFF OF  
RWCU LINE 1206-6

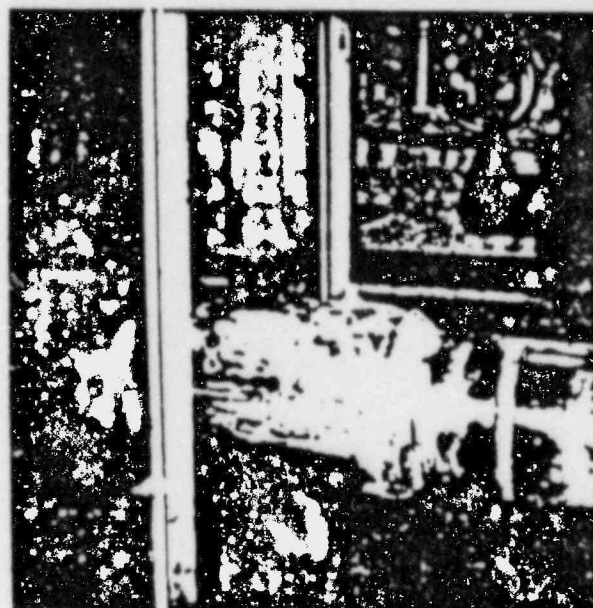
U-2 CLEANUP PIPE REPAIR  
FEB., 1982  
LINE 2-1202-6-A, WELD 125-F6

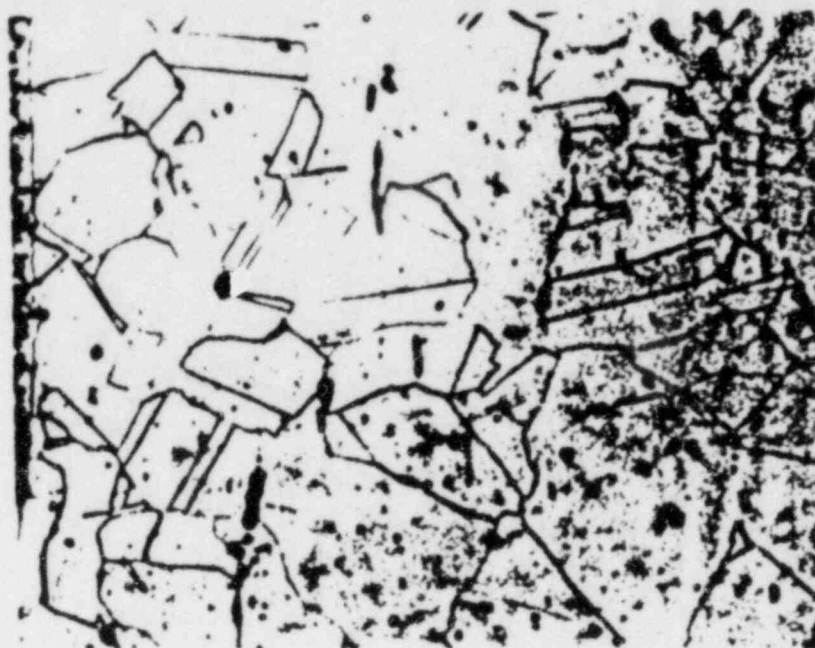
(200x) Figure 2 10% oxalic electrolytically  
Photomicrograph taken adjacent to the fusion line on the pipe side of the spool  
piece. No evidence of sensitization can be seen (stepped structure).

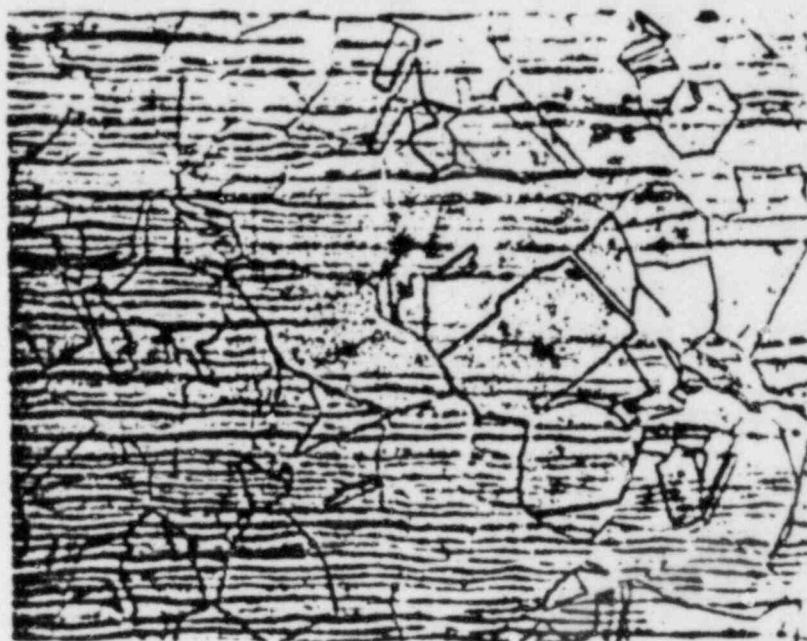
1200x1      Figure 4      10% oxalic electrolytically  
Photomicrograph taken of material unaffected by the heat input from welding.  
The structure can be classified as stepped (unsensitized).
