HISTORY OF VERMONT YANKEE
FEEDWATER SPARGER
MODIFICATIONS AND FUTURE
PLANS

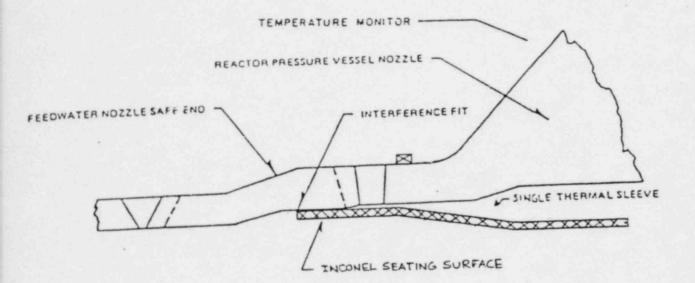
## VERMONT YANKEE FEEDWATER SPARGER THERMAL SLEEVE

- LIQUID PENETRANT INSPECTION OF NOZZLES REVEALED CLAD CRACKS

AT BLEND RADIUS PRIMARILY AT THE 1800 (BOTTOM) LOCATION AFTER

FOUR (4) YEARS OPERATION
- NO BORE CRACKS
- MAXIMUM DEPTH AT ANY GRINDOUT = .3125" TOTAL DEPTH AT 1750 LOCATION
- SHALLOWEST DEPTH OF ANY BWR WHICH EMPLOYED A LOOSE FIT SPARGER
- CRACKS GROUND OUT
- NEW INTERFERENCE FIT FEEDWATER SPARGERS INSTALLED ALONG WITH JUNCTION BOX TEE
- INTERFERENCE FIT THERMAL SLEEVE SEATING SURFACE IS INCONEL WITH A .010" .013" INTERFERENCE
- STAINLESS STEEL CLADDING WAS NOT REMOVED
- STARTUP OPERATING PROCEDURES MODIFIED TO REDUCE FEEDWATER
  FLOW CYCLING AND MINIMIZE OPERATING TIME AT LOW FEEDWATER
  TEMPERATURES

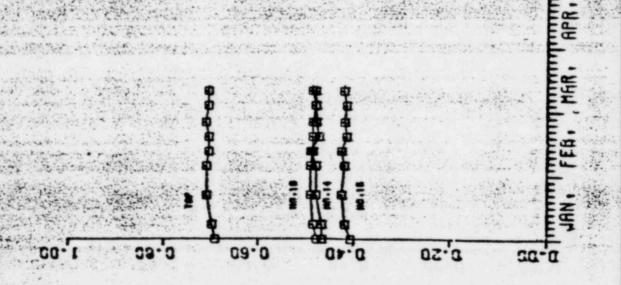
FEEDWATER NOZZLE TEMPERATURES

NORMLZD. TIC READINGS
