This report contains the results of a special inspection concerning a circumferential thru-wall rupture near the weld prep section of valve MUV-43 in the makeup line of A-1 loop. Preliminary reports attribute the failure to thermally induced cyclic fatigue. The affected valve and related piping has been replaced. Similar areas in the three (3) high pressure injection (HPI) lines have been inspected and no distress/degradation was observed. The thermal characteristics of all the HPI nozzles are being reanalyzed by B&W.

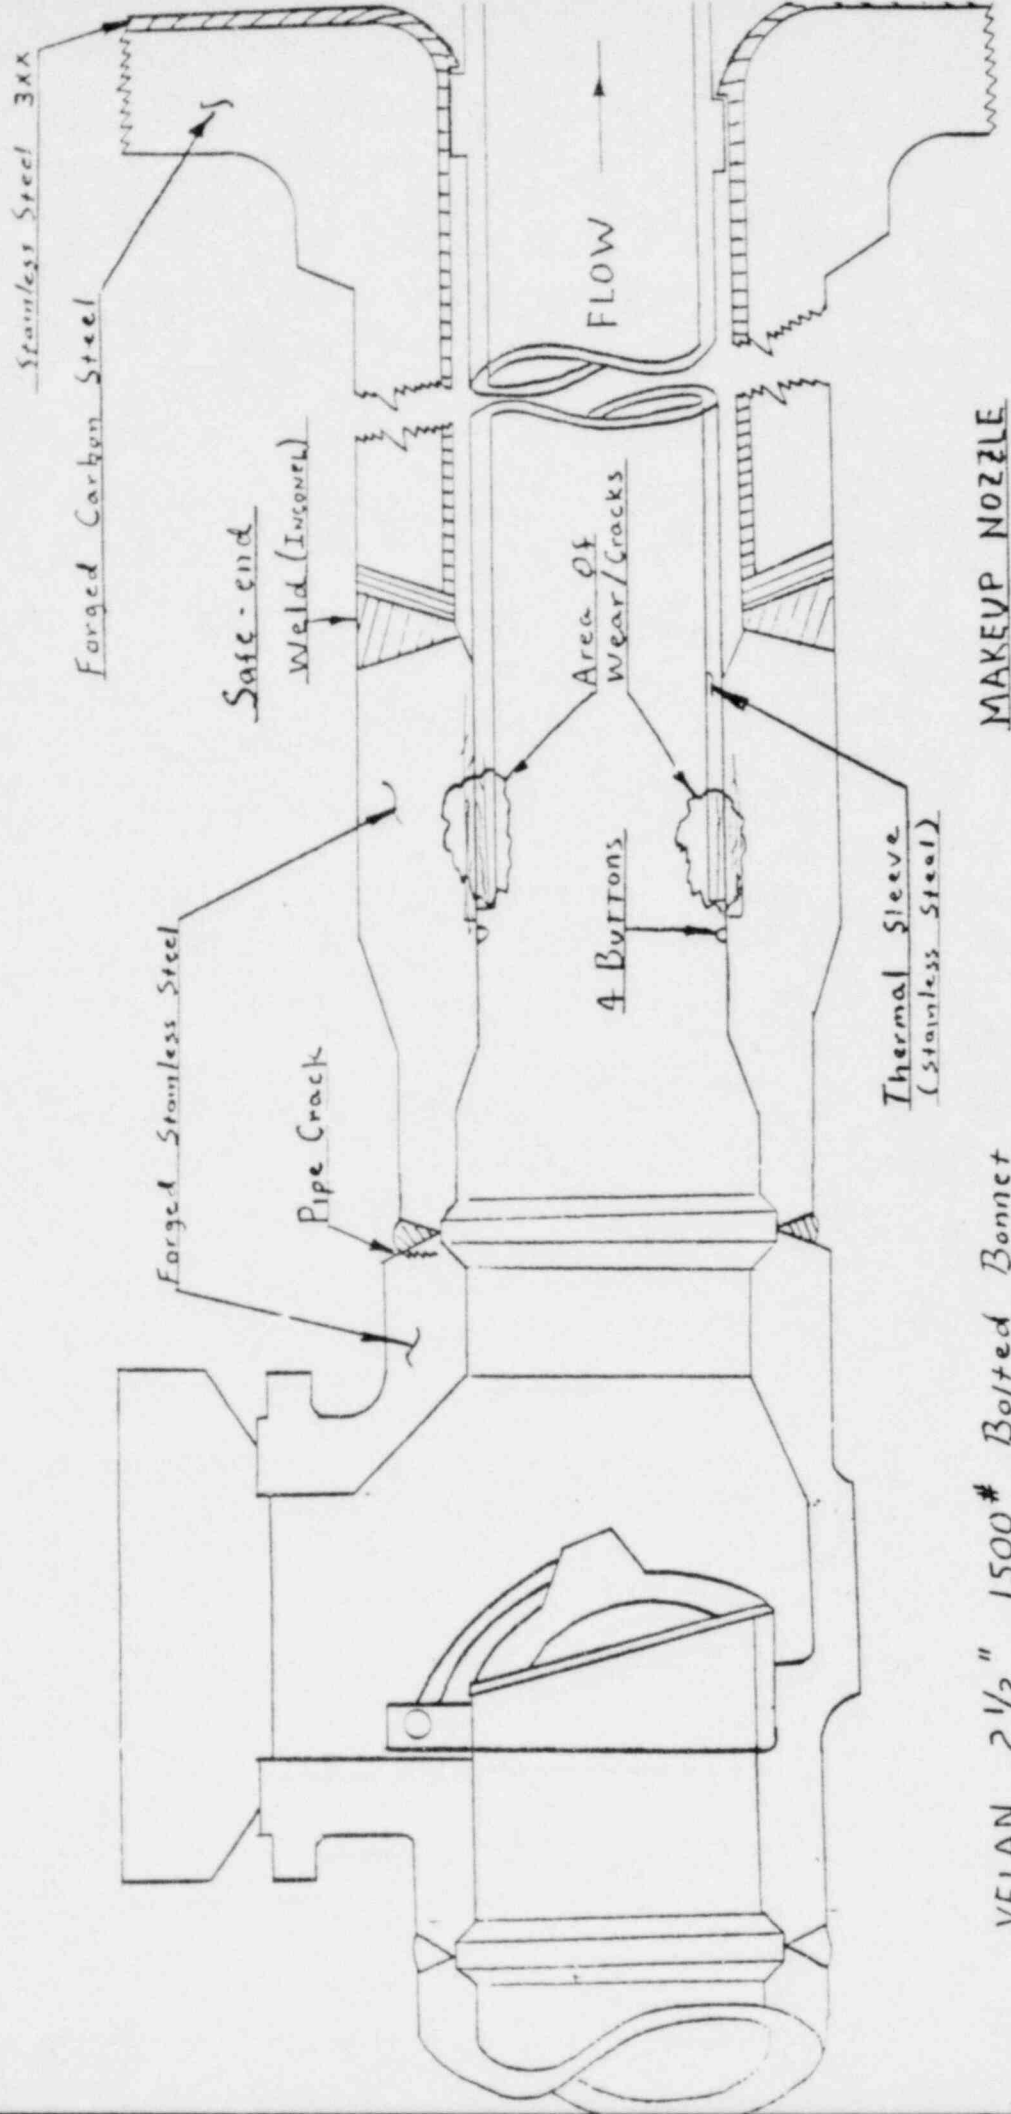
Figure 1.

On February 2, 1982 the inspector arrived on-site to investigate a nonisolatable pressure boundary leak related to the check valve next to the HPI nozzle on the cold leg of RC Loop A. The valve is used for normal makeup and was identified as MUV-43. Discussions with the licensee representative disclosed the crack was located on the downstream side of the valve at or near the fusion line of the safe-end to valve weld (see figure 1). The crack extended over 180° of the circumference.

Schematic showing position of safe-end and thermal sleeve relative to cracked weld. Crack ran 180° from top center to 6 o'clock.

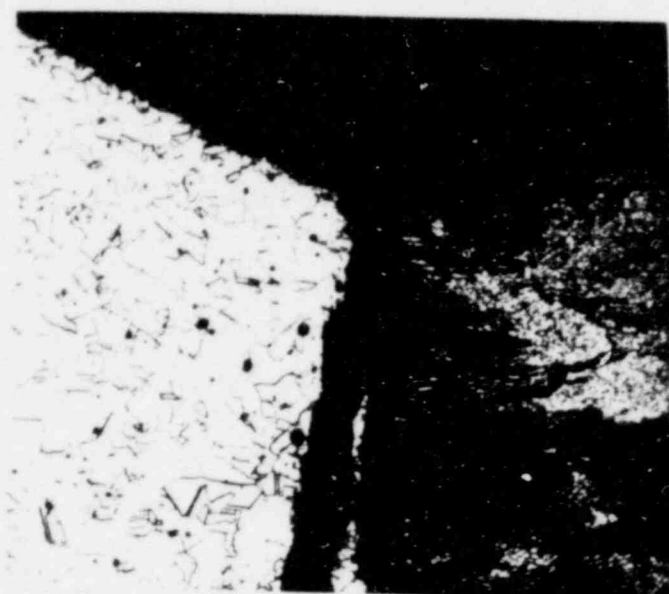
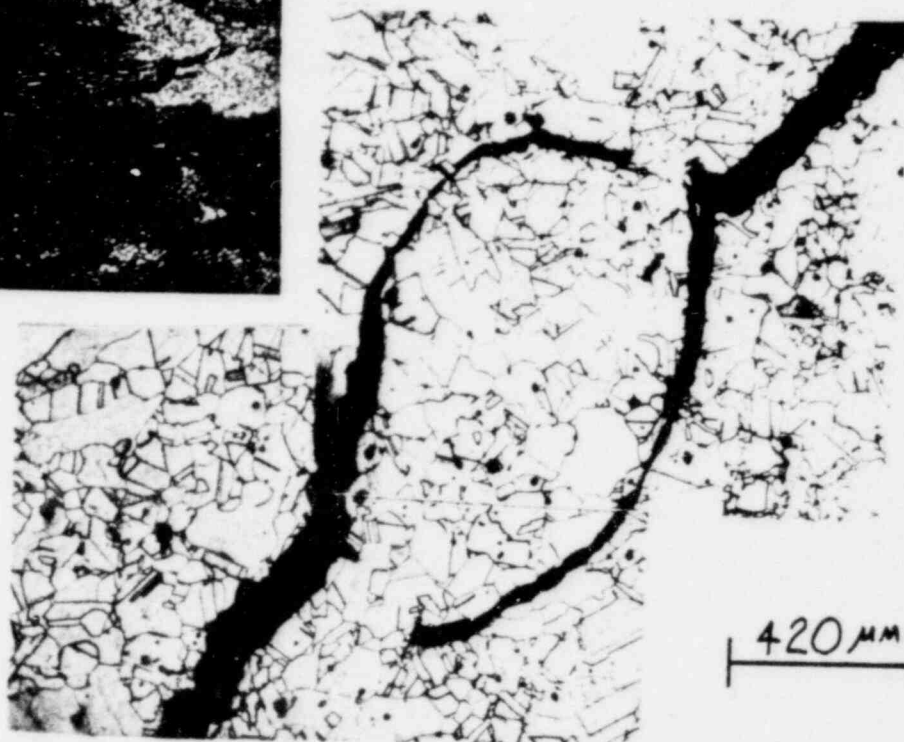
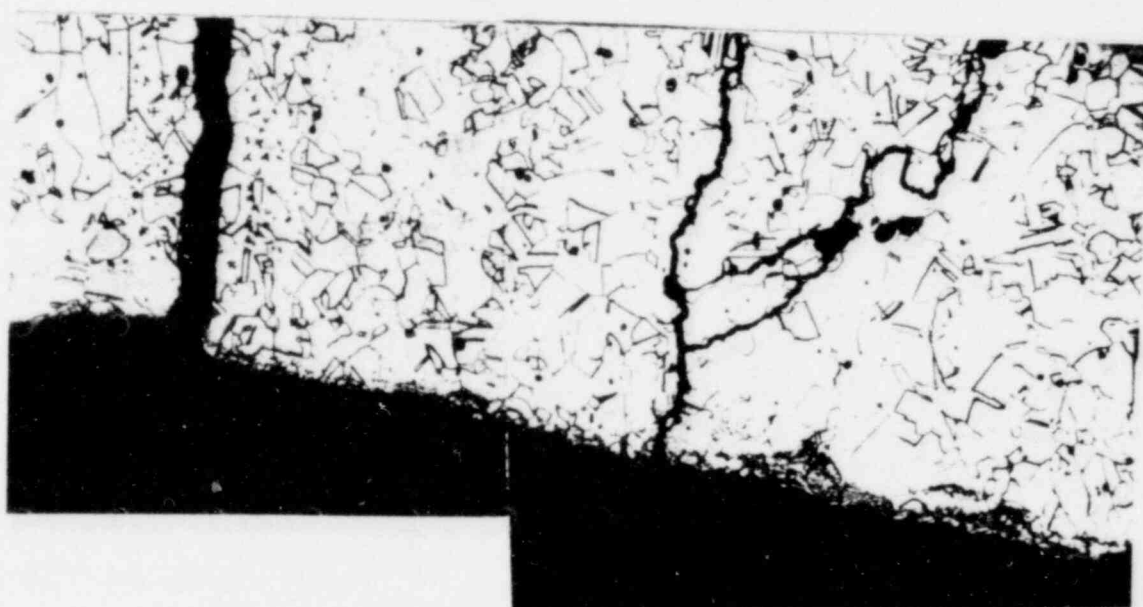
FIGURE 2 PHOTOMICROGRAPHS OF IMPORTANT FEATURES OF THE OD TO ID CIRCUMFERENTIAL CRACK

point of initiation was a machine tool mark inside the valve body near the weld prep area and the other on the OD at/or near the fusion line in the toe of the weld, see Figure 2. The OD crack propagated towards the center of the valve wall and away from the center of the weld at an angular direction of about 45° but at a slightly different plane direction from the ID crack. Both linked-up somewhere at midpoint which produced the thru wall crack, see Figure 3. The mode of failure was identified as thermal cycle fatigue. There were numerous longitudinal cracks on the inside surfaces of the valve and in the weld which were not associated with any specific stress risers. Most of these cracks had the appearance of "heat checks" and propagated to approximately 20-25% of wall thickness, see Figure 6. Propagation of both ID and OD cracks in the valve body probably occurred by combined mechanical and thermal loading of the system. Scanning Electron Microscope (SEM) fractography showed the presence of river markings and crack arrest markings (striations), characteristic of fatigue, at the root of both the OD and ID circumferential cracks, see Figure 4. Thumbnail markings were reported seen on the OD crack. Metallography showed that the cracks were transgranular with very little branching which further supports the fatigue mechanism. There was no evidence of chemical attack on the valve body or safe-end.

Note: This figure shows (a) that the OD crack initiated at the discontinuity between the check valve and the safe end-to-check valve weld, (b) that the cracks appear to move away from each other, and (c) that the ID crack initiated at a discontinuity formed by a machine tool. The crack is transgranular

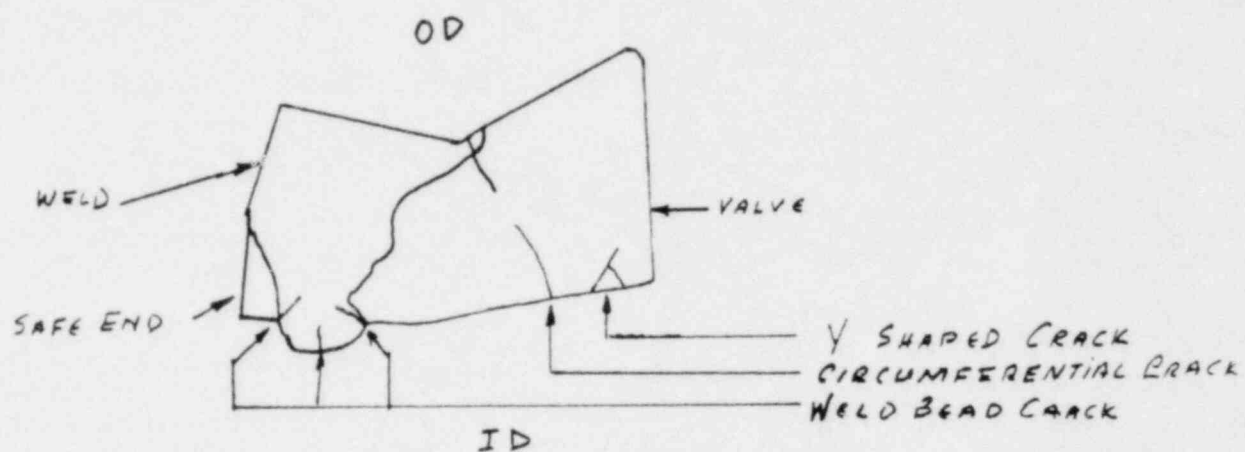
Figure 3.  
Schematic depicting approximate location  
on direction of trough wall crack.

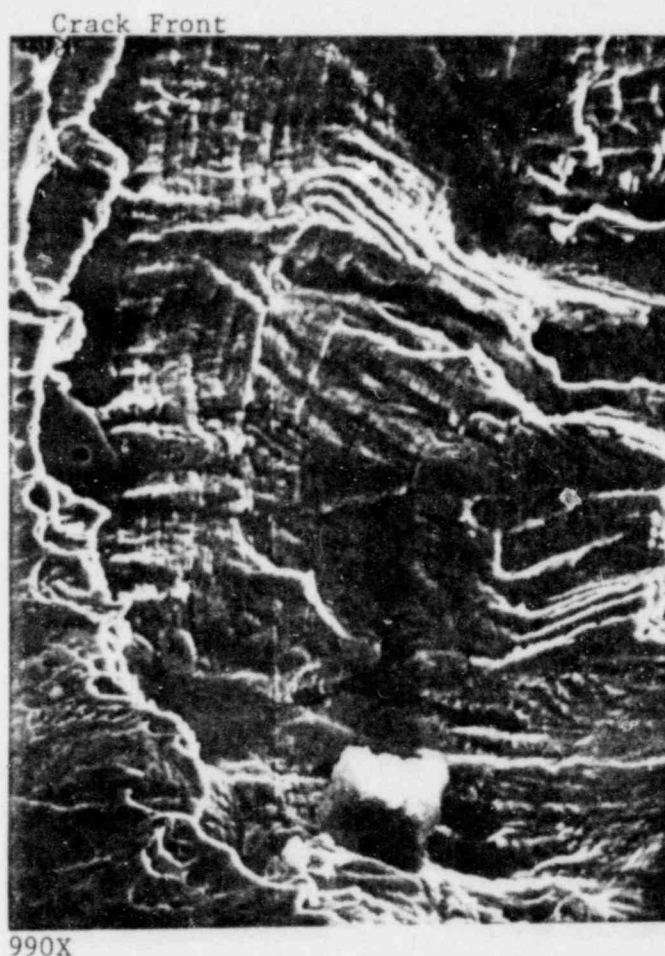
FIGURE 4 . SEM PHOTOGRAPH OF THE ID CIRCUMFERENTIAL  
CRACK FRONT

Note: This photograph shows the river  
markings and crack arrest markings which  
are evidence of fatigue.

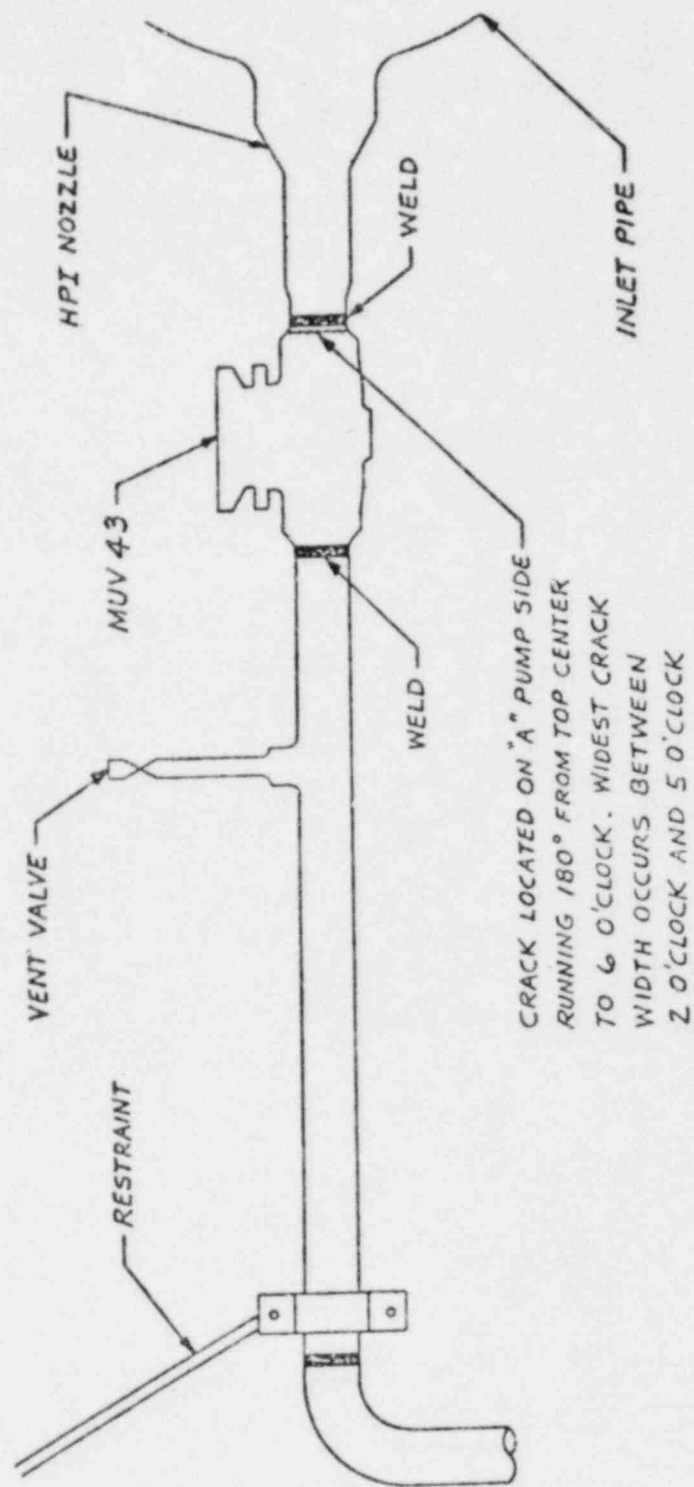
The as built configuration of the makeup pipe line segment that failed had the check valve (MUV-43) attached on one side to the HPI nozzle safe-end and to the 2½" diameter pipe on the other side. The line segment was essentially in a horizontal position. See Figure 5. A review of design drawings as conducted by the licensee and B&W disclosed that original design assumptions included a pipe extension piece between the valve and the HPI nozzle safe-end which was missing from this and the other three HPI lines. This matter will be discussed later in this report.

Figure 5. Schematic of HPI Hardware Relative to Crack Location

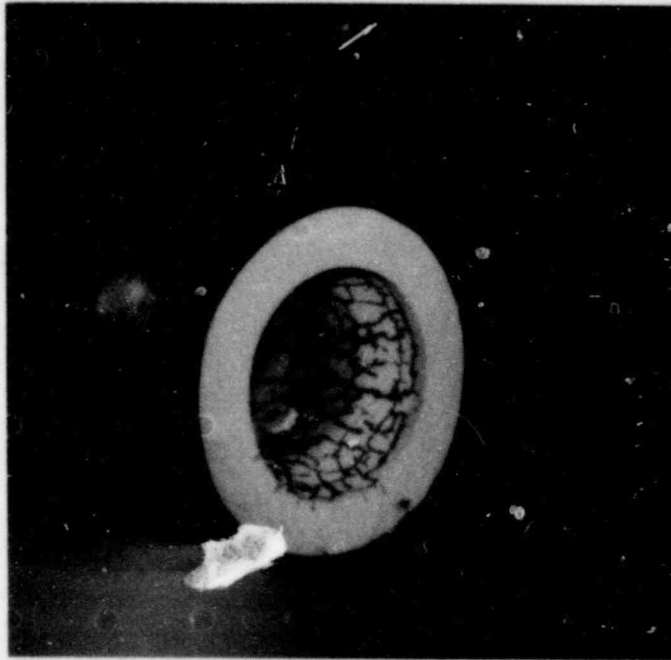
Figure 6 .  
Photograph of HPI/makeup nozzle safe-end depicting  
network of thermal fatigue crack indications as  
they appeared after liquid penetrant examination.

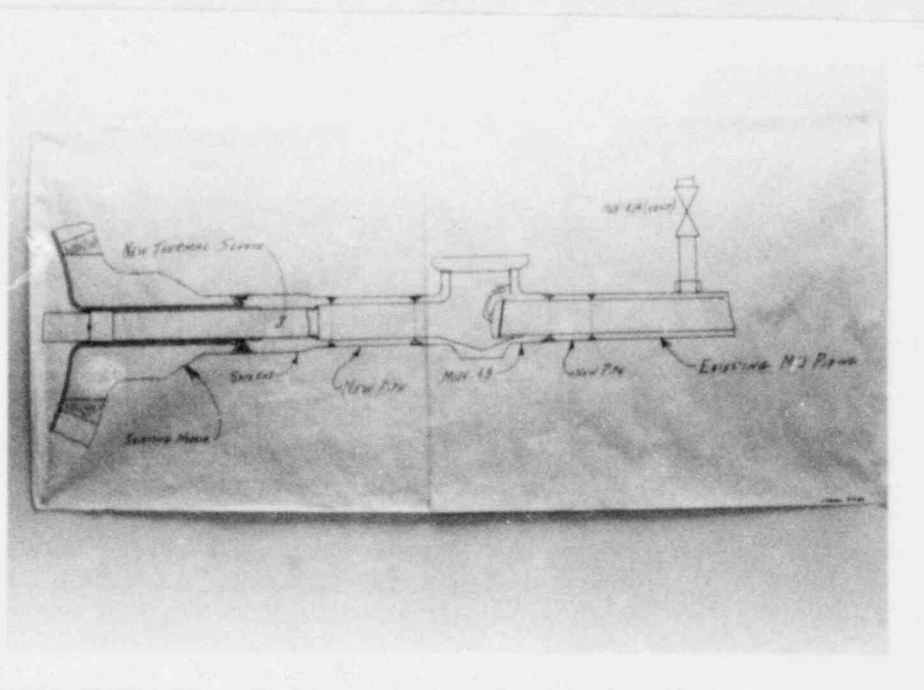
Figure 7  
Photograph depicting new pipe configuration  
which conforms with design stress  
calculations.

The new configuration included the pipe extension in accordance with design calculations. The new configuration appears as shown in Figure 7. Also the licensee disclosed that the upstream end of the new thermal sleeve will be hard rolled to fit the contour inside the safe-end and contact rolled on the downstream end inside the nozzle above the restraining button welds as shown in Figure 7. At the time of this inspection, repair activity had progressed to the extent where a short piece of pipe had been welded on each end of the replacement valve. The welds were radiographed and subsequently ultrasonically examined to satisfy applicable code (B31.7/ASME XI) requirements.
