TOLEDO EDISON COMPANY  
DAVIS-BESSE NUCLEAR POWER STATION UNIT ONE  
SUPPLEMENTAL INFORMATION FOR LER NP-32-82-03

DATE OF EVENT: April 19, 1982

FACILITY: Davis-Besse Unit 1

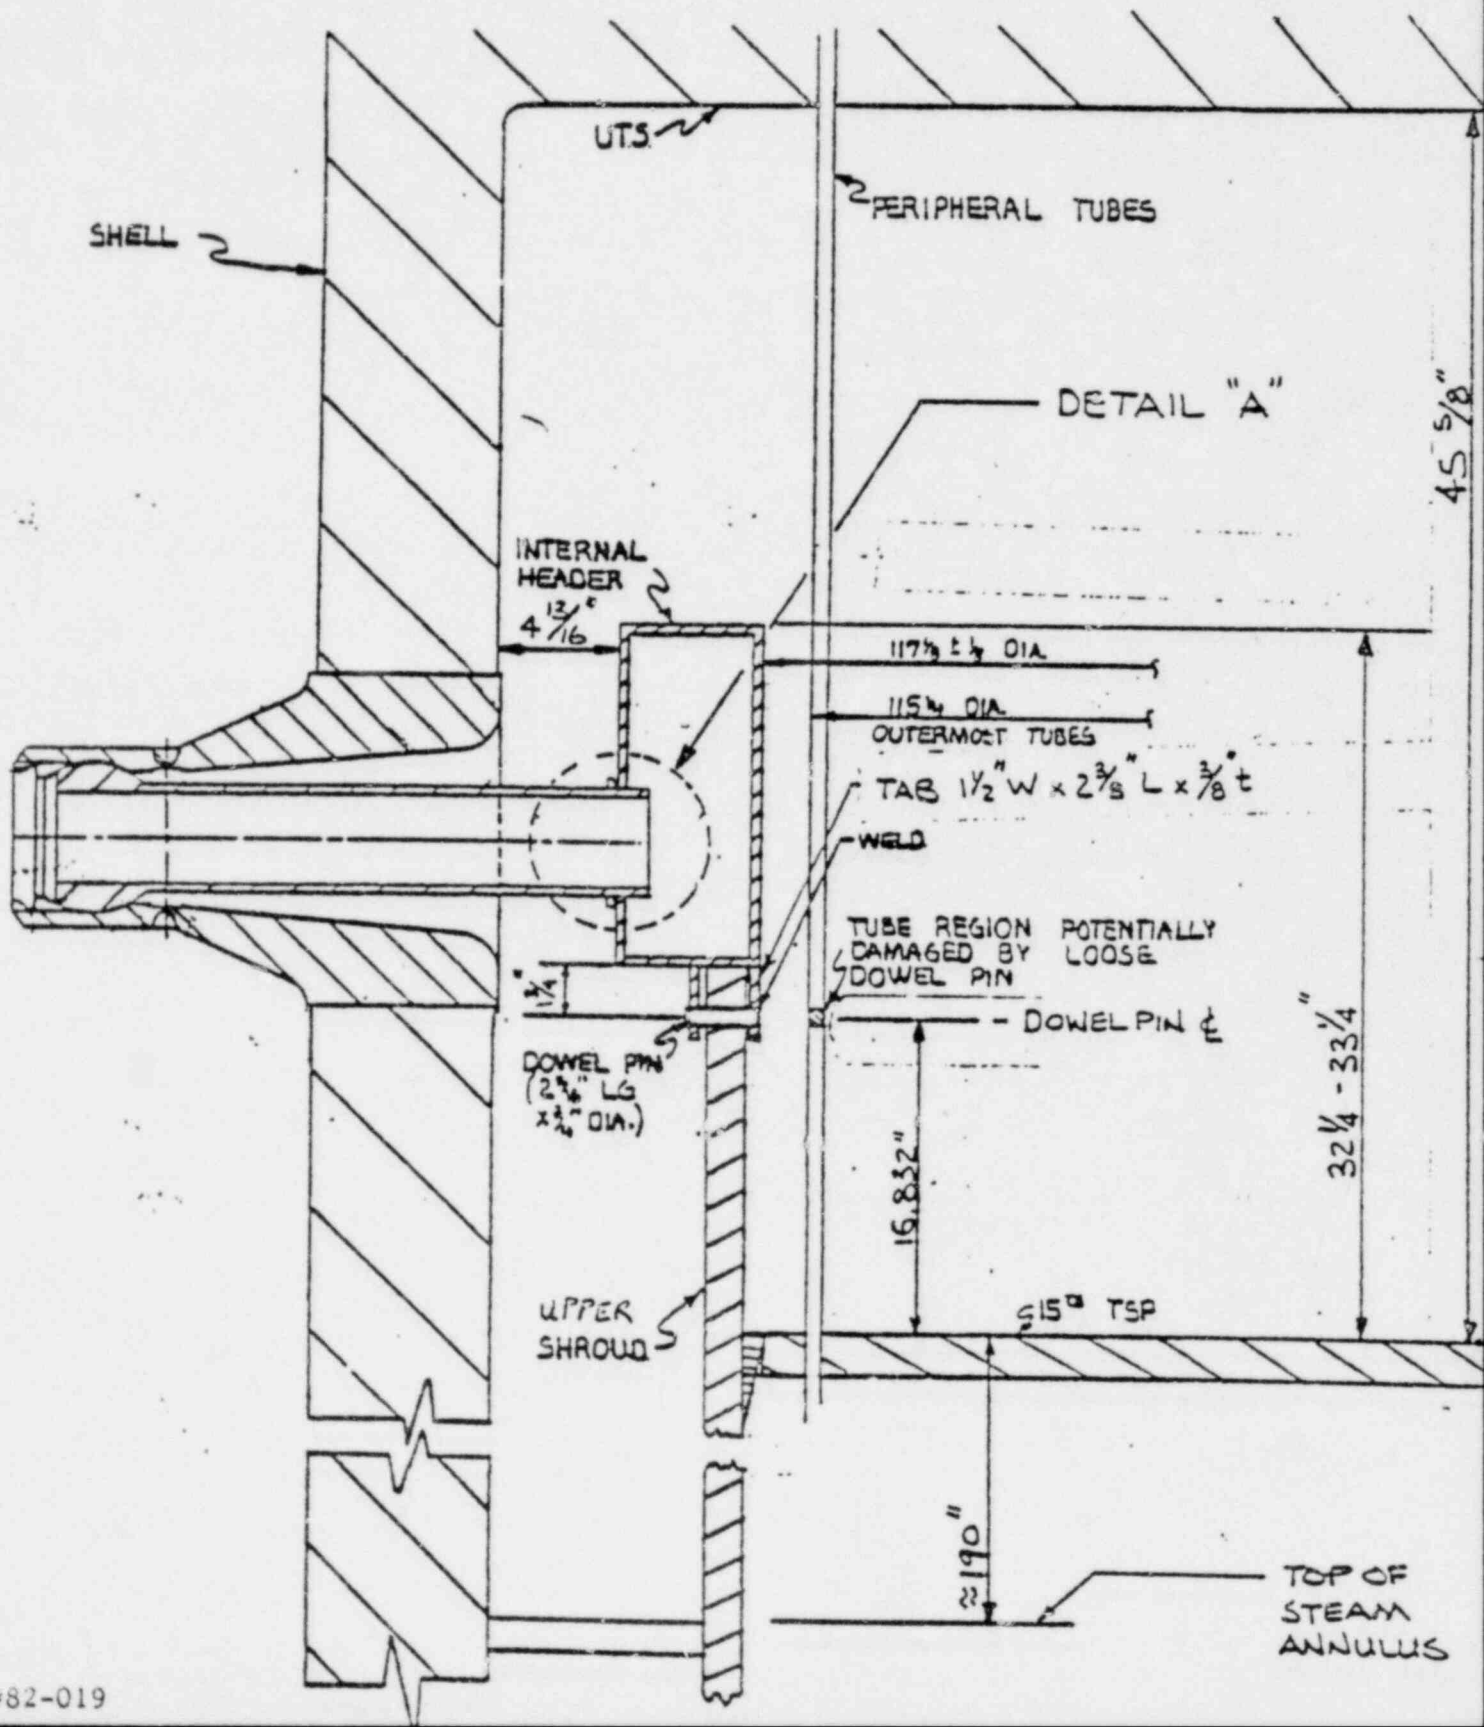
LONGITUDINAL SECTION AT DOWEL PIN

- (4) The outboard wall of the header is distorted inward (concave) as much as  $4\frac{1}{2}$ ".
- (5) Certain header support brackets are bent, and on some the bottom ligaments are torn out or have broken off.

- (6) Dowel pins are missing at six of eight locations inspected. Three dowel pins and two brackets have been retrieved from the steam annulus area in 1-2 SG.

- (7) There is evidence of wear on dowel pins and brackets.
- (8) The auxiliary feedwater nozzle thermal sleeve was not in alignment with the header on Unit #1 (1-1 SG).

To stabilize the internal header, eight holes will be drilled through the steam generator shell and shroud near each dowel pin and bracket location. Those dowel pins and brackets which are not or cannot be securely fastened to the header or the shroud will be removed. If any additional dowel pins or internal brackets are found to be missing they will be located and retrieved. The header will then be centered on the shroud and the assembly will be securely fastened to the shroud. Although the exact method by which the header will be attached to the shroud has not yet been identified, several methods are being considered. The concept of header stabilization is still under review. The seismic and accident loads to which the header may be subjected are currently being evaluated to ensure that the header will remain in place.

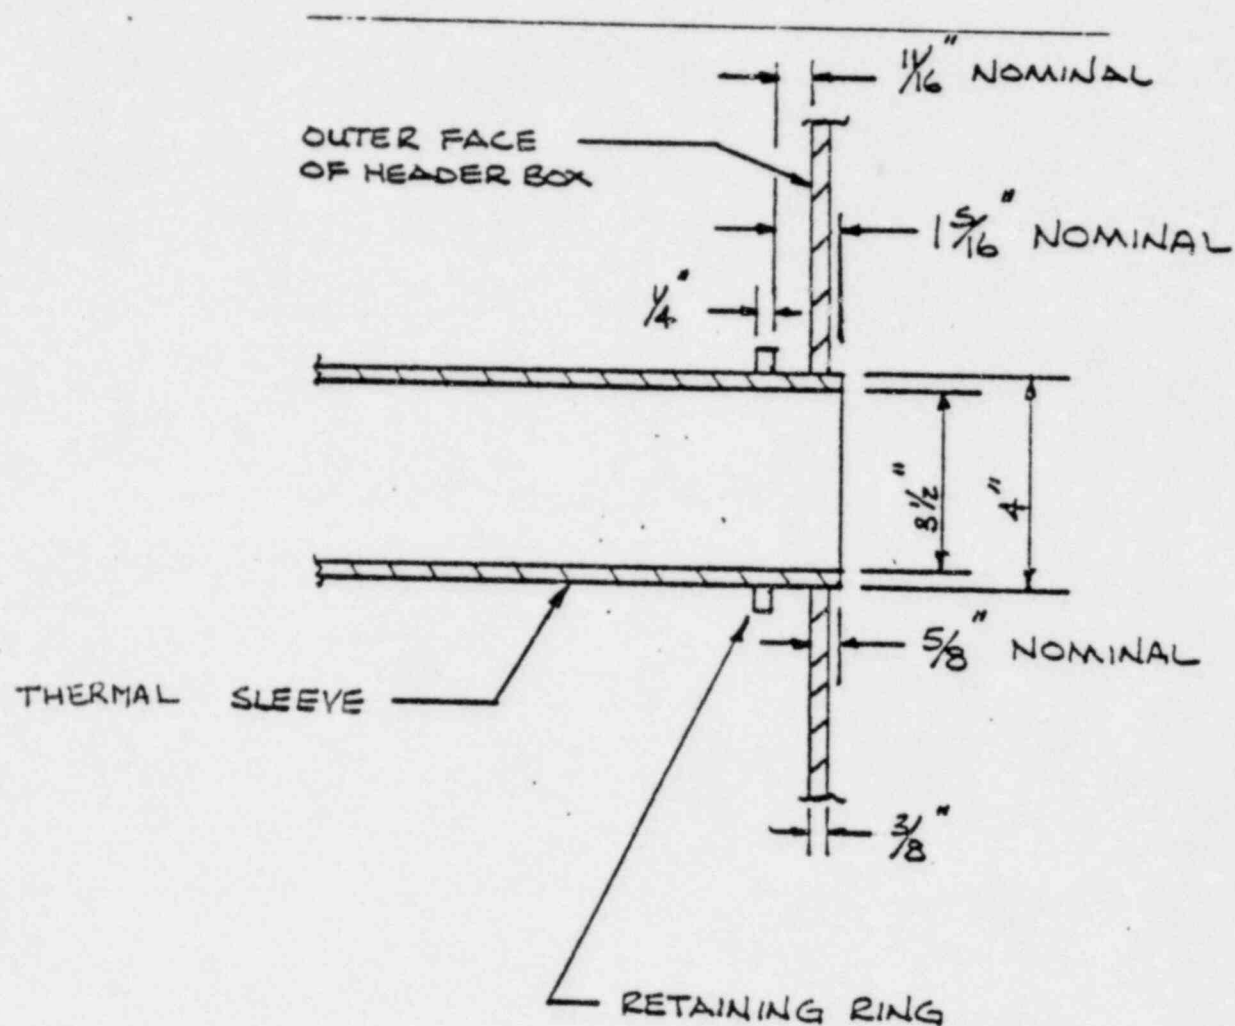
AUXILIARY FEEDWATER SLEEVE/HEADER INTERFACE

1 The entire header is structurally sound. Other than the deformations previously noted, no indications of weld or material cracking have been found. The UT and PT examinations on the header at the manway of steam generator 1-2, and the PT examinations of the inner wall of the header, accessible through the auxiliary feedwater nozzle, support this finding. Preliminary results of the UT and PT examinations of the auxiliary feedwater nozzle area of the shell indicate that no damage occurred as a result of auxiliary feedwater splashing back on the nozzle from the misalignment between the header and the thermal sleeve on steam generator 1-1.

Corrective Action: Two major objectives must be satisfied by the corrective actions taken for this problem. The existing internal auxiliary feedwater header must be restrained to preclude further damage to the steam generator tubes, and a means to inject auxiliary feedwater to the steam generators must be provided. To satisfy these objectives the internal auxiliary feedwater header will be attached to the shroud on which it currently rests, and an external auxiliary feedwater ring will be installed with eight injection nozzles to provide auxiliary feedwater flow. The existing auxiliary feedwater nozzle will be blank flanged and the internal header will not be used for flow distribution.

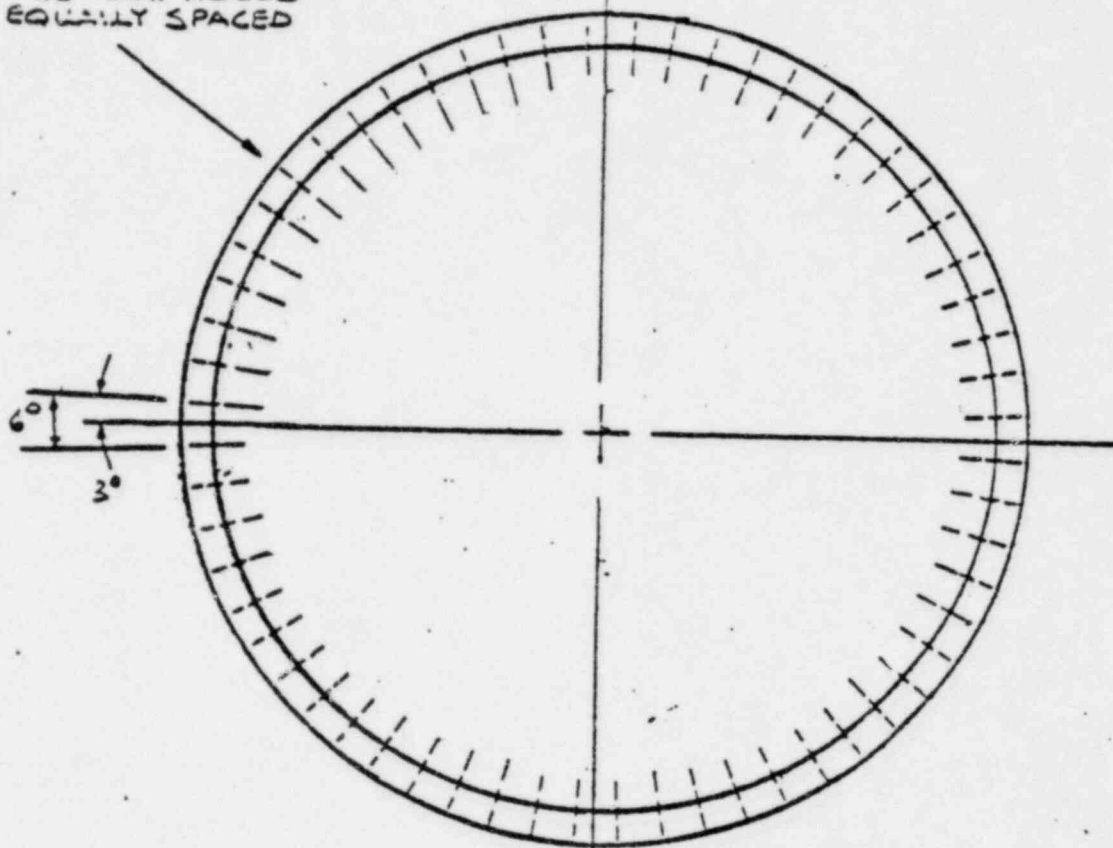
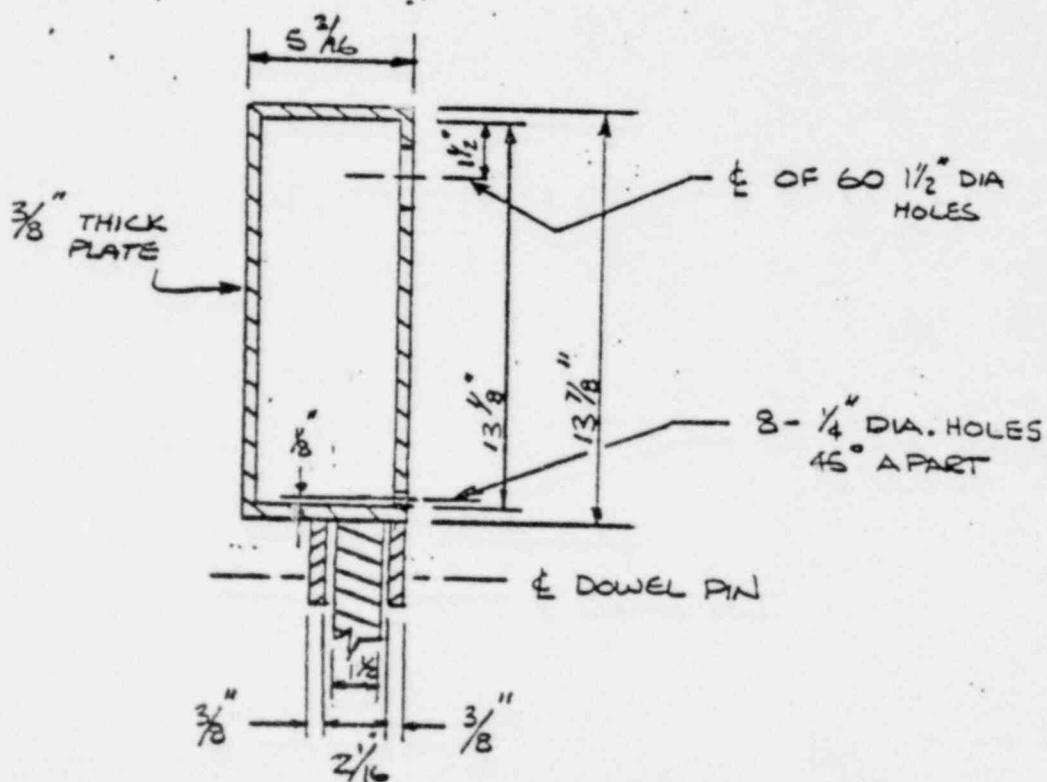
LOCATION OF AUXILIARY FEEDWATER

60 1/2" DIA. HOLES  
EQUALLY SPACED
